**PRELIMINARY ENGINEERING GEOLOGIC AND
GEOTECHNICAL INVESTIGATION:**

DARK GULCH CROSSING STABILIZATION PROJECT
Pescadero Creek County Park
San Mateo County, CA

March 2019 (revised)

Job: SMRCD-DARKGULCH-775

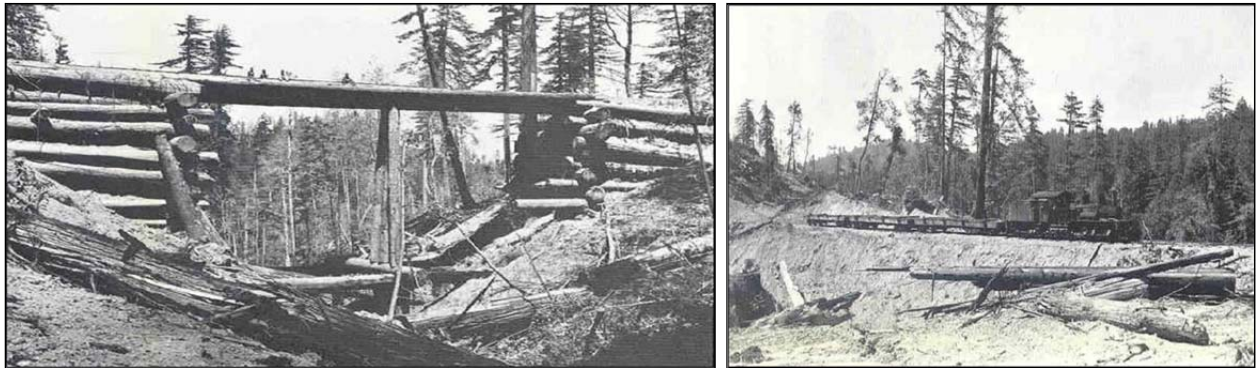
Photo 1: Rail crossings on Old Haul Road circa 1940s. Left Photo (A) shows trestle and possible crib log box culvert. Note the men sitting on top of the crossing. (Santa Cruz Lumber Company photo (1943)). Right Photo (B) is an example of large fill embankment. (Jack Gison photo (1947)). Both photos referenced in Dwight Ennis, <http://www.santacruzlumberco.com/index1.htm>

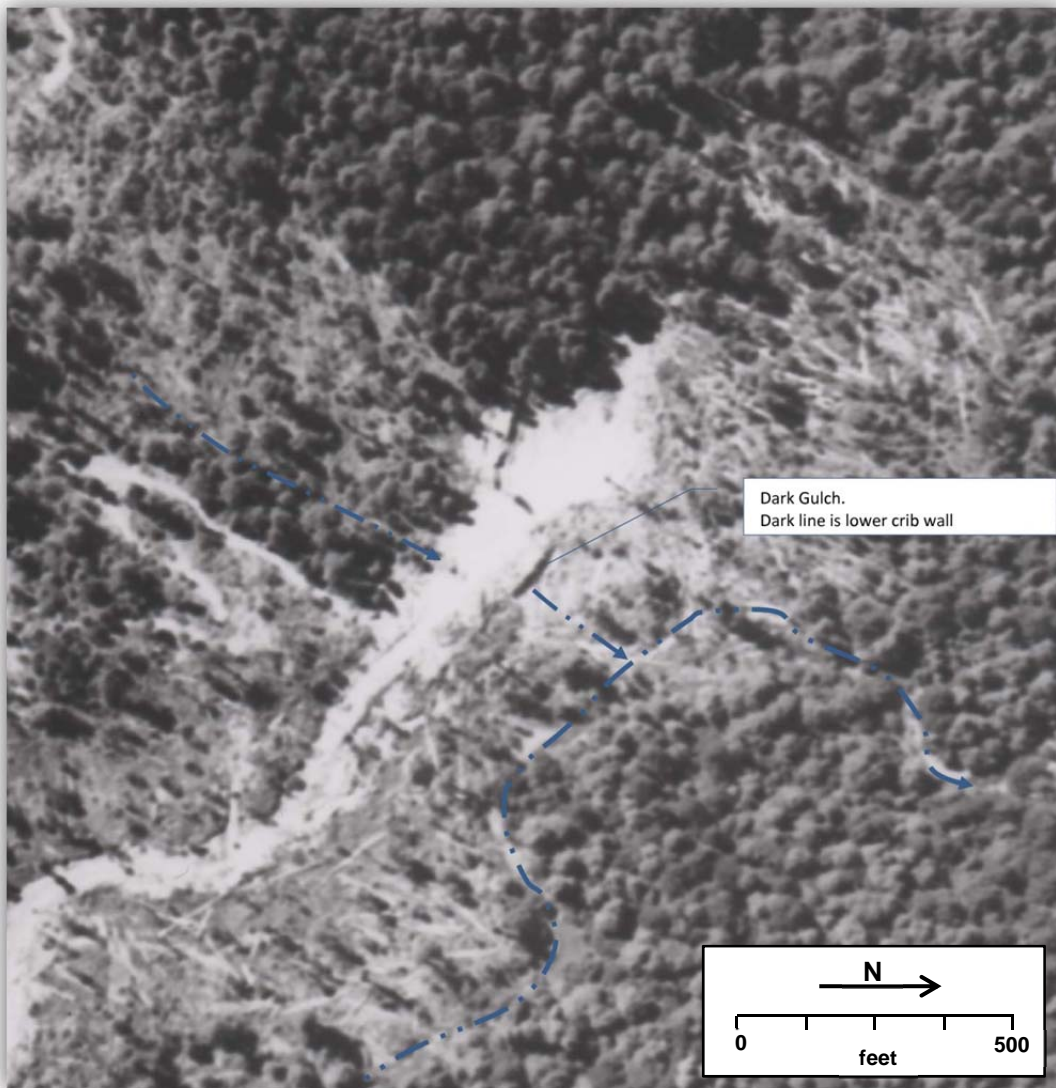
The Dark Gulch crossing is visible in the 1948 aerial photographs (Photo 2) which shows bare ground along the Old Haul Road, the downstream crib wall and the large landing located to the west of the crossing. The upstream wall is not apparent in the aerial photographs due to the ground in that area appearing washed out in the photos. The area extending upstream along Pescadero Creek had been tractor harvested and the area downstream not yet reentered.

Photo 2: 1948 aerial photograph of Dark Gulch. The rail line appears to have been recently constructed down to this point. The photo clearly shows the shadow formed by the downstream cribwall. The upstream wall is not apparent due to the photo being washed out in that area. To the right of the crossing is a large landing. The spoils from the construction of this landing were likely used to infill Dark Gulch.

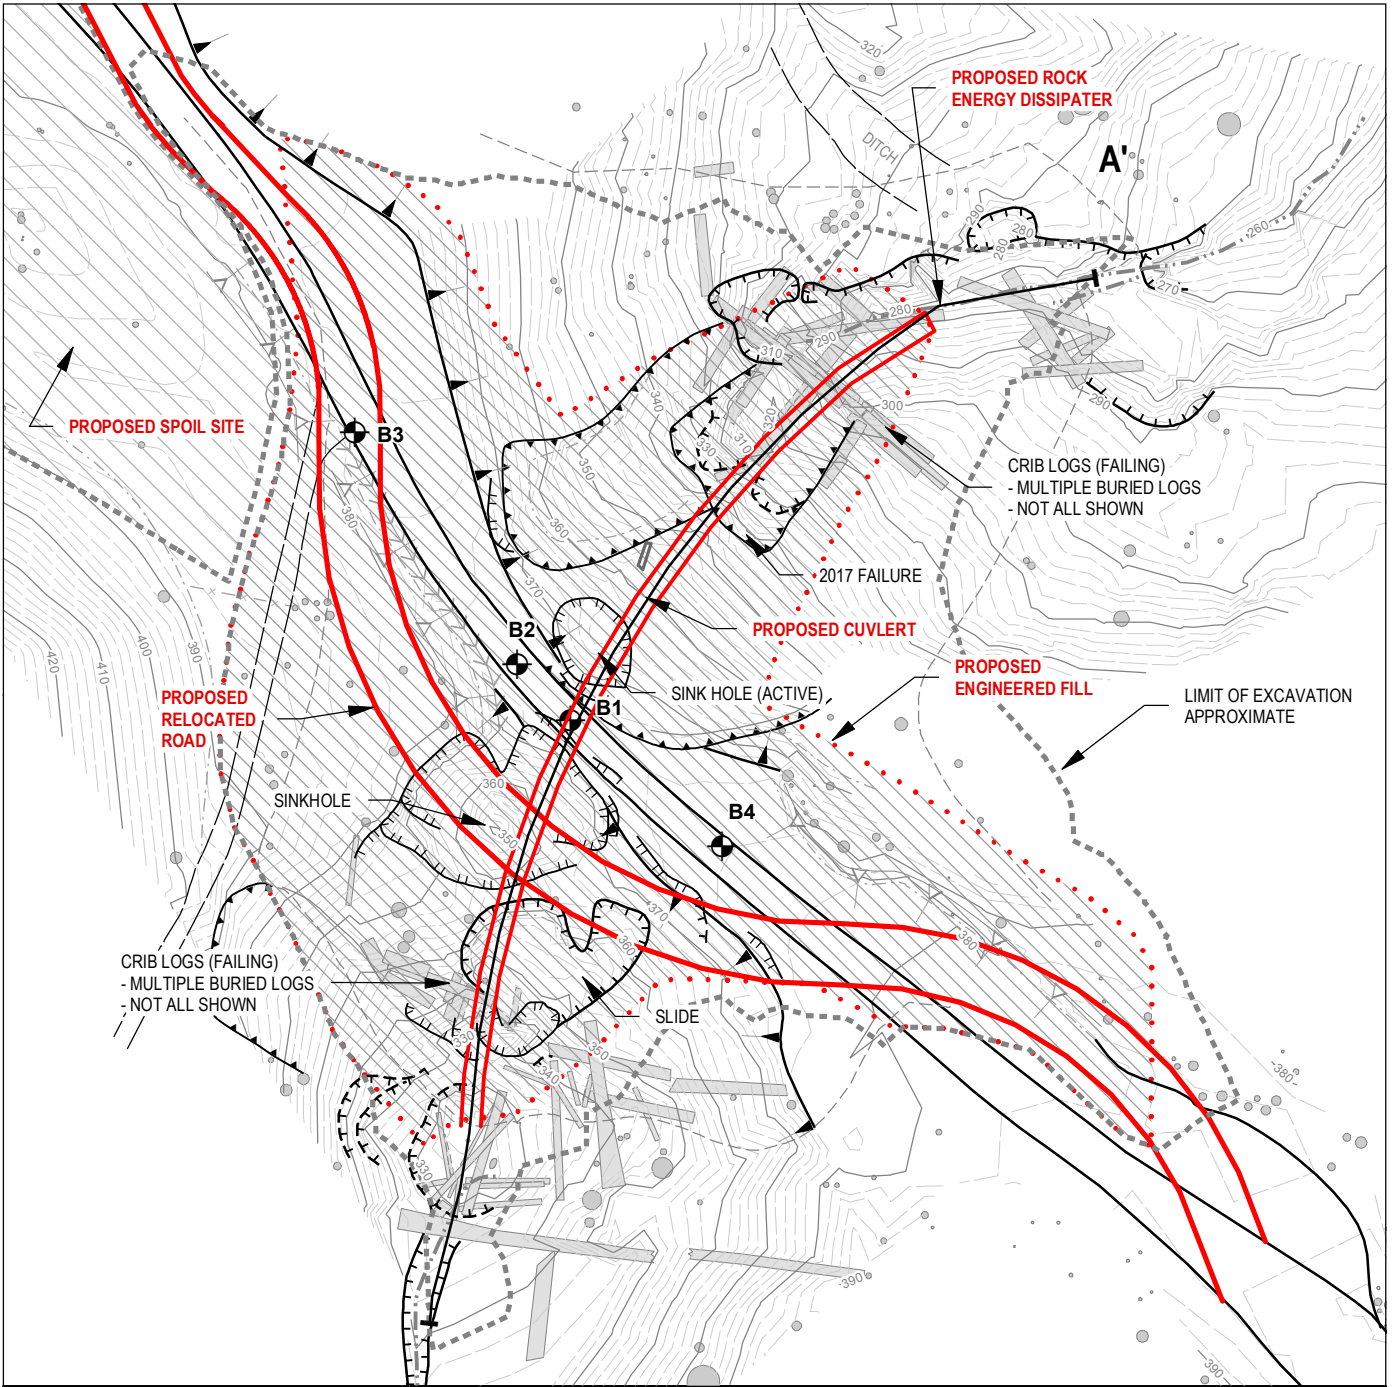
FIGURE 3

The fill consisted primarily of loose to medium dense silty sand to sandy silt with generally little organic material of significance to a depth of 69 feet, which correlates well to what would be predicted from interpretation of site topography. The lateral limits of fill are depicted on Figure 3

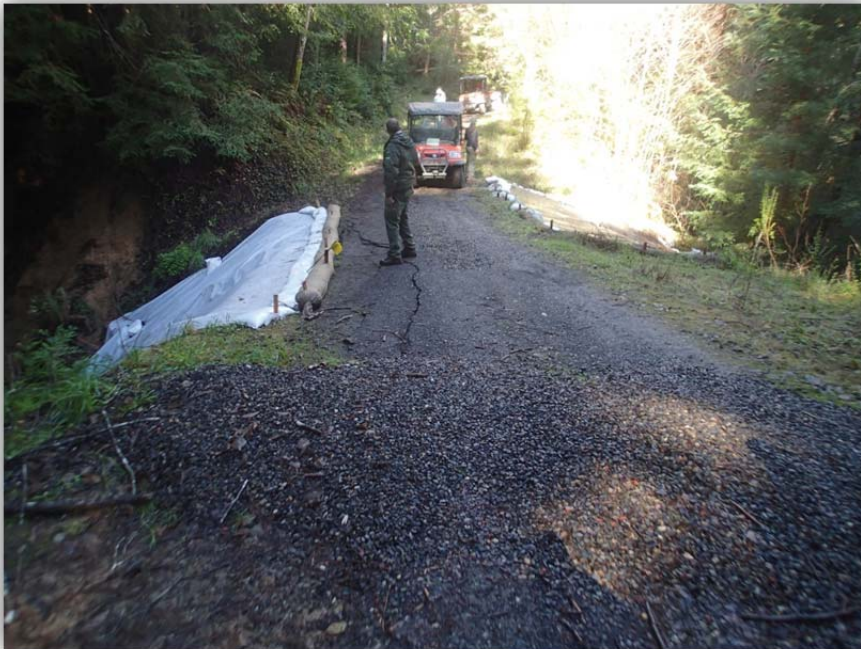
On the upstream side of the crossing is a 40 foot diameter sinkhole and a small debris flow. In 1996 Tom Spittler (CGS Engineering Geologist) noted erosion at this site and commented that an attempt appeared to have been made to repair it with end dumped rock. That attempt was only partially successful and only temporarily beneficial. Enlargement of this sinkhole has continued to occurred.

On the upstream side of the crossing this included deepening and expansion of the large sinkhole, cracking and incipient instability of the fill embankment, and erosion and small slope failures along the toe of the fill.

Photo 3 Photo shows cracking of road prism around upstream sinkhole. The sinkhole has been covered with plastic tarp.

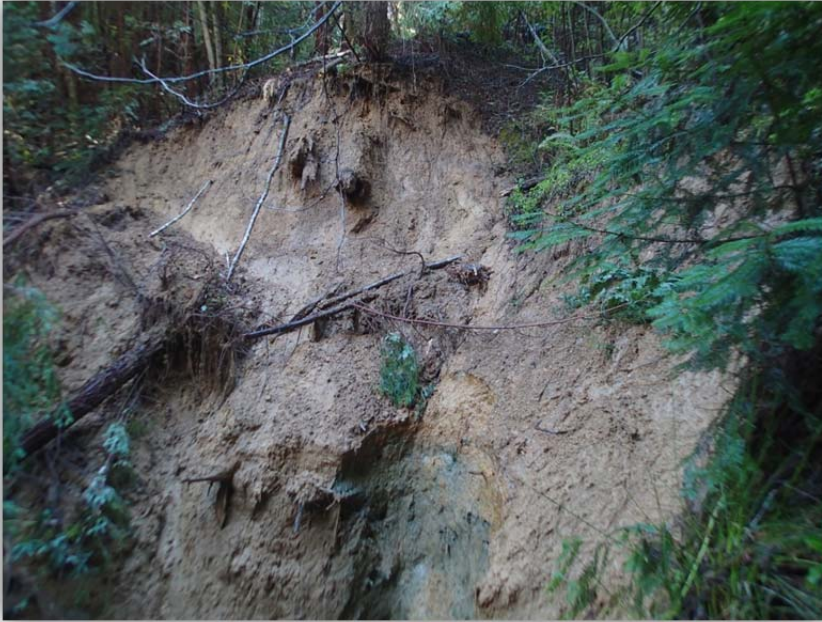
On the downstream side of the crossing the 2017 erosion and instability included the failure of a 40'L x 40'W x 4'+ D portion of the fill embankment as a debris slide behind the crib logs with this portion of the slope now no longer supported by the logs. In addition, significant expansion and deepening in the smaller sinkhole, erosion where stream flow emerges from the toe of the fill embankment, and local incipient cracking the fill face.

Photo 4 Photo showing upper 2017 slide scar

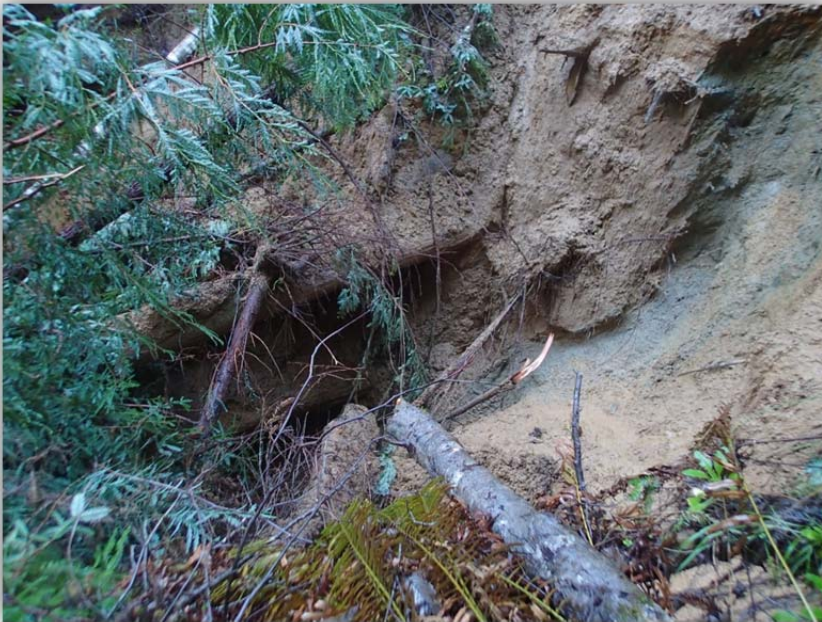
Photo 5 Photo showing lower portion of the 2017 slide scar. The cribwall that had supported the fill embankment is to the left of the photos. The exposed logs are the tie back logs that extended back into the fill prism and proving the structural integrity to the cribwall. With these logs now exposed the structural integrity if the wall has been compromised.

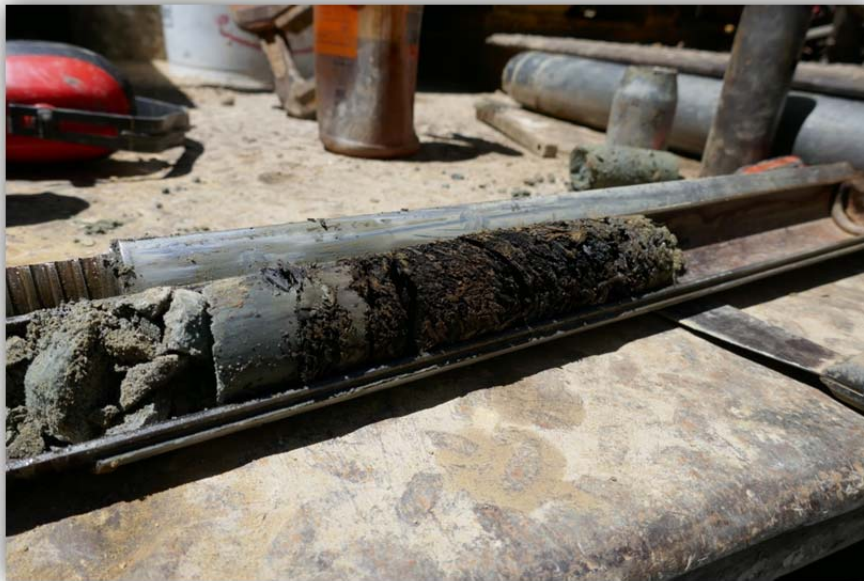
The bottom of Boring B-1 encountered an old redwood log or root on top of sandstone bedrock. No clayey organic rich soils were encountered. This suggests that a stable footing to the fill embankment exists, which is positive for crossing reconstruction.

Photo 6 Photo of the core sample taken near the end of Boring B1. The photo shows the log at the base of the fill (to the right) on top of sandstone bedrock (to the left)
