### **Butano Creek Channel Reconnection & Resiliency Project**

### **Project Completion Report**

Date:	February 24, 2020
То:	Jim Robins (Alnus Ecological/SMRCD), Andrew Hall (SMRCD)
From:	Sam Diaz, Rafael Rodriguez, Jai Singh and Chris Hammersmark (cbec inc.)
Project:	16-1027-4 – Butano Creek Channel Reconnection and Resilience Project
Subject:	As-Built Survey and Variances from Design

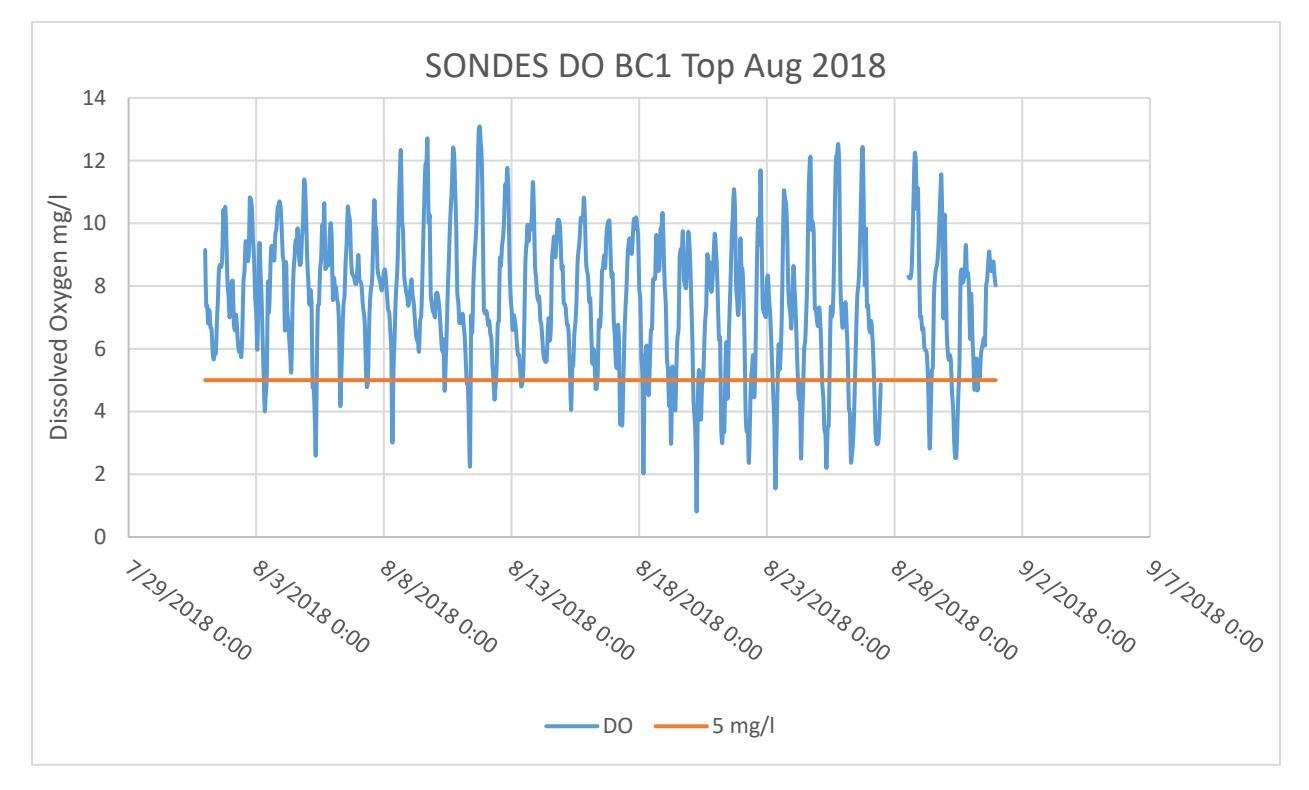
Figure 1. Chart showing the diurnal pattern of dissolved oxygen in Butano Creek (BC1) 0.25m below the water surface during Aug 2018. Of note is the frequency with which the DO drops below 5 mg/l in the late evening/ early morning.

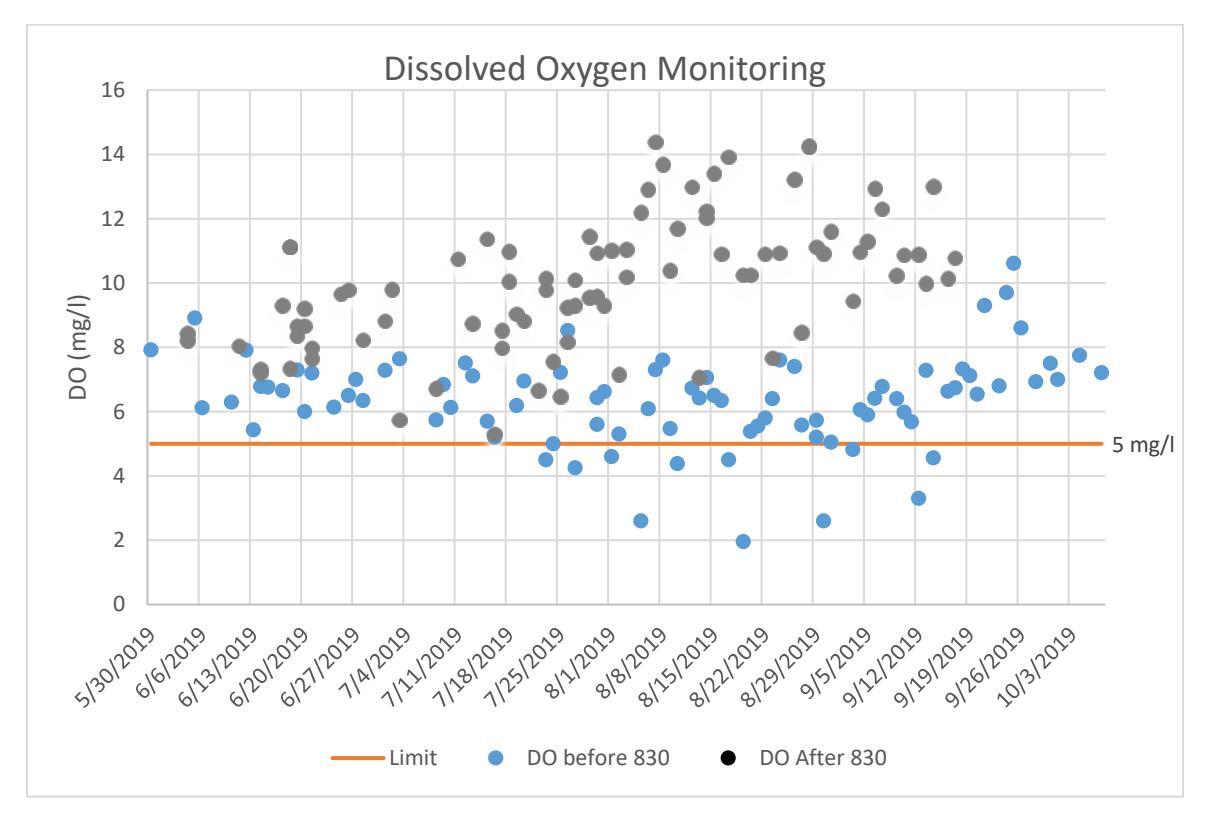
Figure 2. Point data showing dissolved oxygen (mg/l) at site BC1S. Blue points represent readings taken before 0830, when there was often a dense marine layer and no wind. Black points represent points taken after 0830 when sunlight and wind became more prevalent.

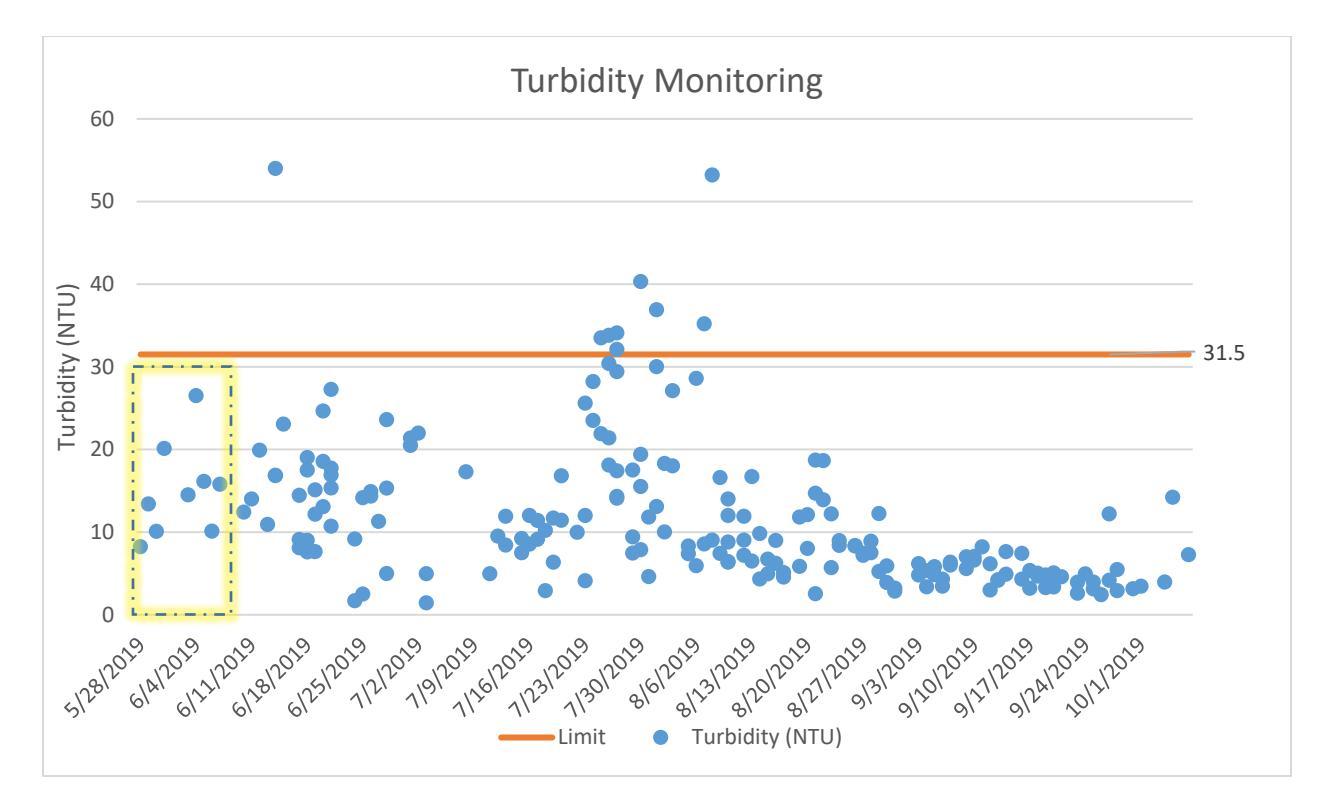
Figure 3. Point data showing suspended sediment concentrations in NTU's at site BC1S. The red line represents the limit set by project permits. Baseline turbidity monitoring is represented by points within the yellow dashed area.

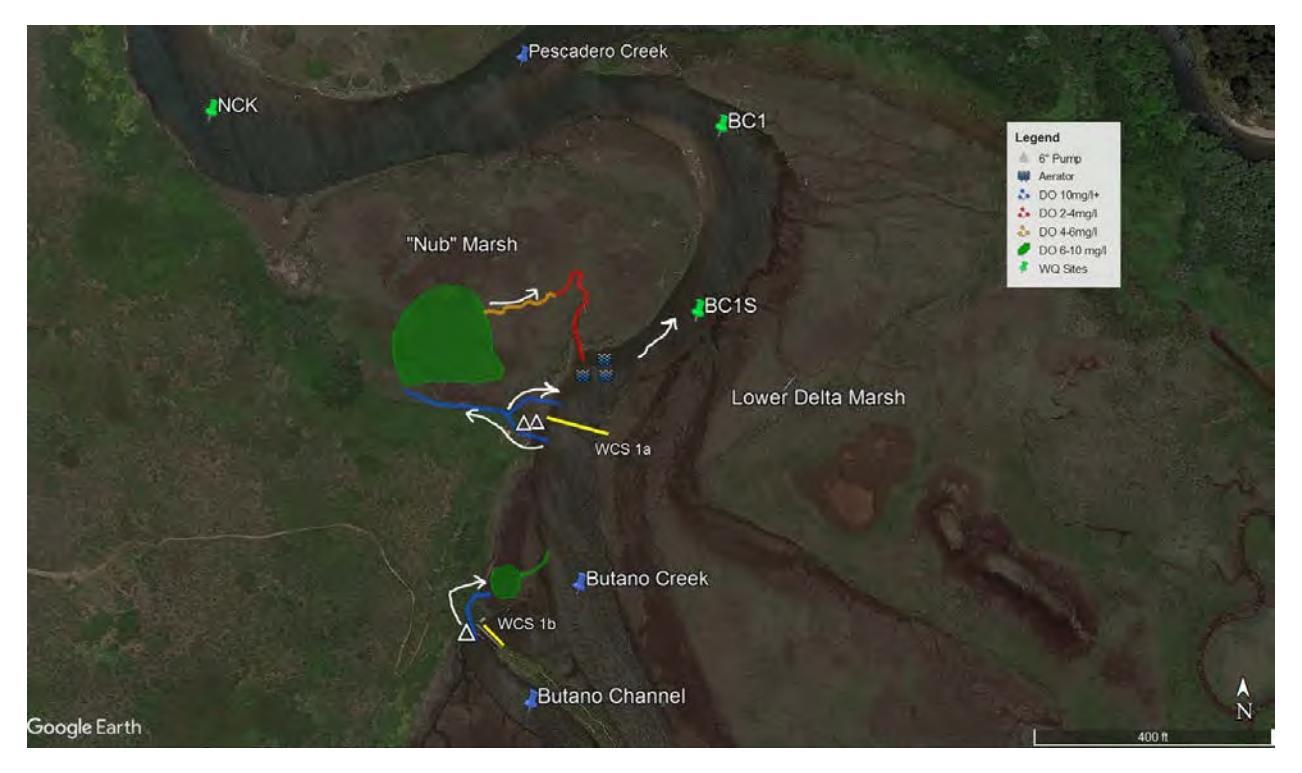
*Figure 4. Visualization of significant water control features of the Butano Creek Reconnection Project and the progression of dissolved oxygen in discharged water.*

<u>8/17/19</u>: At 0738, DO was recorded at 4.50 mg/l. As of 8/15, HARC was no longer using the 6" pumps and water was being passively managed by opening the two culverts built into WCS 1a. There was no project related activity that could explain the drop in DO. The "nub" marsh plain had not been inundated since 8/10 and there was no residual flow coming from the channel besides normal tidal fluctuations. Looking at the SONDES data for the top of the Butano Creek 1 site, throughout the 2018 season, there are multiple instances of DO dropping well below 5 mg/l overnight (Figure 4). At 1427, DO was 10.9 mg/l.
