**Appendix A**  
**PILARCITOS INTEGRATED WATERSHED MANAGEMENT PLAN**  
**WATERSHED ASSESSMENT UPDATE**

**Pilarcitos Integrated Watershed Management Plan  
Watershed Assessment Update**

September 29, 2008

**PWA REF. # 1884 - T3A**

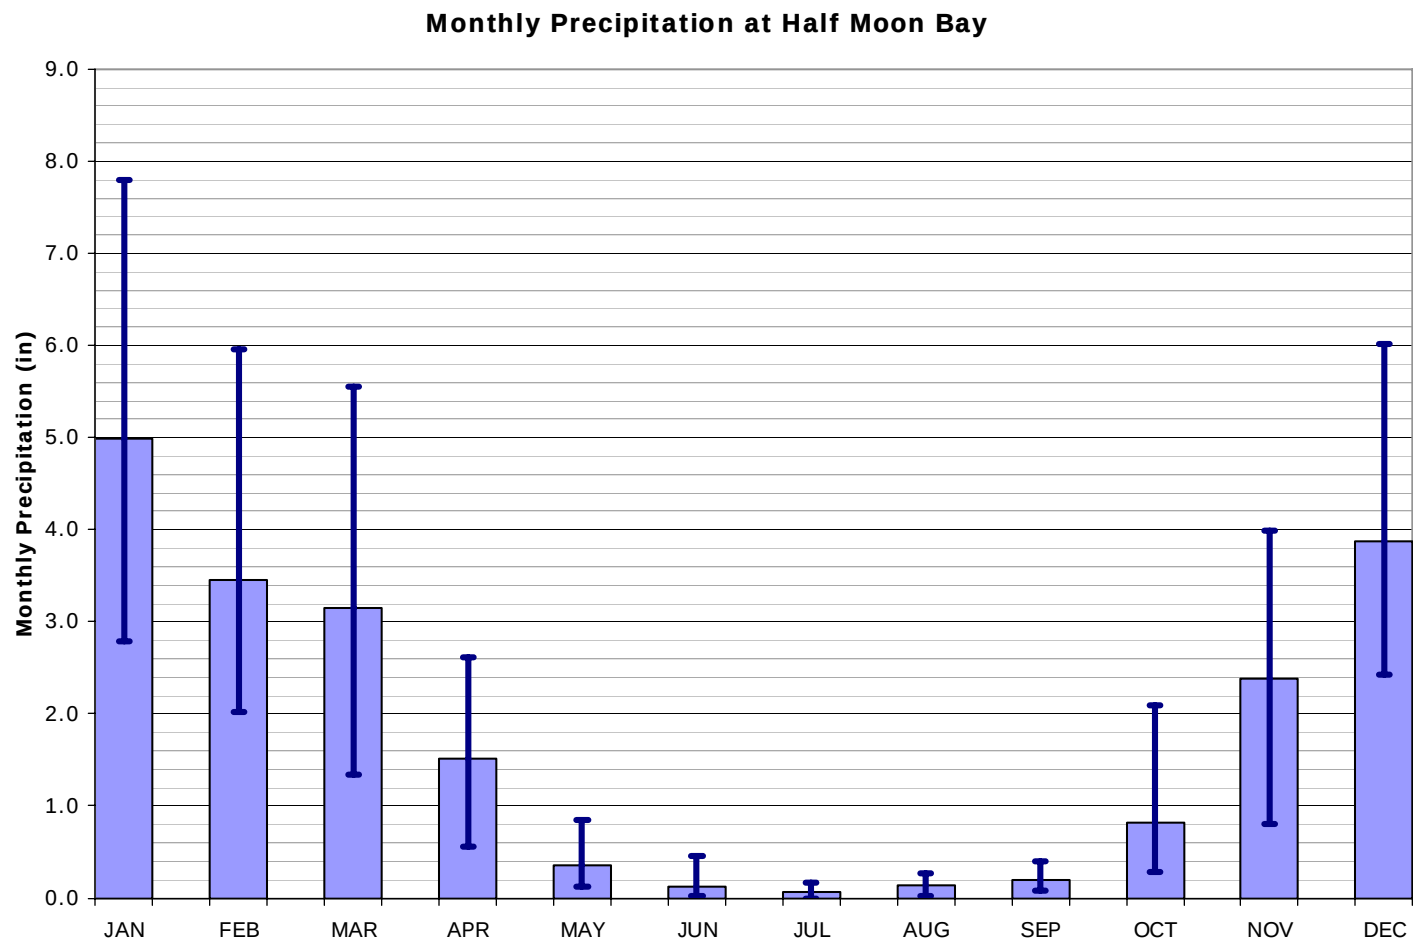
*figure 5*  
*Pilarcitos IWMP*

Notes: National Weather Service. Error bars represent the 25th and 75th percentile of the monthly precipitation distribution. Total length of record = 54-58 years.  
Source: Sound Watershed Consulting

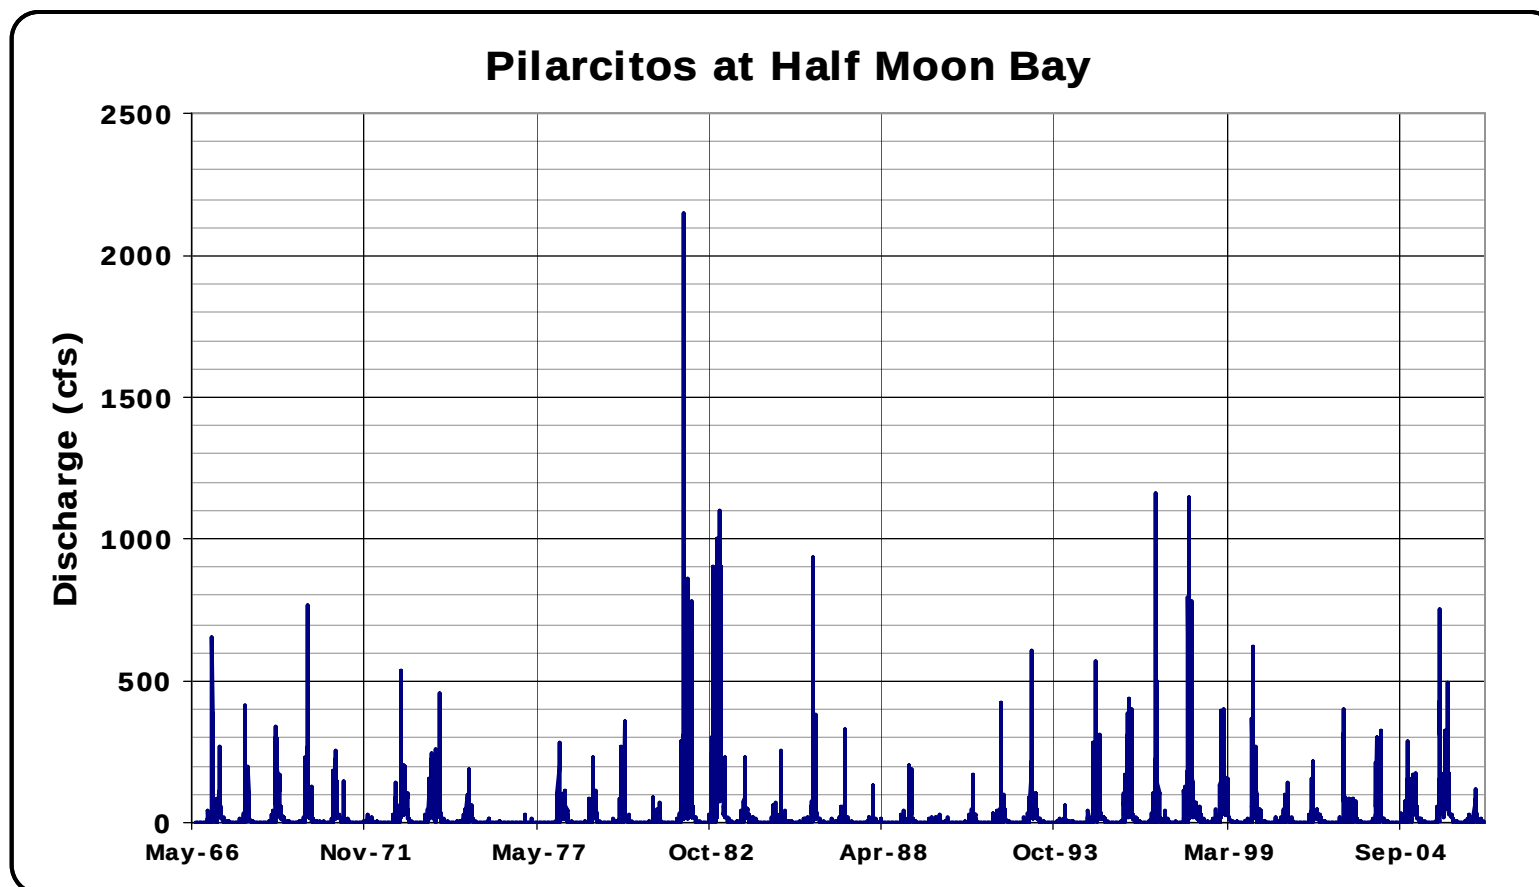
*figure 7*  
*Pilarcitos IWMP*

Notes: USGS Station (11162630)  
Source: Sound Watershed Consulting

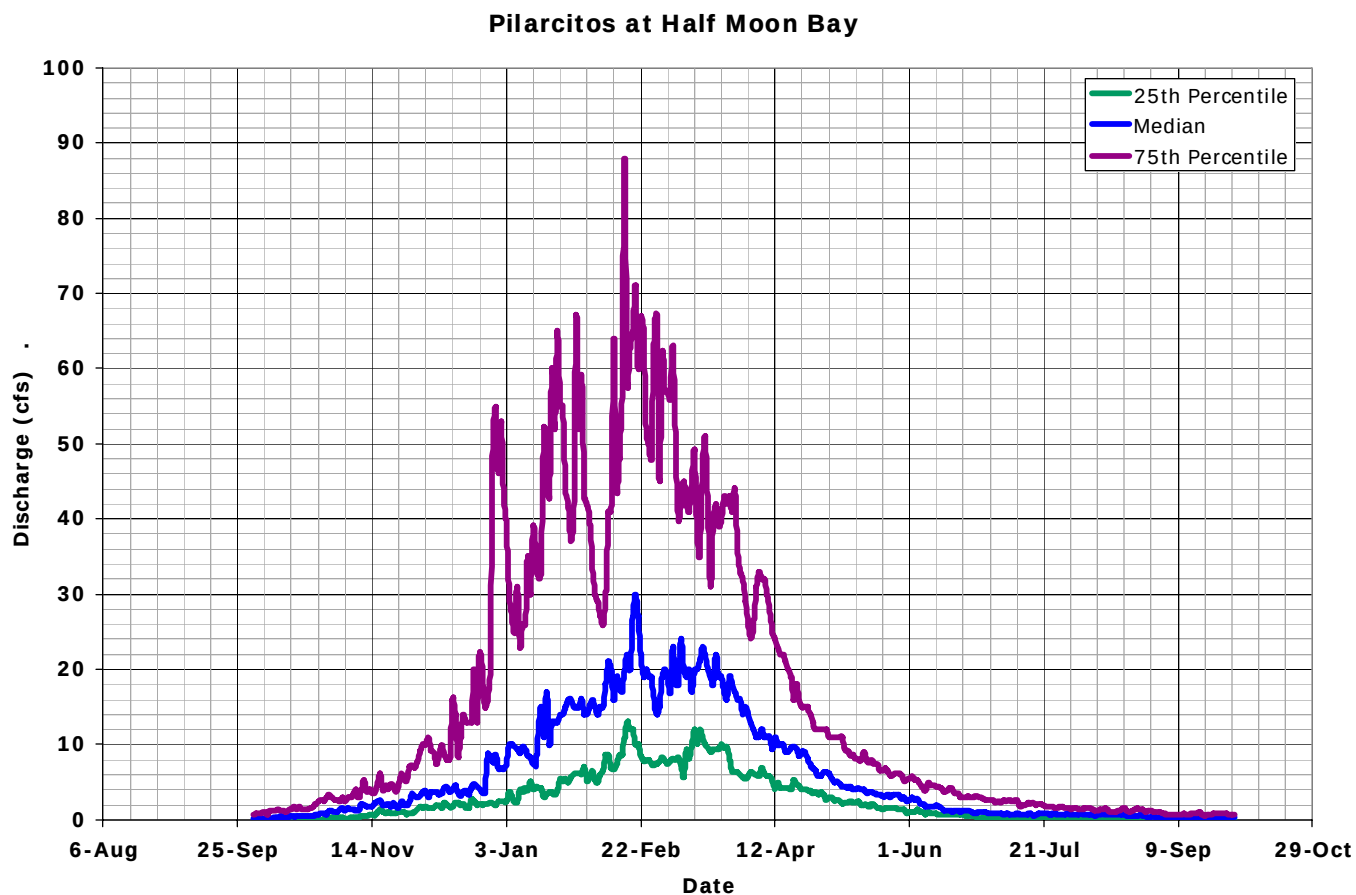
Notes: Annual hydrograph represents the typical conditions over the period of record. Flows below the 25th percentile typically indicate drought periods, while flows above the 75th percentile are typically considered unusually wet years.

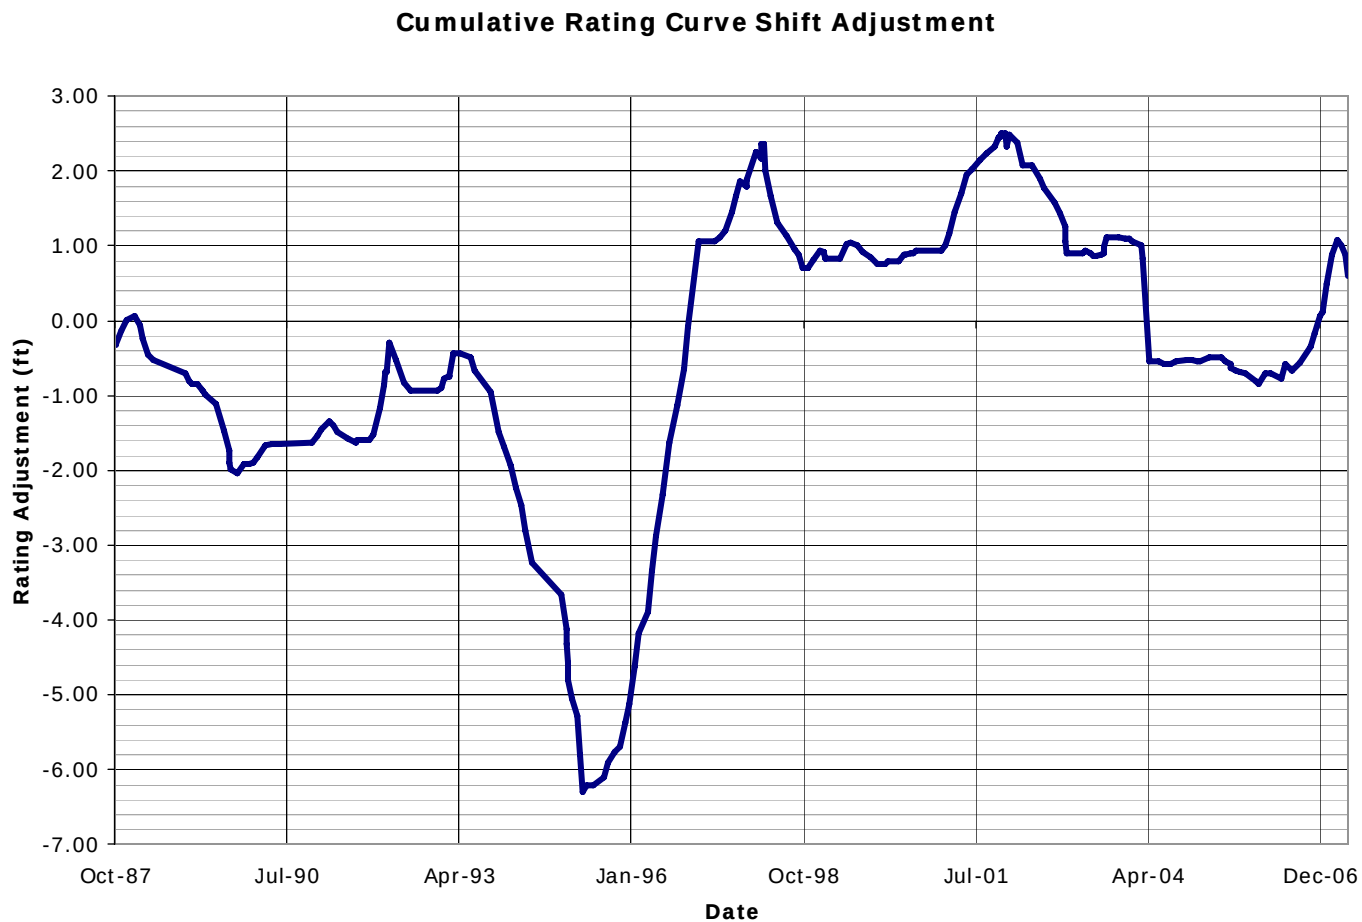
*figure 14*  
*Pilarcitos IWMP*

Notes: USGS station (11162630) measurement data. Plot indicates channel changes near the gage location that influence gage  
Source: Sound Watershed Consulting

The USGS has rated the stream gage below Stone Dam as “poor,” which implies that the hydraulic control at the stream gage location is significantly dynamic. This may be in part due to the very low quantity of discharge and the relatively small channel that can dramatically limit the accuracy of streamflow measurements. The existing rating curve for peak discharges (Figure 17) indicates that flows rarely exceed a stage of two feet. Observed shifts in the rating curve (Figure 17) suggest chronic aggradation prior to December 2002 when a significant channel change occurred (most likely a large deposit of sediment or debris). Based on the rating curve, the channel appears to have naturally recovered from this disturbance by October 2004 and has been relatively stable since.

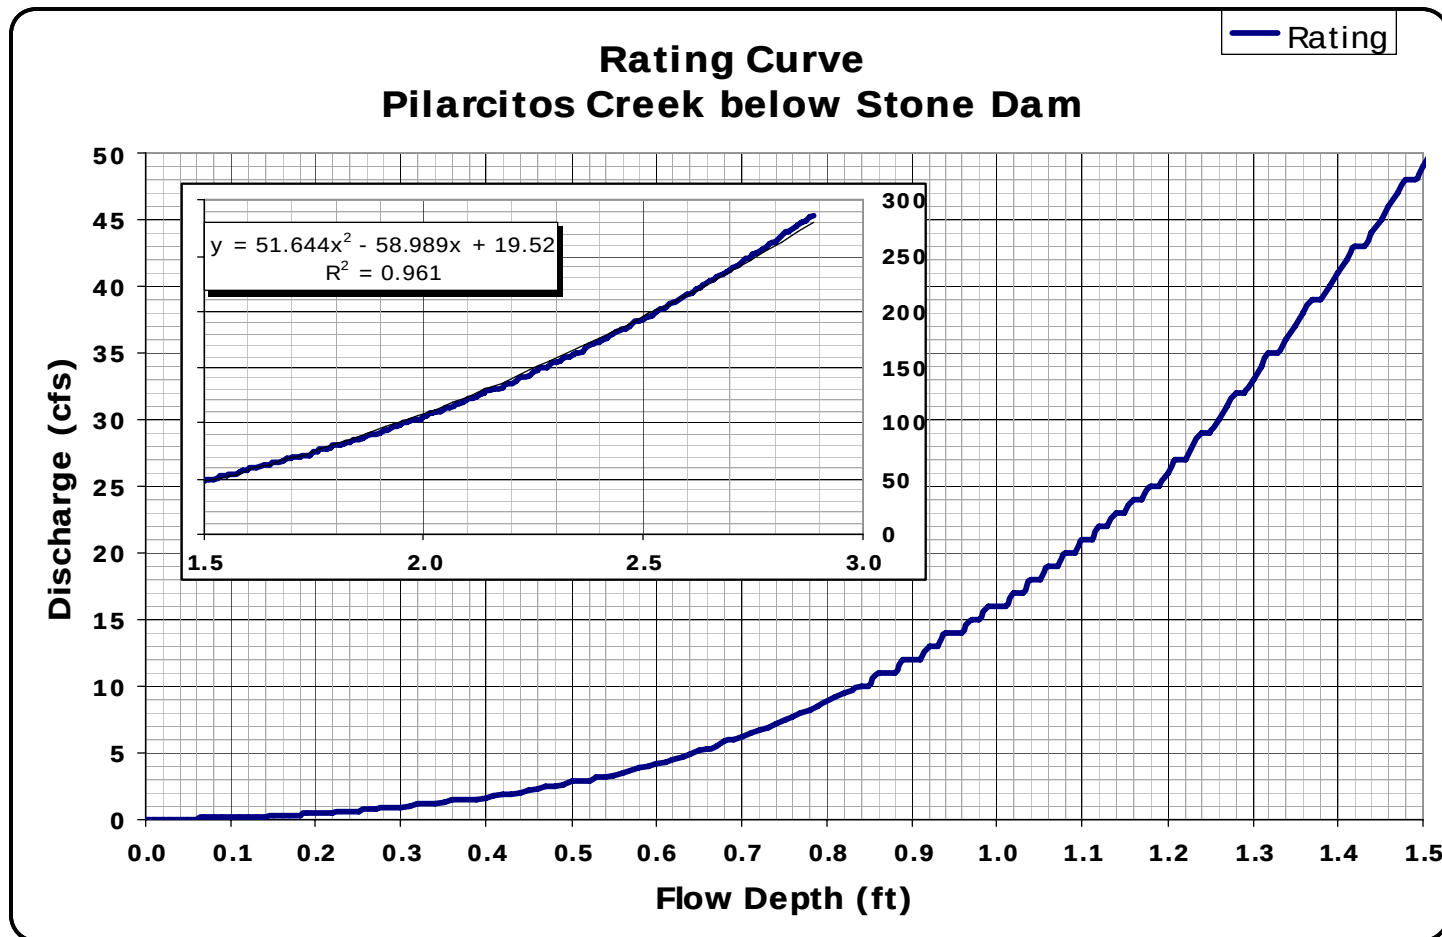
*figure 17*  
*Pilarcitos IWMP*

Notes: USGS gage 11162620 rating data  
Source: Sound Watershed Consulting

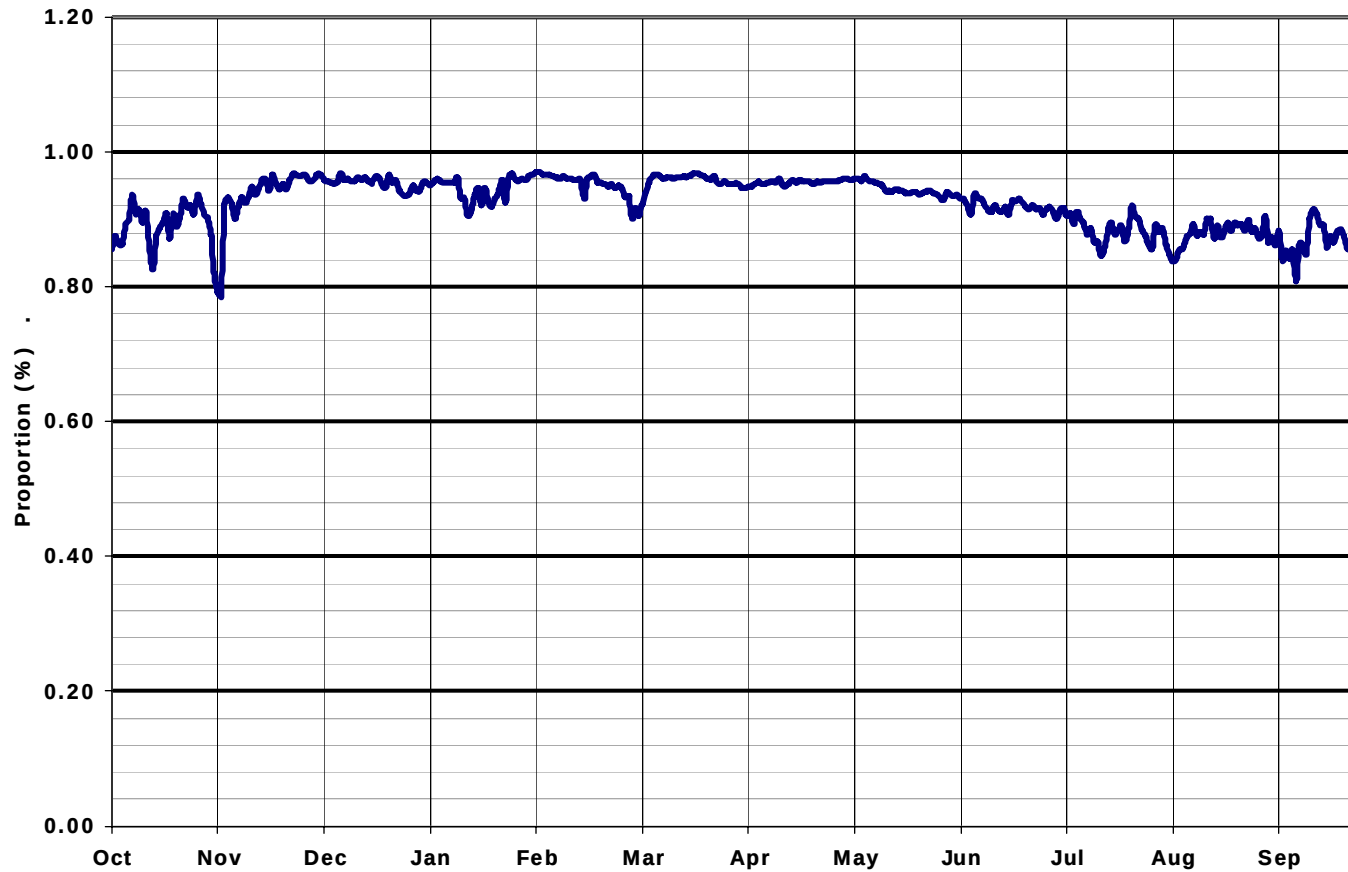
*figure 19*  
*Pilarcitos IWMP*

Proportion of Flow at Half Moon Bay from Lower Watershed

Notes: lower watershed includes all contributing area below Stone Dam.  
Source: Sound Watershed Consulting

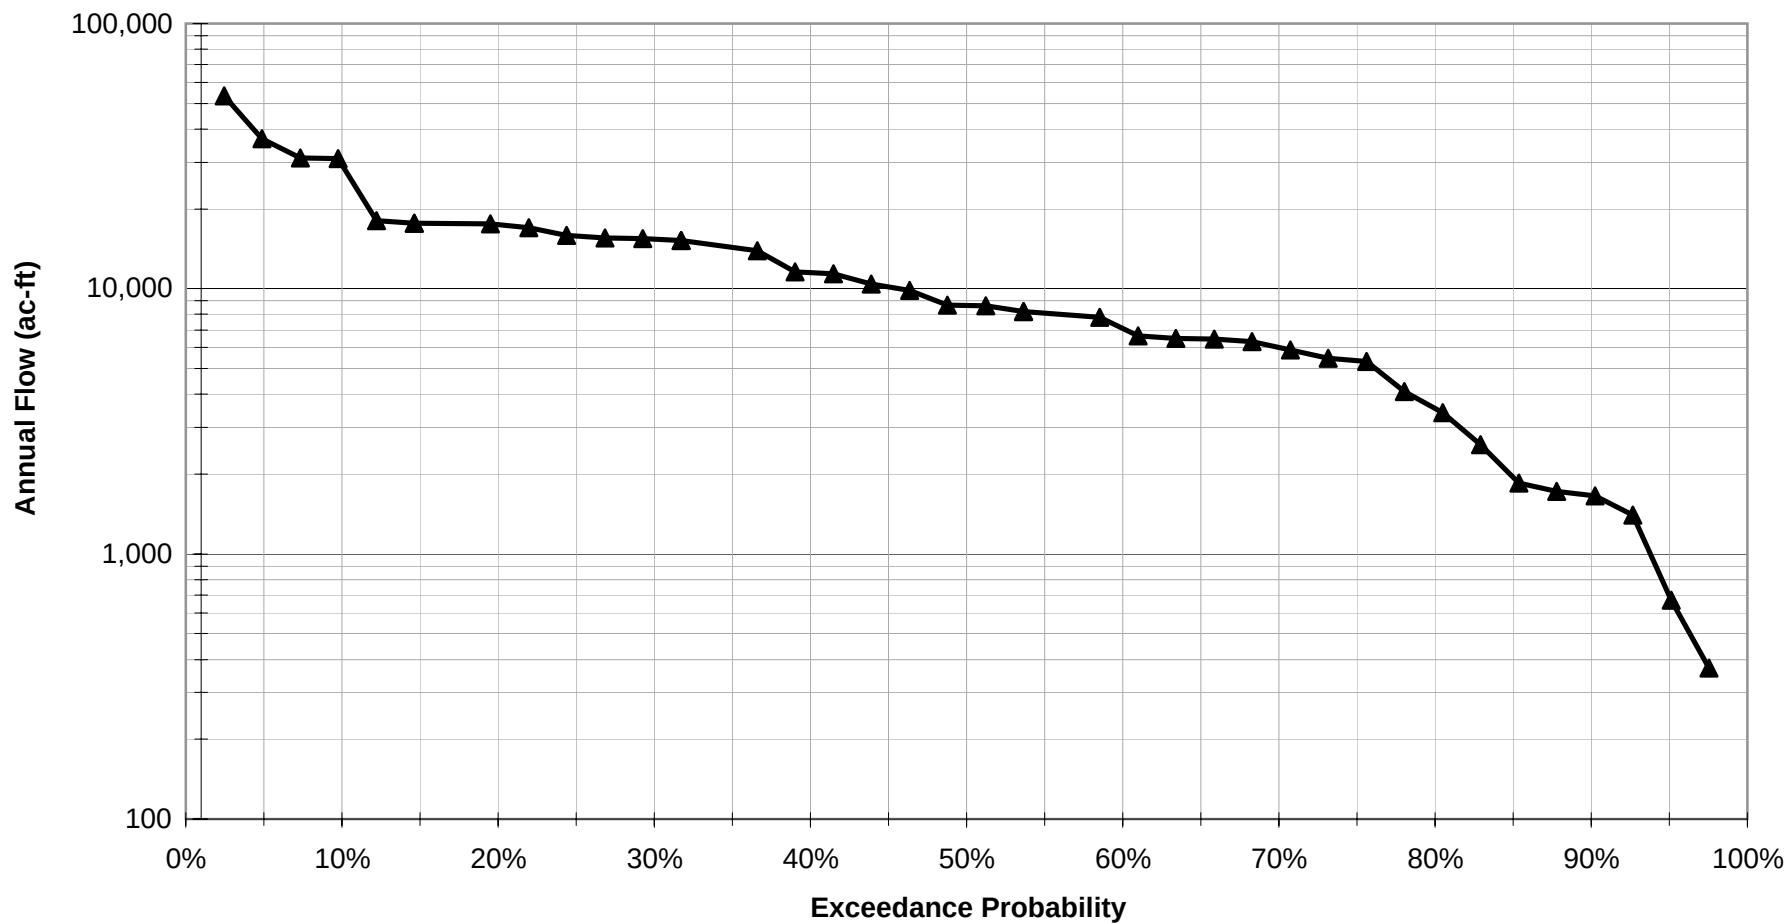
*figure 20*  
Pilarcitos IWMP

Annual Flow Exceedance Pilarcitos at Half Moon Bay

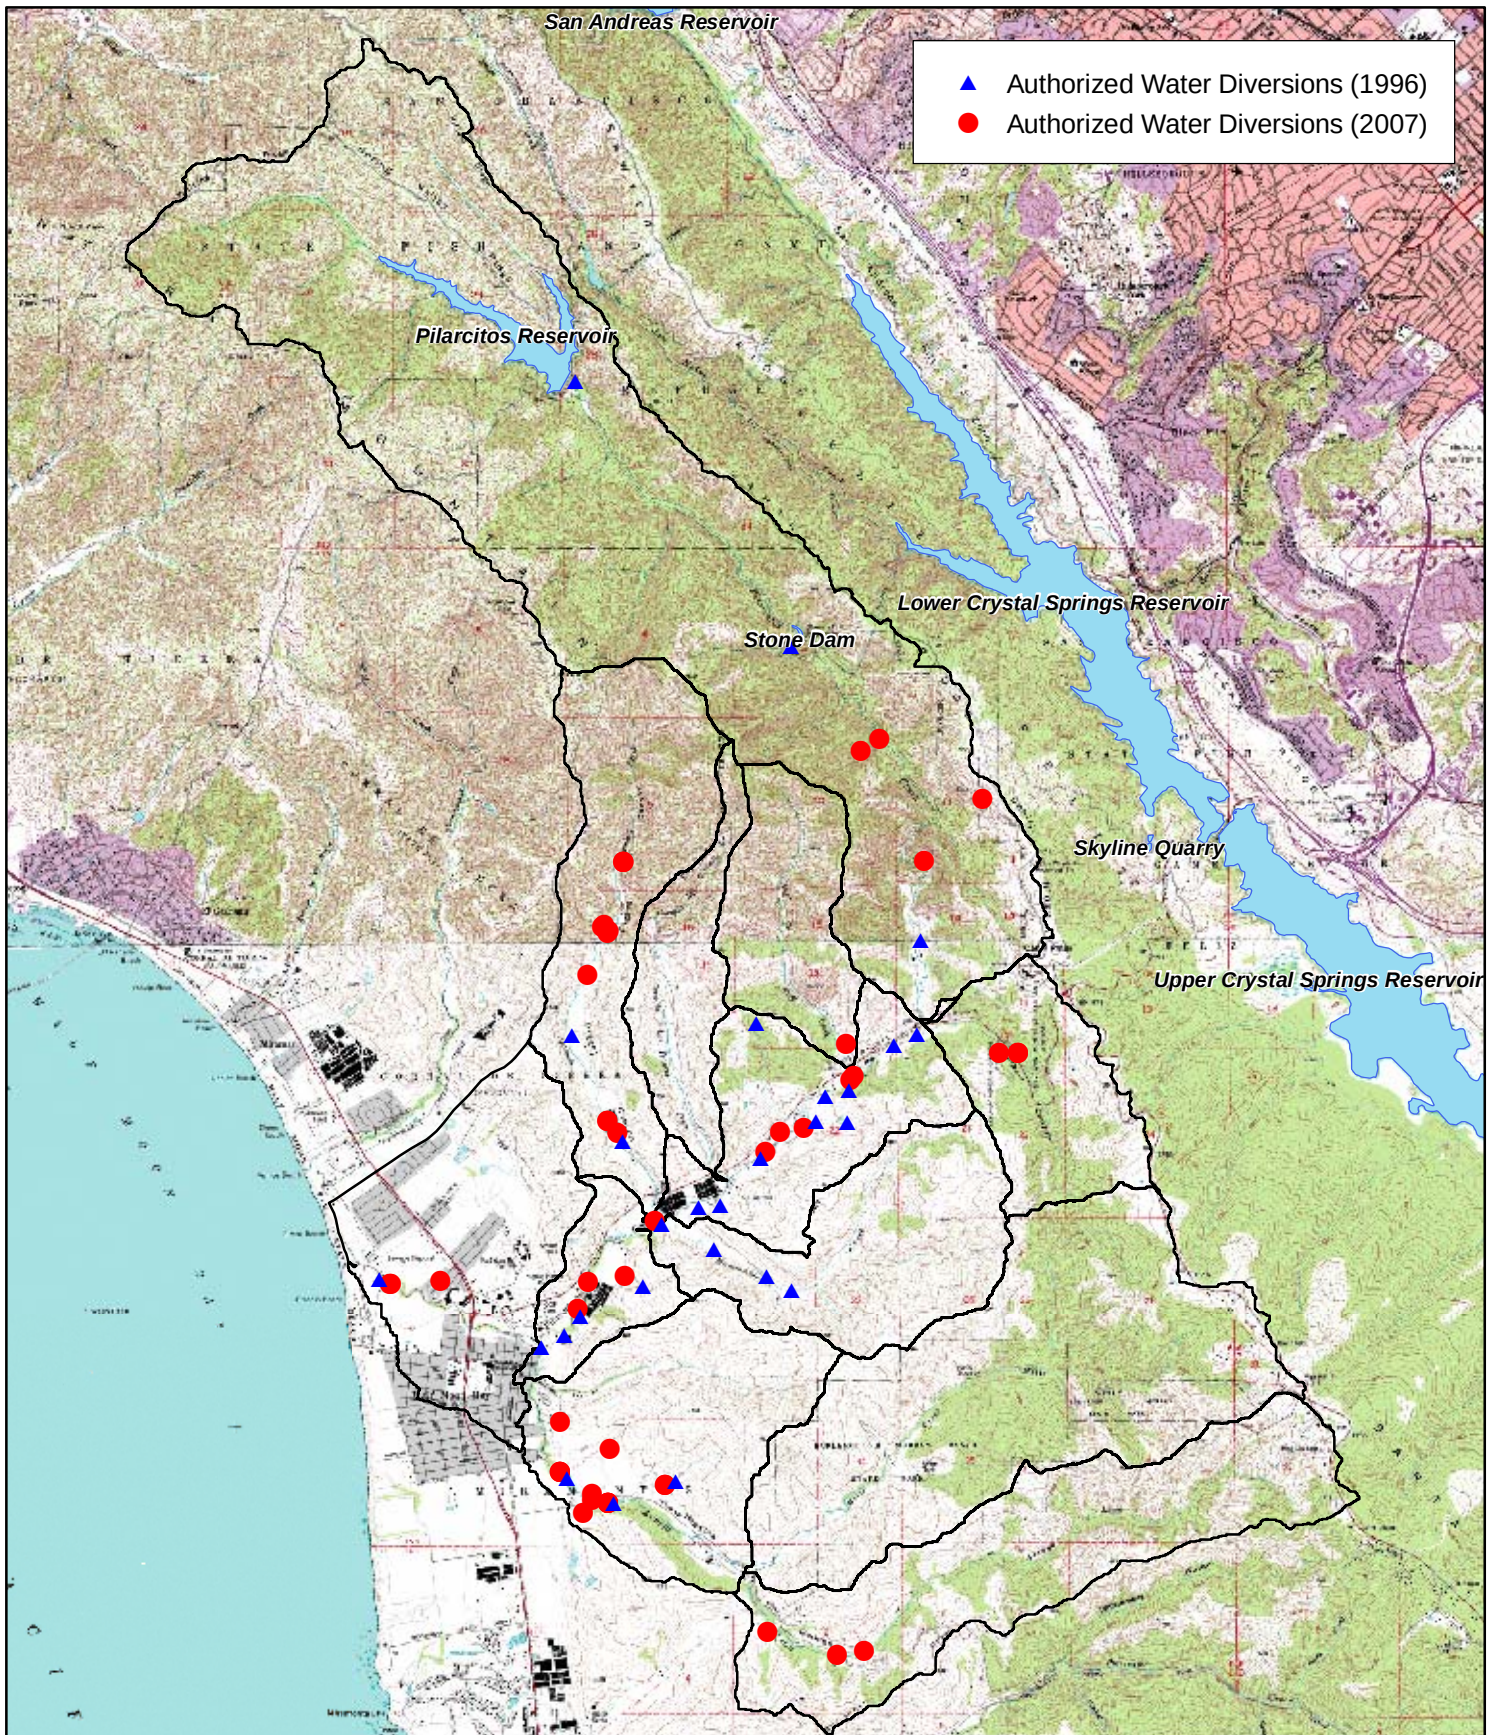
figure 22

Source: USGS (DRG), SFPUC (water bodies), 2007 Water Diversions were downloaded from the WRIMS State Water Resources Control Board database on June 21, 2007.

We updated the previous summary of permitted and unpermitted water rights diversions using SWRCB WRIMS database (<http://www.waterrights.ca.gov/> accessed on June 20, 2007). Figure 22 is a map of authorized diversions as registered at the WRIMS database from the Restoration Plan (PWA 1996) and from 2007. Table 7 summarizes permitted appropriative water rights diversions, as well as statements of pre-1914 diversions for each subwatershed. The amount of permitted appropriative diversions in the watershed total about 878 acre-feet per year. Most appropriative users are prohibited by conditions in their permit or licenses from diverting water during the summer. The amount of riparian diversion and pre-1914 appropriative diversions are reported in statements filed with the SWRCB as 2,296 acre-feet per year. The details of both permitted diversions and statements are provided in Table 7.

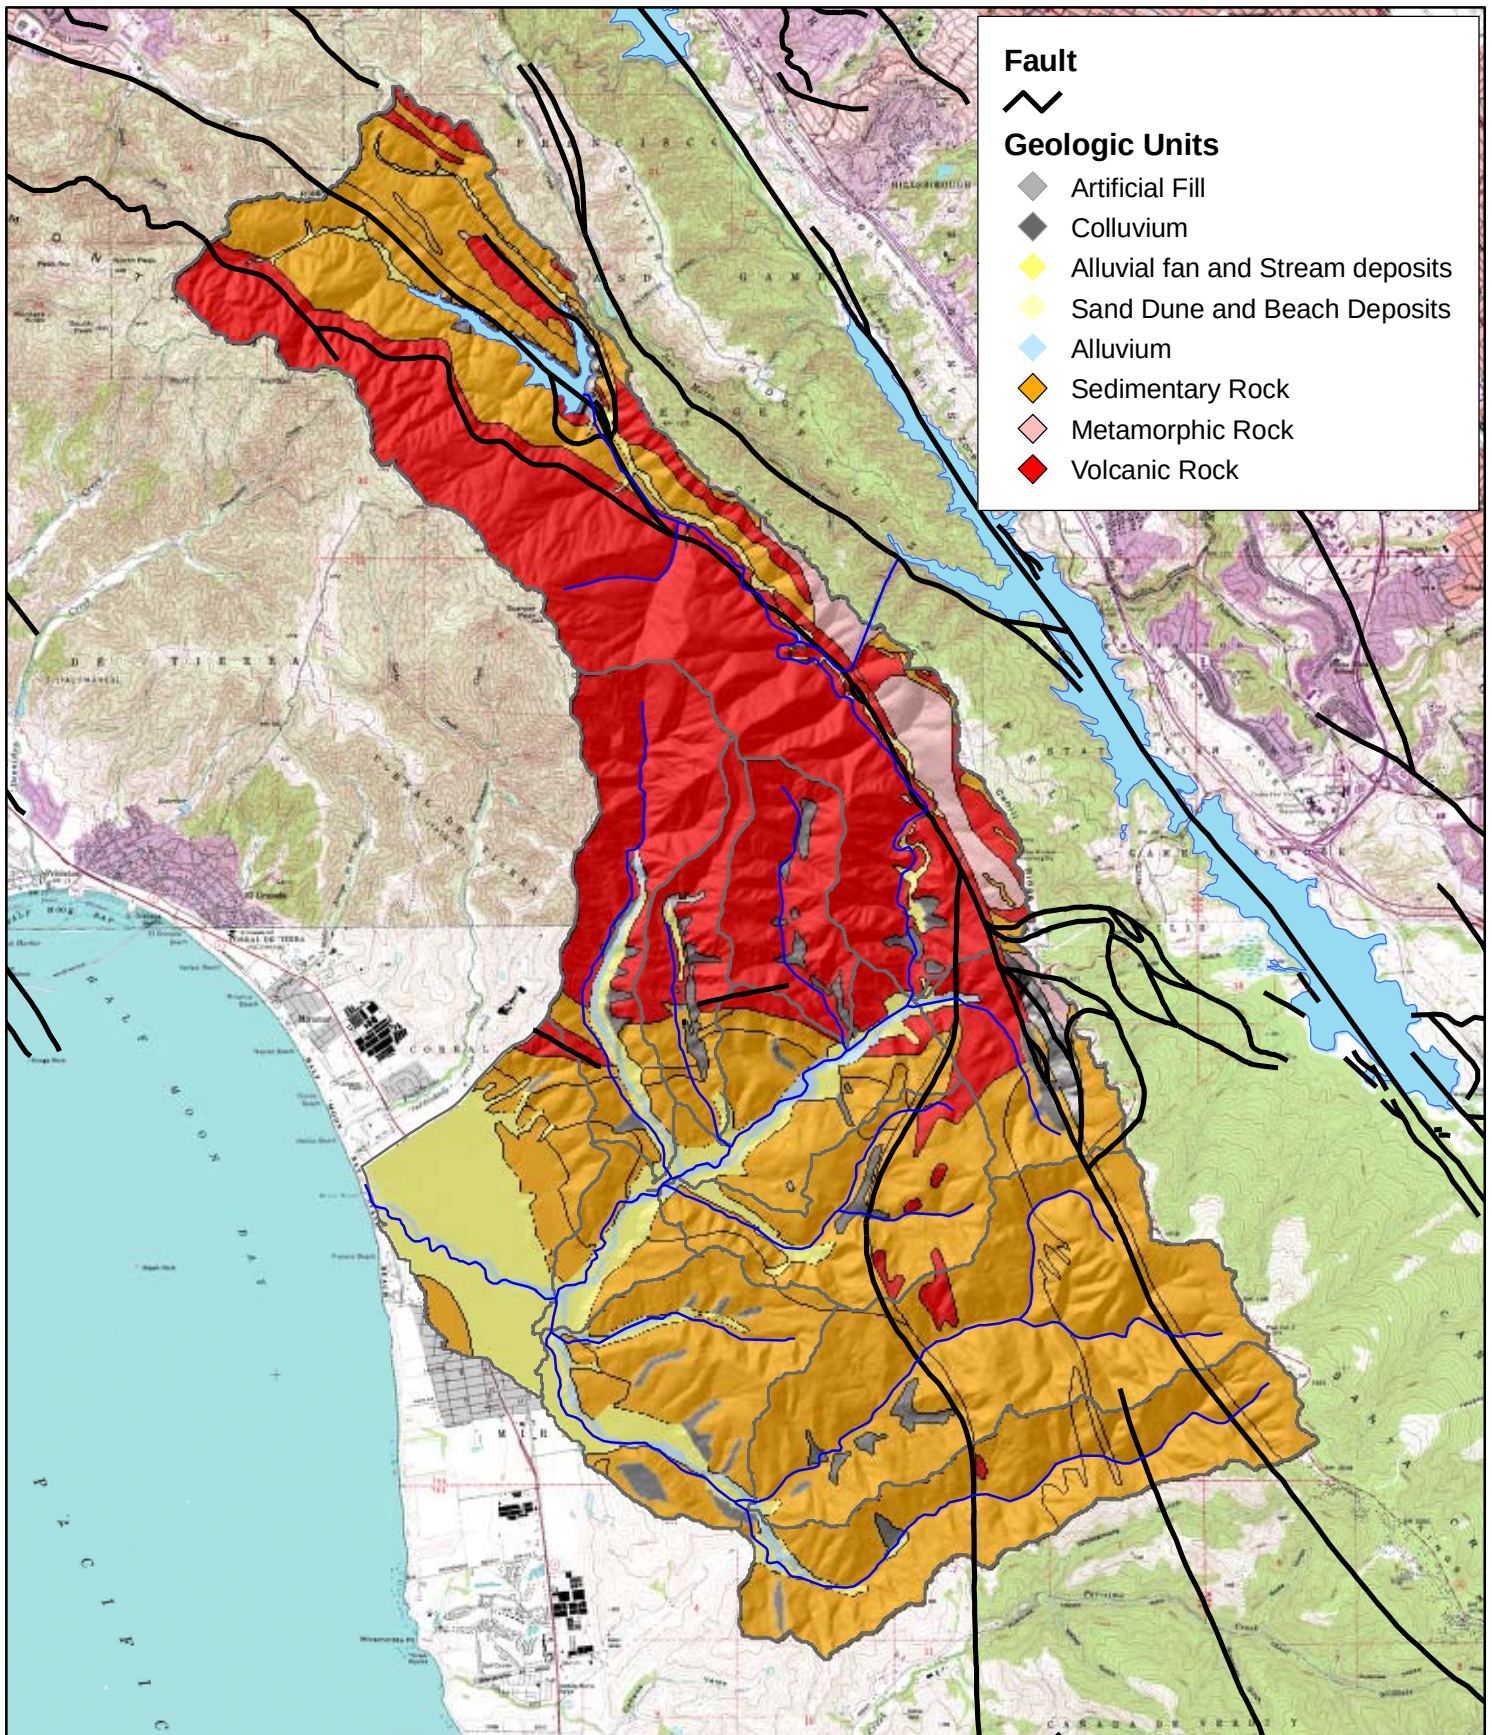
figure 24

Source: USGS (DRG, DEM, Geology), SFPUC (water bodies)

Geology in the Pilarcitos watershed is primarily a mixture of sedimentary and volcanic rocks (Figure 24) (Brabb et al. 1998). Sedimentary rocks of the Franciscan assemblage and the Monterey Formation are found throughout the eastern part of the watershed in the Madonna, Mills, and Arroyo Leon subwatersheds and are found to a lesser degree in the Apanolio and Corinda Los Trancos subwatersheds. Limestone and greywacke exist in Upper Pilarcitos above Pilarcitos Reservoir. Volcanic rocks, predominantly granitic rocks of Montara Mountain (Brabb et al. 1998), are found throughout the western part of the watershed in the Upper Pilarcitos, Apanolio, Corinda Los Trancos, and Nuff Creek subwatersheds.

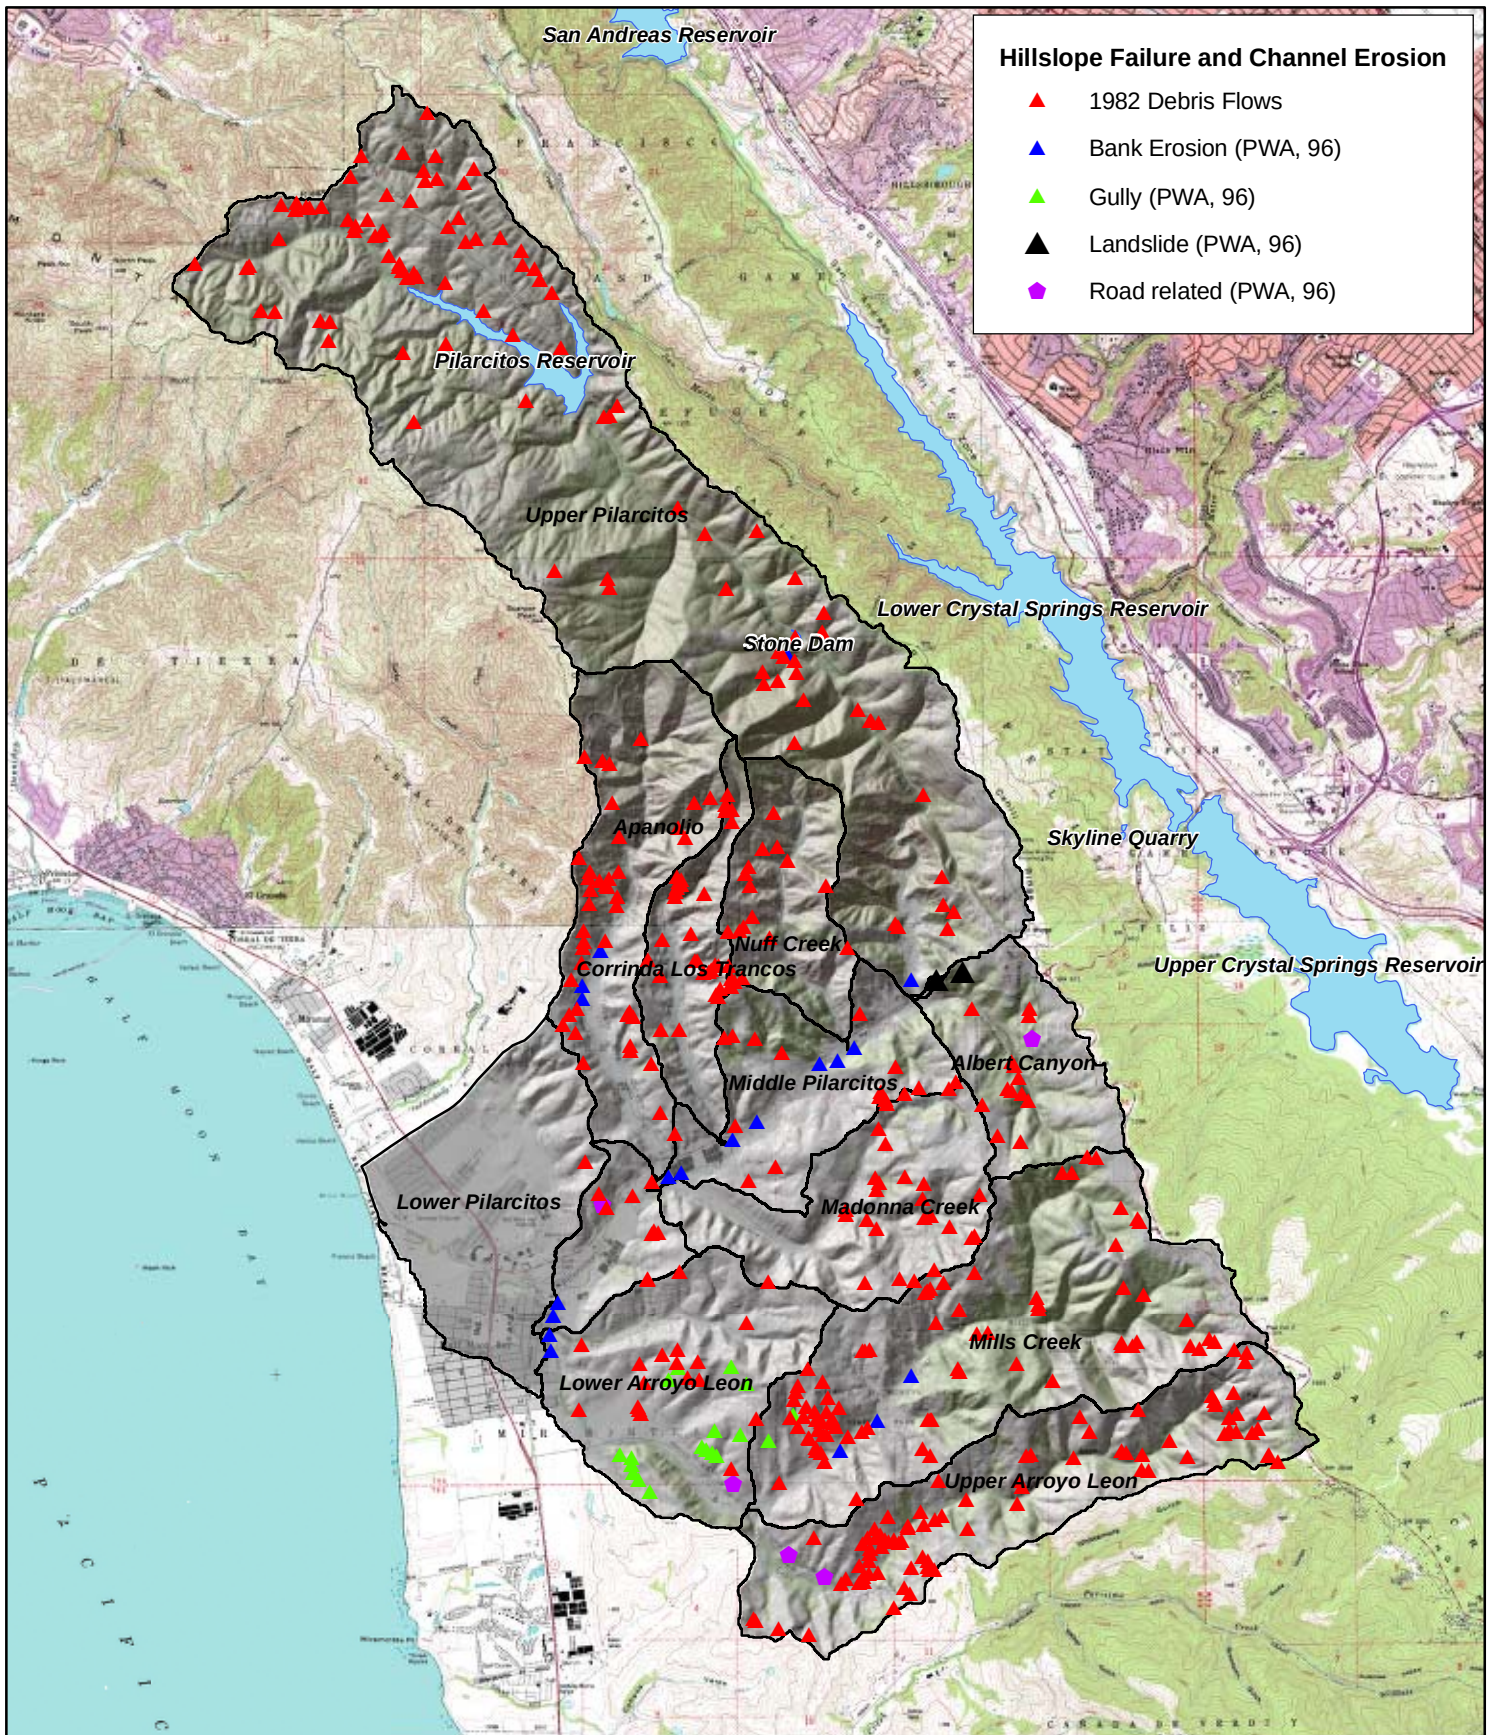
figure 26

Source: USGS (DRG, Debris Flows), SFPUC (water bodies), PWA (Bank Erosion, Road Related Erosion, Landslides, Gullies)

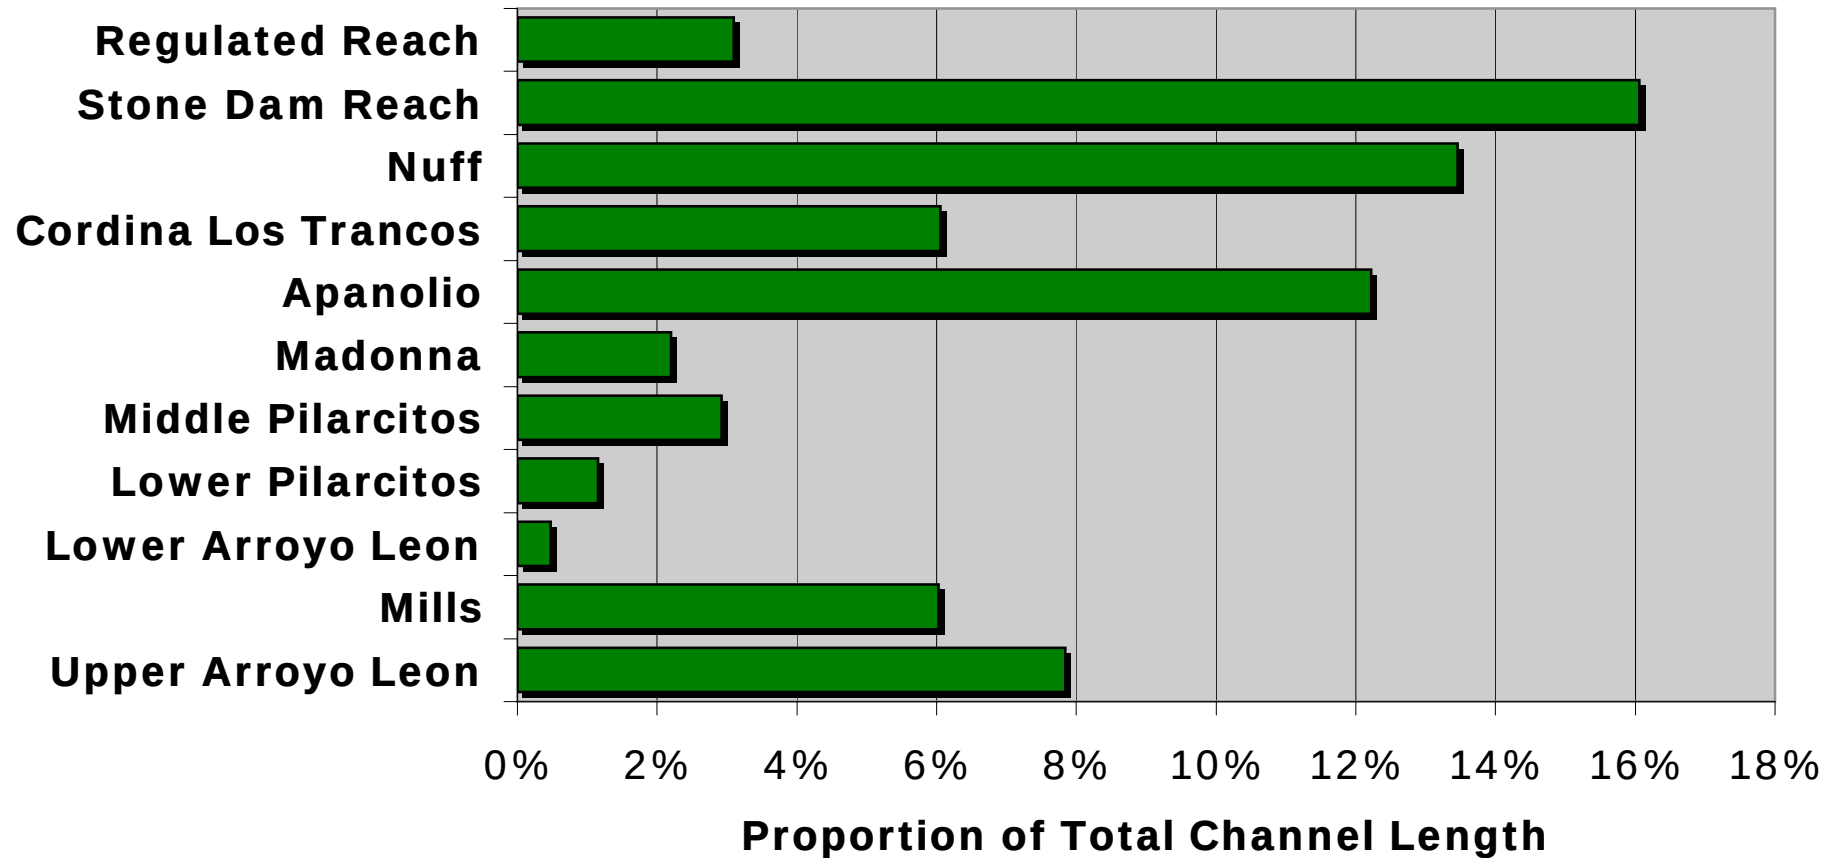
*figure 27*  
*Pilarcitos IWMP*

## Channel Length Greater Than 60 % Slope

The extent to which natural hillslope erosion (gullies, landslides, debris flows) contributes to channel sedimentation is defined by the source-area gradient or slope, convergence, deposition-site conditions, and connectivity with the Pilarcitos Creek mainstem and/or the tributary channels (Benda and Cundy 1990). This connection between the hillslope and the channel is influenced heavily by the steepness of the slopes in the watershed. Steeper, convergent slopes also tend to be more erosive as they are more prone to failure in the form of landslides and debris flows (Deitrich and Dunne 1978). Upon failure, such features create a “hollow” that cyclically fills and evacuates over a period of decades to millennia (Dietrich et al 1987). The proportion of each watershed that contains these sources of landslide and debris flow sediment was evaluated by integrating a two different DEM analysis tools (convergent channel network and slope) and performing basic statistics for the distribution of these features. The convergence channel network was defined for all linear features with a contributing area greater than five acres, and equals over 416 miles for the entire watershed, 61 percent of which includes hollows (Table 8). The steep convergent channels are predominant in the reach below Stone Dam, Nuff Creek and Apanolio Creek (Figure 27).

Balance (2003a) suggested that this result was counter-intuitive because of the sedimentary rocks found in the Arroyo Leon and Mills Creek, which they described as more erodible than the granitic rocks of Montara Mountain. However, both Balance (2003b) and Brabb et al. (1998) note the highly fractured and deeply weathered nature of the granitic rocks found in the Apanolio, Corinda Los Trancos, and Nuff Creek subwatersheds and in the lower portion of Upper Pilarcitos below Stone Dam (Figure 24). These subwatersheds also contain a high average hillslope gradient and a larger area with slopes greater than 60 percent (Figure 27 and Figure 28).

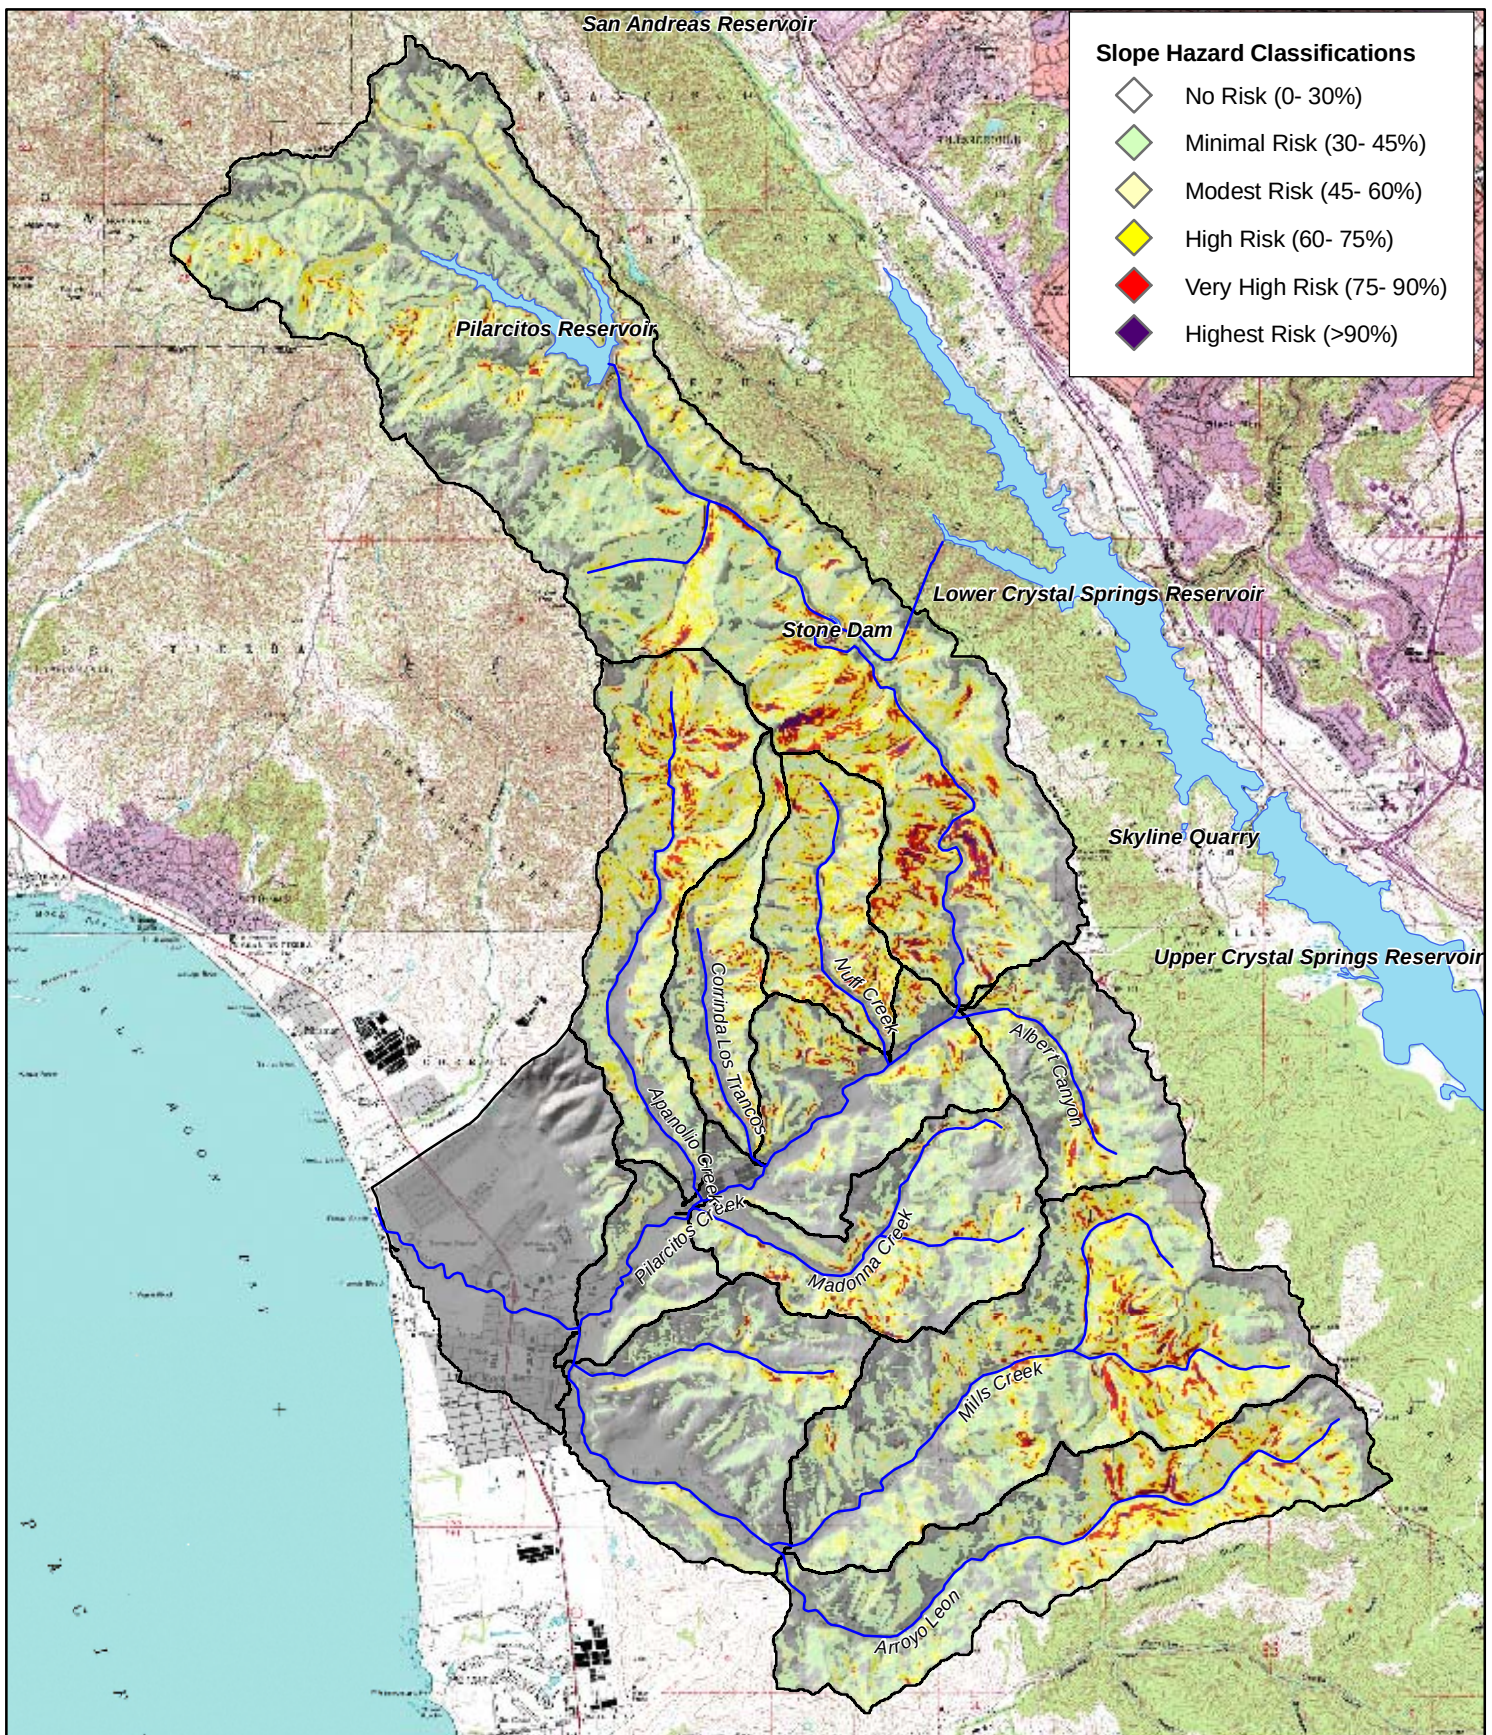
figure 28

Source: USGS (quadrangle, dem), SFPUC (water bodies)  
SWC (Slope classifications)
