**Appendix A**  
**PILARCITOS INTEGRATED WATERSHED MANAGEMENT PLAN**  
**WATERSHED ASSESSMENT UPDATE**

**Pilarcitos Integrated Watershed Management Plan  
Watershed Assessment Update**

September 29, 2008

**PWA REF. # 1884 - T3A**

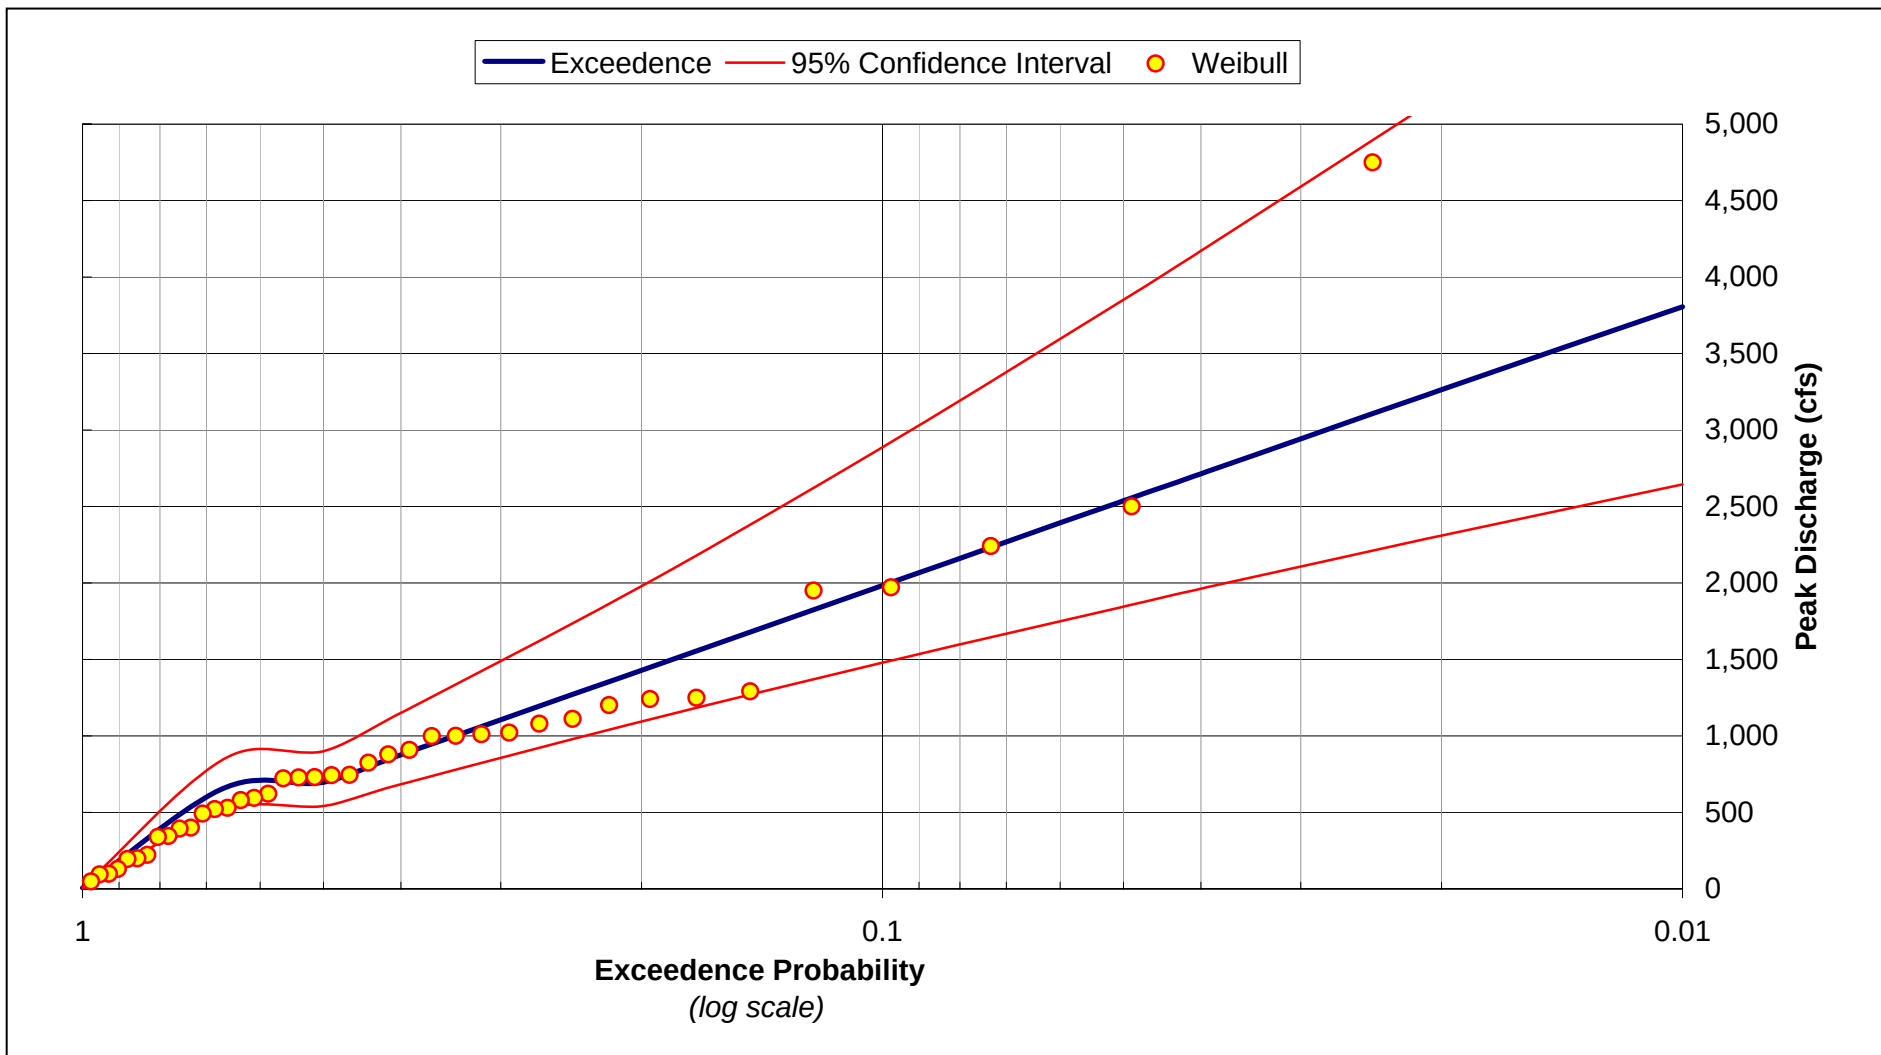
| Notes: USGS Station xxx (Pilarcitos Creek at Half Moon Bay)<br>Source: Sound Watershed Consulting | <i>figure 31</i><br>Pilarcitos IWMP |
| | Annual Peak Discharge Probability Pilarcitos Creek at HMB |
