# **PESCADERO-BUTANO WATERSHED ASSESSMENT**

*Final Report*

*March 5, 2004*

*Prepared for*  
*Monterey Bay*  
*National Marine Sanctuary Foundation*  
*299 Foam Street*  
*Monterey, CA 93940*

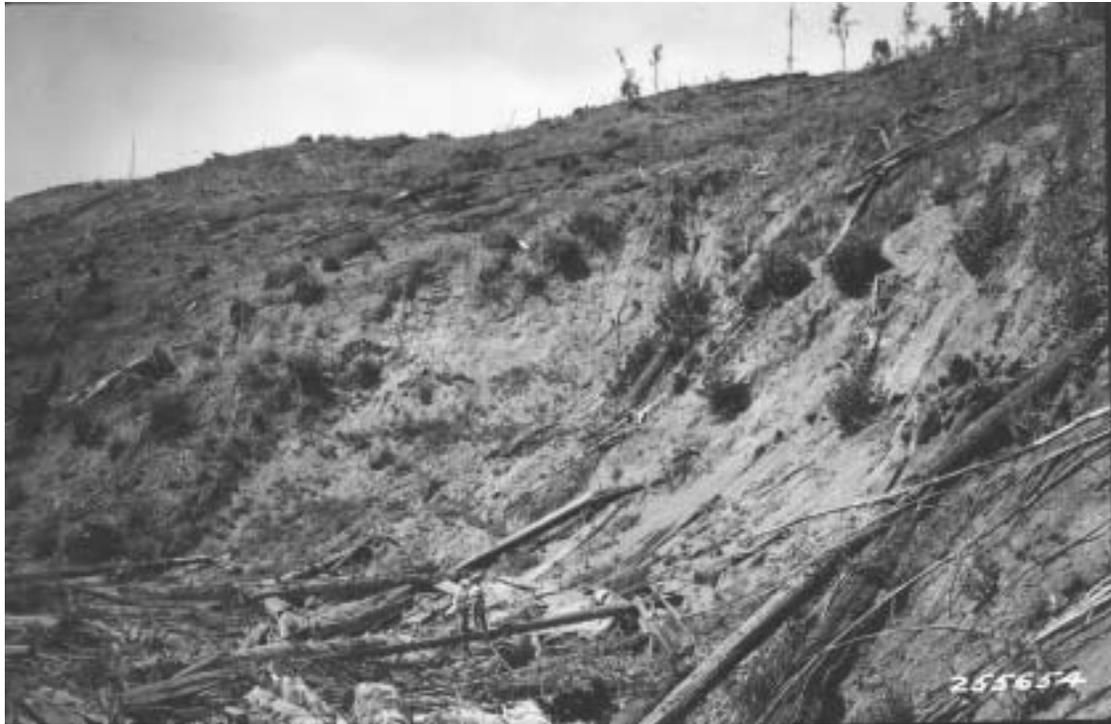
**Figure 2-1:** South slope of Pescadero Creek, logged in 1929. Photo taken June 24, 1930. From collection in the National Archives, Washington, D.C. Photo appears in Viollis, 1979.

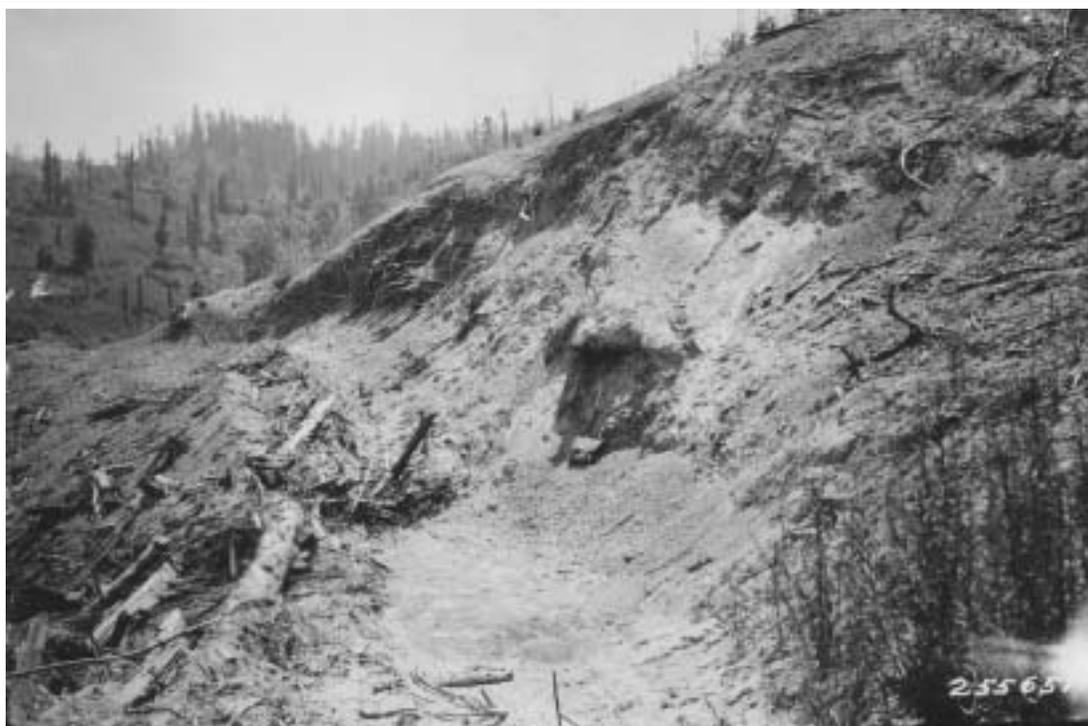
**Figure 2-2:** Looking south near Pescadero Creek. Photo taken June 24, 1930. From collection in the National Archives, Washington, D.C. Photo appears in Viollis, 1979.

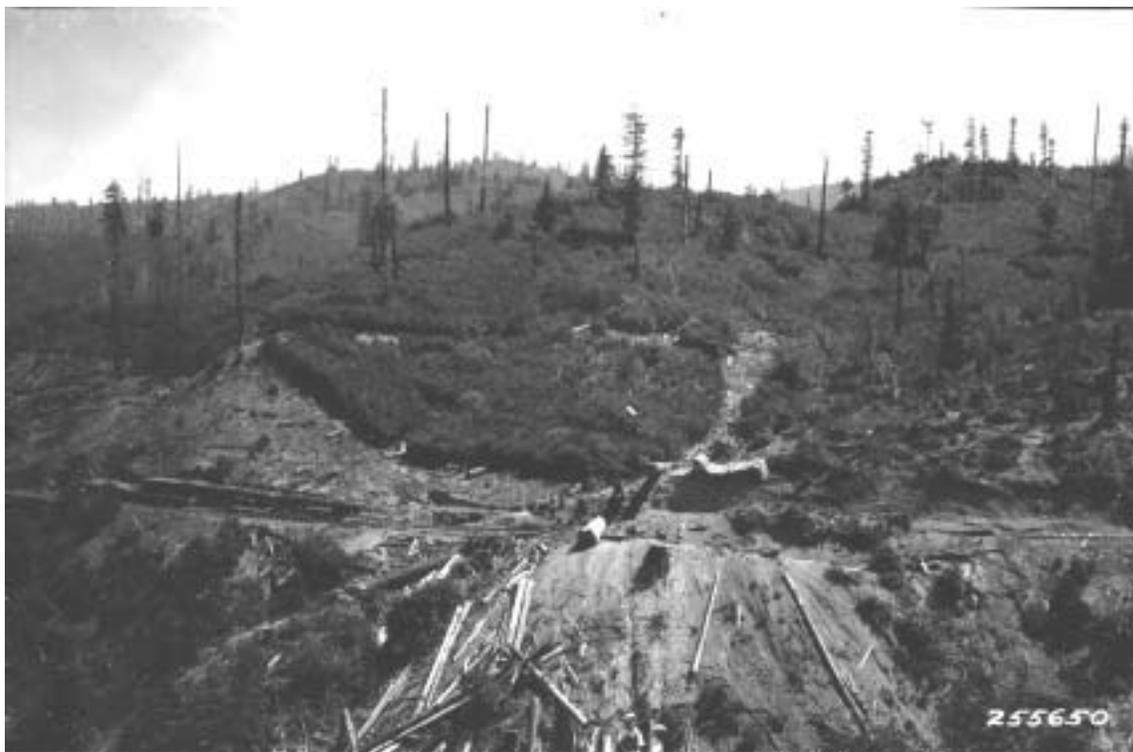
**Figure 2-3:** Looking south near Pescadero Creek. Photo taken June 24, 1930. From collection in the National Archives, Washington, D.C. Photo appears in Viollis, 1979.

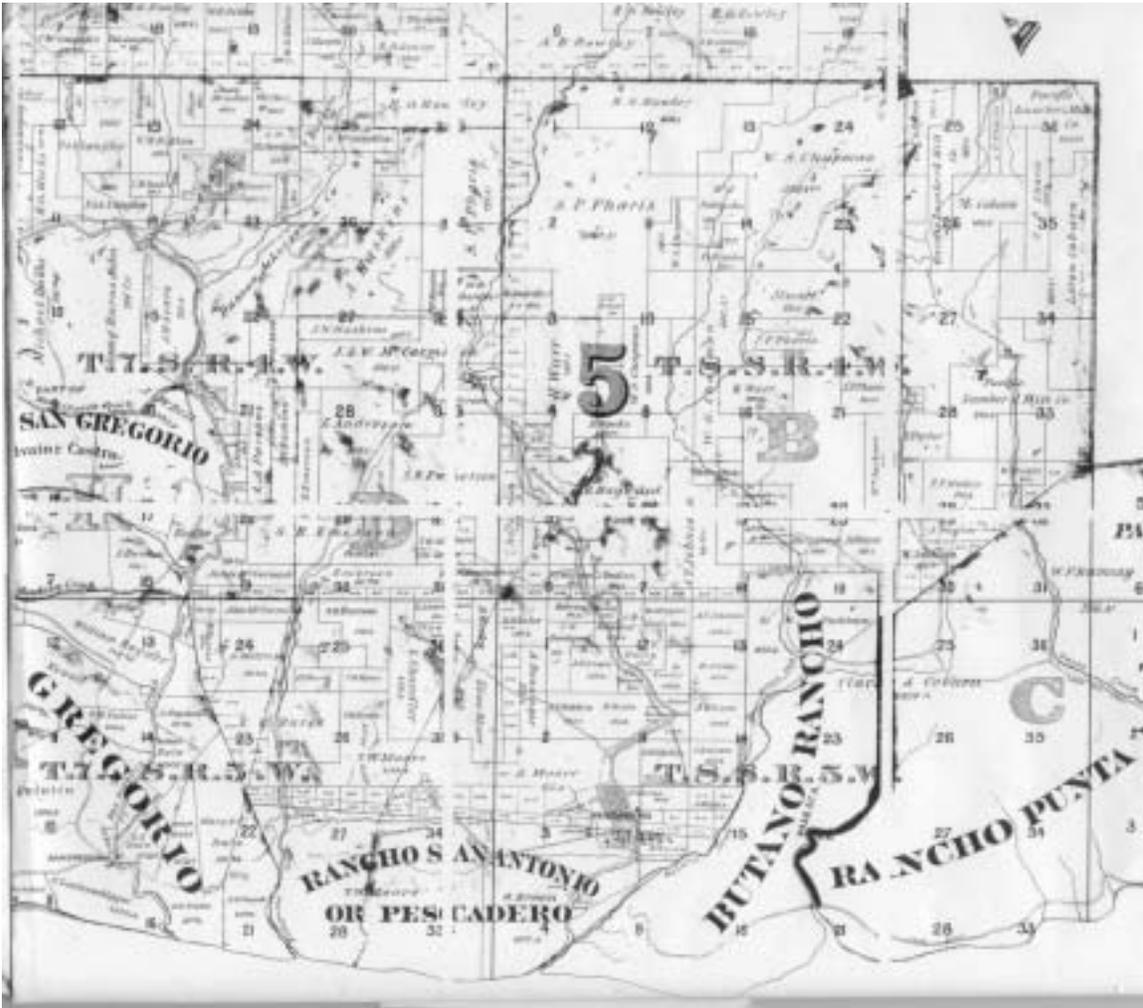
**Figure 3-1:** Official Map of the County of San Mateo, 1877. This map illustrates the early disparity between the subdivision and development of the Pescadero vs. Butano rancho lands. Pacific Lumber and Mill Co. owns a relatively limited amount of land in the upper watershed, compared to later acquisitions by lumber interests. (Source: San Mateo County Historical Society)

The reference to “Clelland’s” is confirmed as being about a mile up in the canyon on the county map of 1877 (Figure 3-1).

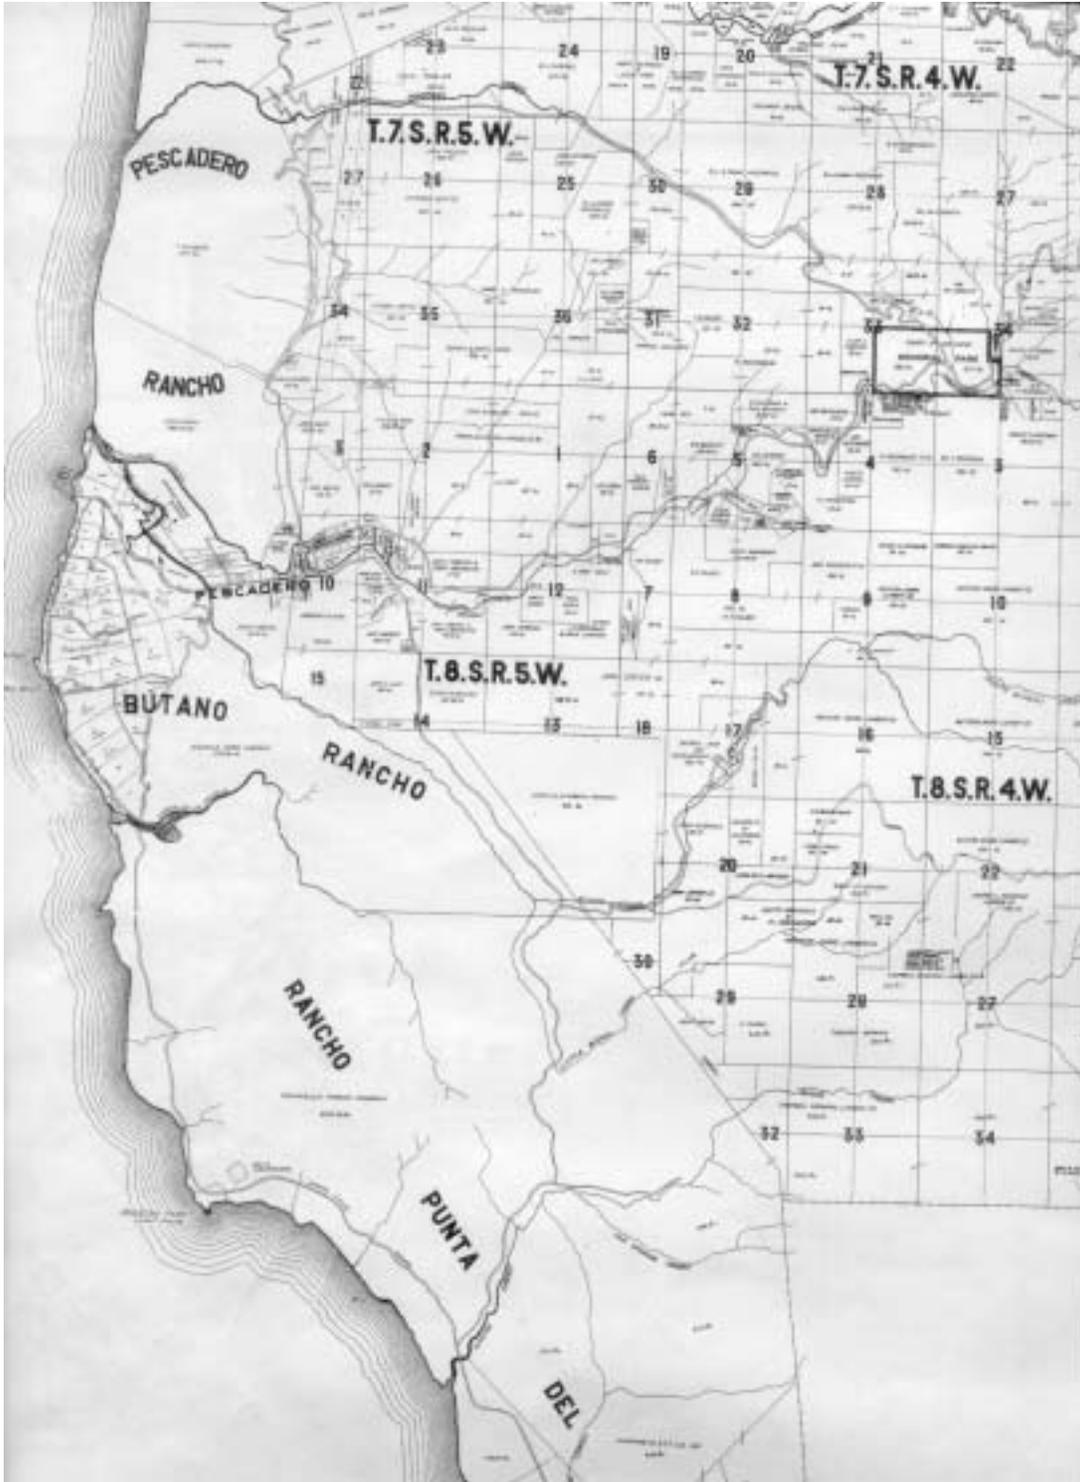
**Figure 3-3:** Official Map of the County of San Mateo, 1927. The official map of 1927 illustrates the subdivision of lands in the northern coastal portion of the Butano Rancho. Western Shore Lumber has by this time acquired significant holdings in the upper watershed, particularly the Upper Butano. (Source: San Mateo County Historical Society)

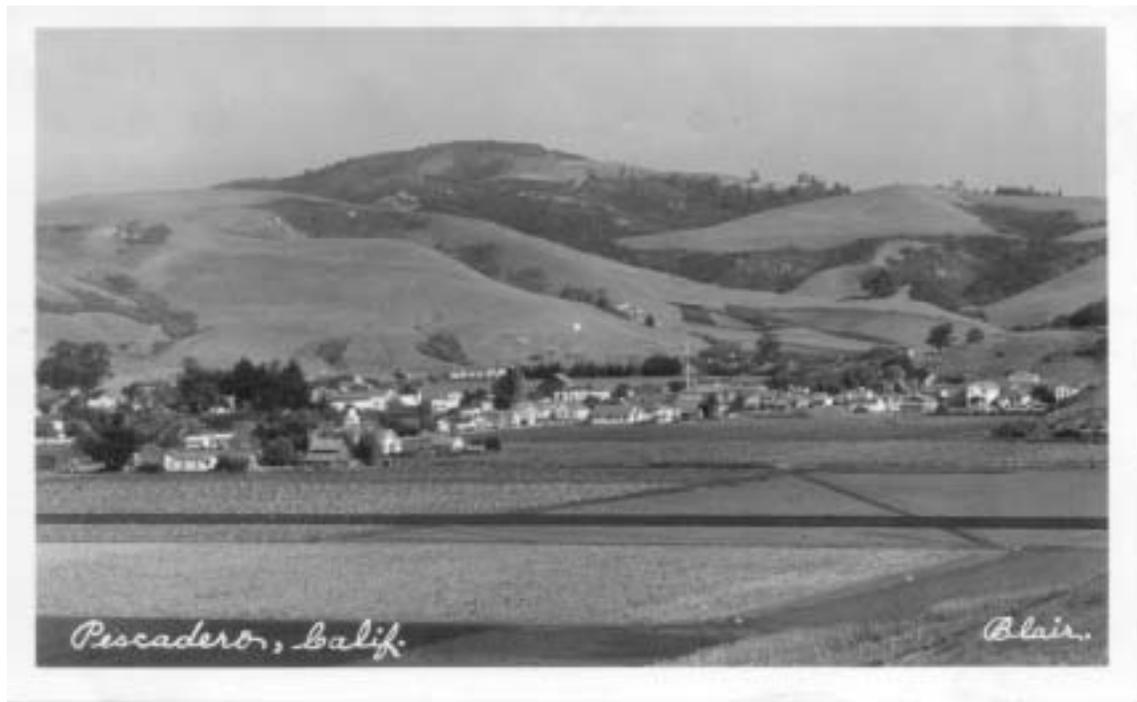
**Figure 3-7:** Pescadero Marsh and Town to the Northeast (Circa late 1950). This view was taken from Cloverdale Road at the site of the old town dumpsite, above Butano Creek. This illustrates the condition of the hillsides at about the time flax growing ended. The area discussed by Ed Weeks, above, can be seen in the central background, to the left of the town flagpole.

Ed Weeks puts the end of the flax production in the Pescadero Valley in 1958 or 1959. The use of synthetics in paint put an end to the need for flax. During a recent driving tour around the valley, Ed Weeks noted that cultivation on the hillsides ended when flax was no longer grown there. He had driven a harvester along the contours of the hillsides during one of the last flax harvests. When pointing at a particular hillside he noted that he could drive a harvester there in 1959, but would not be able to do so now because of the huge gullies that have been eroded into the hills. He was not sure what had caused the erosion, but was very clear that it was not there when flax was being grown in the late 1950s.

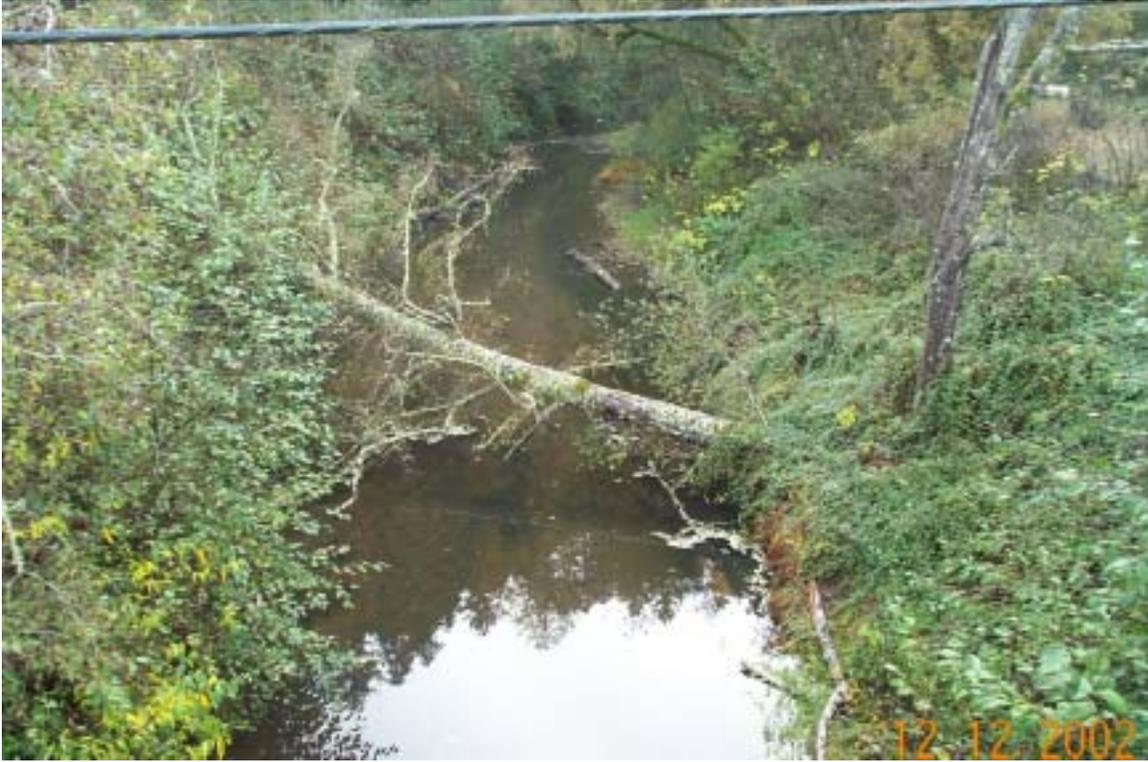
**Figure 4-2: Photograph of Pescadero Creek just downstream of the USGS gauging station, taken from the Pescadero Road bridge.**
