## Coastal San Mateo County Gully Erosion Report

SAN MATEO COUNTY  
RESOURCE CONSERVATION DISTRICT

March 31, 2017

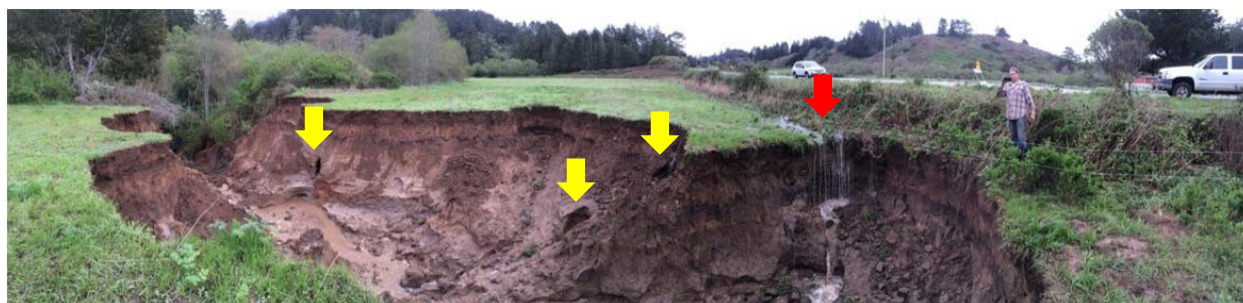
**Figure 2.** A large gully that opened adjacent to Butano Creek (left side of the photo) in March 2016 that initiated due to storm drainage flows redirected by a failed culvert. Concentrated subsurface flows via soil piping and subsequent tunnel formations can be seen (yellow arrows), as well as concentrated surface flows that contributed to headward expansion of this gully (red arrow). Note that this is a panoramic photo; the gully mouth (on the left side of the photo) points west, and the man in the photo is standing almost opposite this (i.e. due east).

Gully formation as a result of subsurface flow can initiate with soil piping and the development of subsurface open conduits that allow for rapid erosion (tunneling) until the tunnel roof collapses (Figure 4). Subsequent flows will then remove the roof sections and debris, creating an open channel, and then rapidly downcut (typically, 5-10m deep, but as much as 15m) until bedrock is reached (Spreiter 1979). Gullies continue to grow laterally by slumping, tunneling, and headward erosion. Gully headwalls are generally steep to vertical, have tunnels or caves leading uphill that (as already noted) can be significant sources of flow to the main gully channel during and after periods of heavy rain. Surface runoff over the lip of the headwall can contribute to head cutting and further gully growth (Spreiter 1979). (Figure 2)

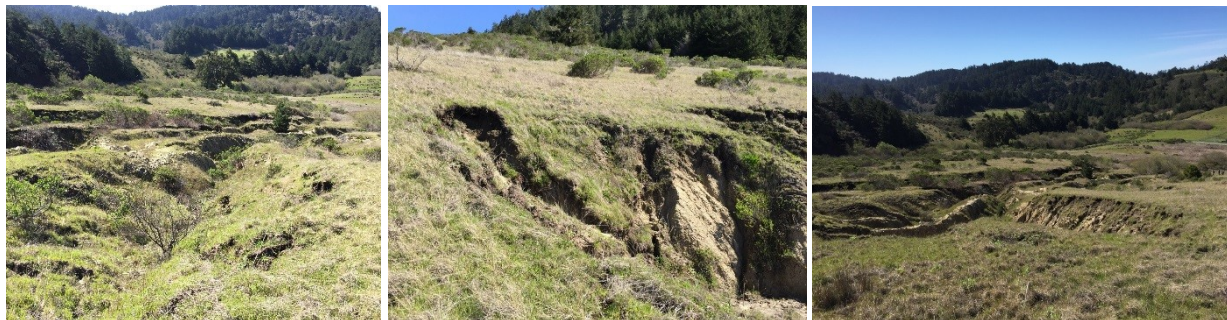
**Figure 3.** Photo on the left shows a gully that has substantially revegetated, but is experiencing headward erosion, or “headcutting” as seen in the close up shown in the middle photo. Photo on the right shows an adjacent gully as an example of active branching resulting from past mainstem gully erosion. Sidewall fluting (i.e. formation of vertical grooves) is visible in the gully branch shown in the photo on the right. Photos were taken during a heavy precipitation winter (2016-2017).

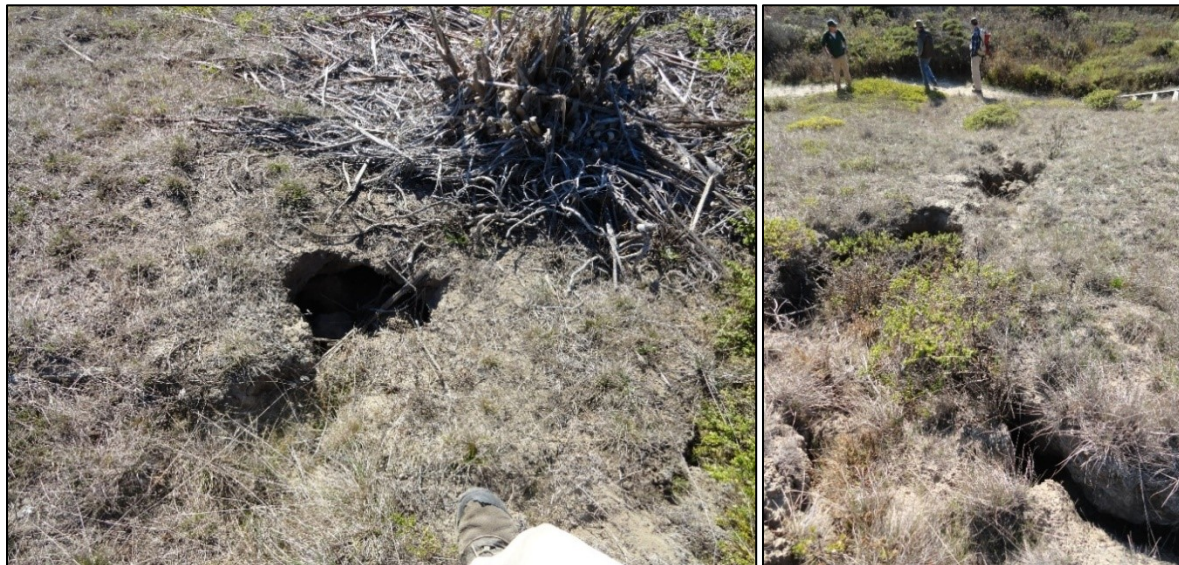
**Figure 4.** Gully development due to soil piping and tunneling, which has led to tunnel roof collapse.

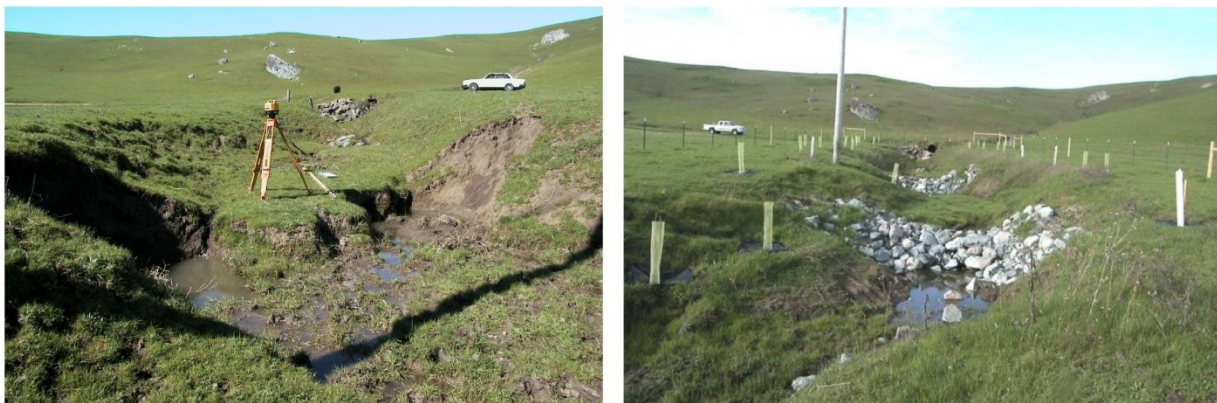
**Rock chutes.** Treatment of gully with rock chutes. During installation (left) and after (right) (from Marin RCD). In this treatment only the steep scarps of the gully were treated. In some areas the entire gully may need to be armored, requiring substantial quantities of rock

Typically rock chutes are constructed by laying back the gully heads or knickpoints to an acceptable slope to create a well-defined spillway (chute). The chute is then armored with properly sized rock rip rap. In dispersive soils, filter fabric is necessary to prevent or at least minimize subsurface soil piping.

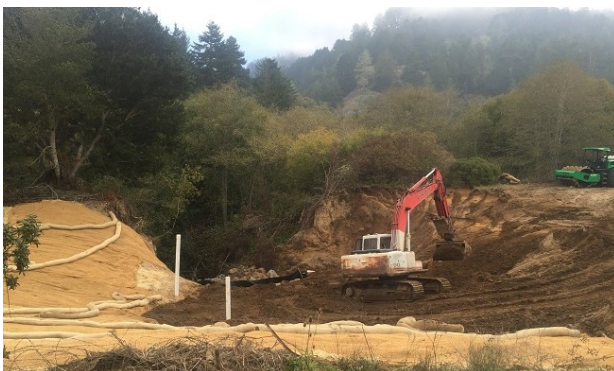
**Gully reshaping and infilling.** A very large gully in the lower PBW that is being treated with extensive reshaping and infilling. Subdrains (indicated by white cleanout pipes) and a large culvert (not pictured) were installed to manage subsurface and surface water flows at this site.

All reshaping and infill projects require aggressive surface erosion control measures and revegetation, as well as continued maintenance to prevent future erosion and gully formation. Furthermore, in areas that are at risk for subsurface piping, the repairs need to include subdrains along the bottom of the backfilled gully and/or across the head of the gully to intercept groundwater and to convey the water to a stable location.

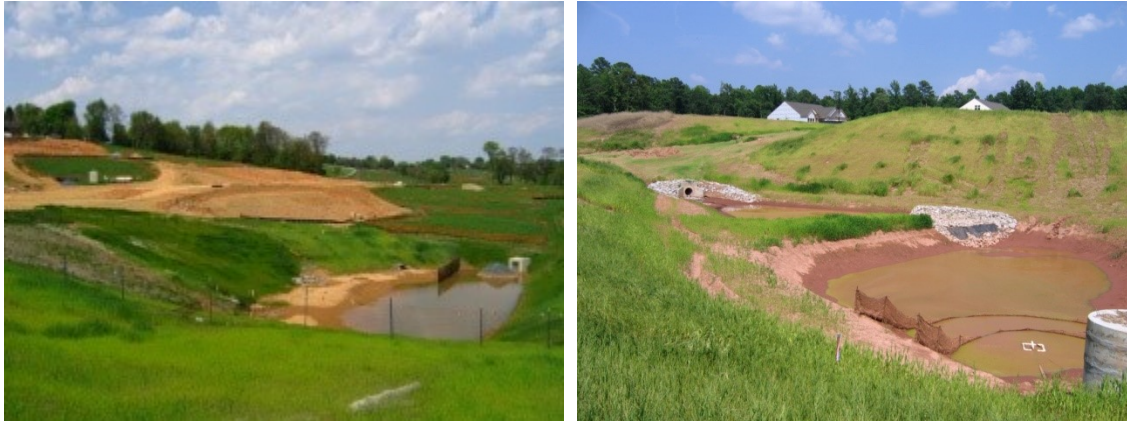
**Sediment catch basin.** Examples of sediment catch basins. The site drains to pond so that sediment can settle before water is allowed to discharge into nearby creeks.

located on steep ground. Several the agricultural ponds in Butano Creek currently serve this purpose, though not intentionally.
