Update to the Coastal San Mateo County Gully Erosion Report

June 30, 2021

(UPDATED) PART I: Understanding Gully Erosion in the Pescadero-Butano Coastal Watershed

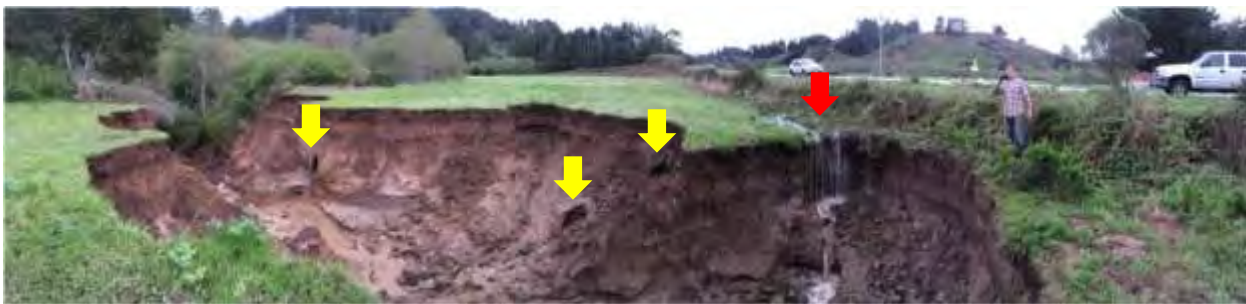
Figure 2. A large gully that opened adjacent to Butano Creek (left side of the photo) in March 2016 that initiated due to storm drainage flows redirected by a failed culvert. Concentrated subsurface flows via soil piping and subsequent tunnel formations can be seen (yellow arrows), as well as concentrated surface flows that contributed to headward expansion of this gully (red arrow). Note that this is a panoramic photo; the gully mouth (on the left side of the photo) points west, and the man in the photo is standing almost opposite this (i.e. due east).

laterally by slumping, tunneling, and headward erosion. Gully headwalls are generally steep to vertical, have tunnels or caves leading uphill that (as already noted) can be significant sources of flow to the main gully channel during and after periods of heavy rain. Surface runoff over the lip of the headwall can contribute to head cutting and further gully growth (Spreiter 1979). (Figure 2)

It is important to recognize that measures necessary to control large gullies can be very costly (e.g., treatment, design, and permitting of the large gully shown in Figure 2 cost almost a half million dollars), and have environmental impacts due to construction on gully-prone sites. In light of these challenges, areas prone to gullying (i.e. underlain by the Purisima Tahana Formation geology, with a south/west aspect and in close proximity to the ocean) should be monitored closely for signs of gully erosion. Initiating gullies should be treated as soon as possible to prevent them from becoming large gullies. Meanwhile, efforts to treat the causes of gullying (e.g. building soil health, properly designing and maintaining rural roads) across a broader geography that extends beyond existing gullied areas, should be prioritized to build landscape resilience to gully erosion.

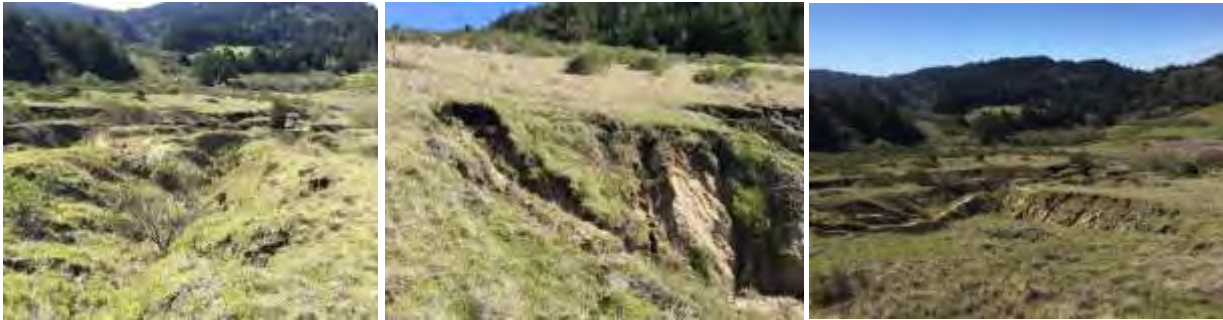
Figure 3. Photo on the left shows a gully that has substantially revegetated, but is experiencing headward erosion, or “headcutting” as seen in the close up shown in the middle photo. Photo on the right shows an adjacent gully as an example of active branching resulting from past mainstem gully erosion. Sidewall fluting (i.e. formation of vertical grooves) is visible in the gully branch shown in the photo on the right. Photos were taken during a heavy precipitation winter (2016-2017).

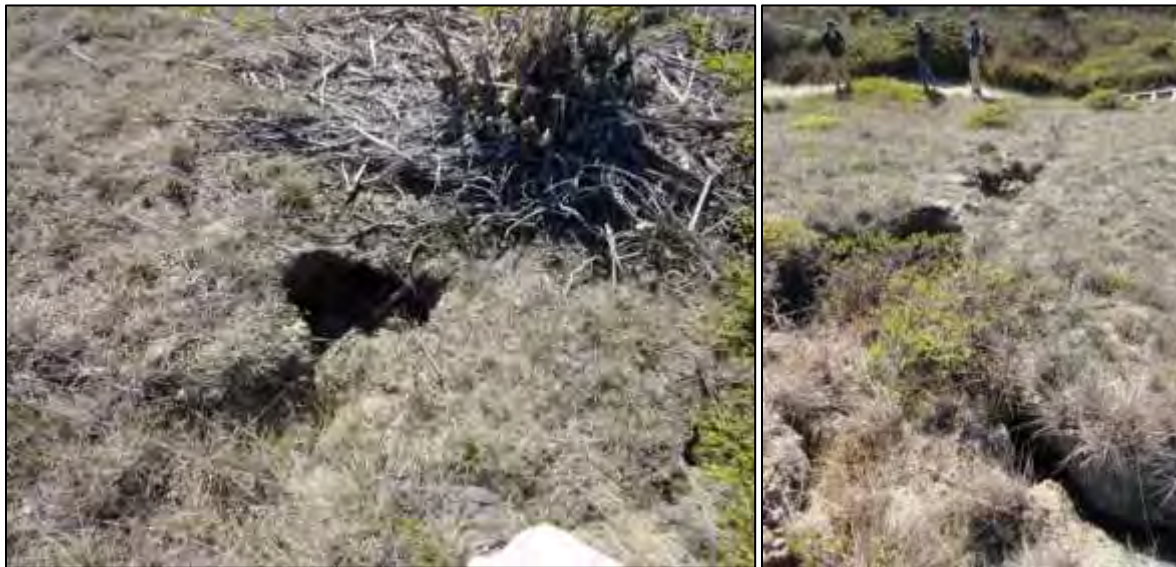
Figure 4. Gully development due to soil piping and tunneling, which has led to tunnel roof collapse.

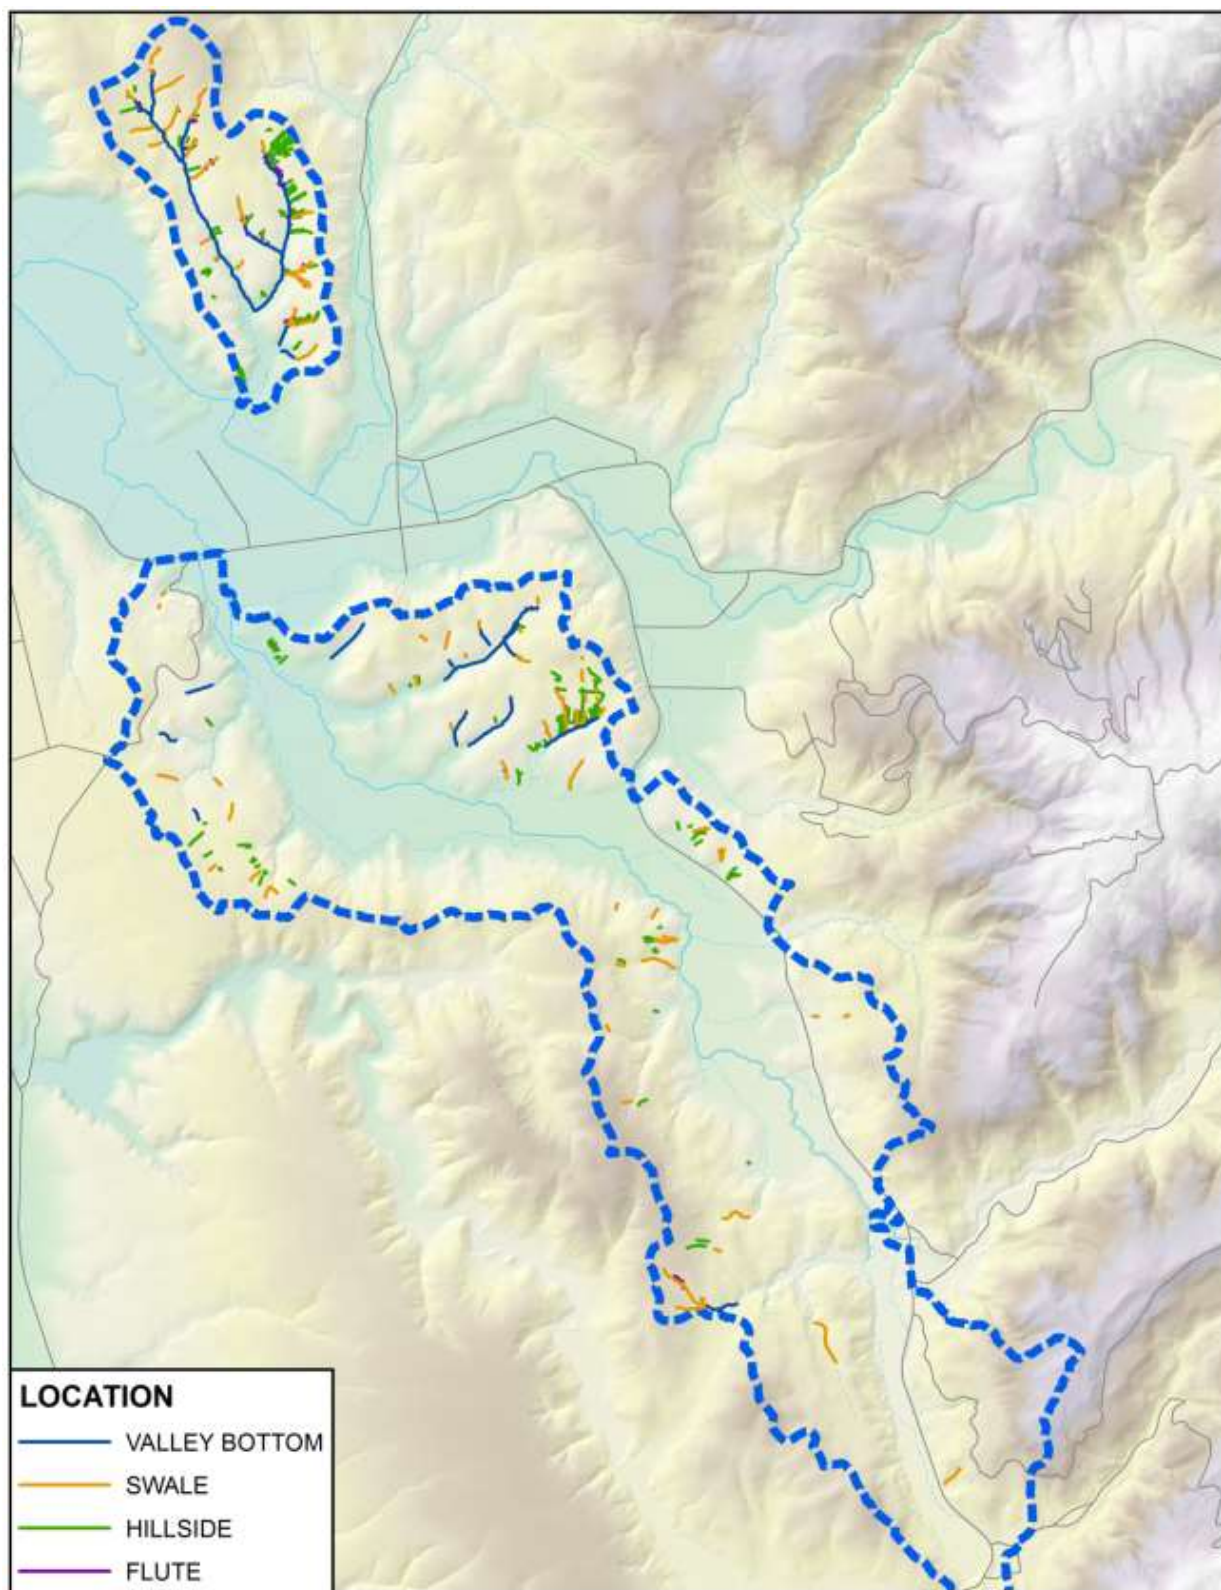
Figure 8. Location of gullies (2016) on hillslopes based on criteria in Table 1.

For Tributary 1 and Lower Butano subwatersheds, the focus of this study, gully location is presented in Figure 8 and Table 3 summarizes gully length and volume. Results of the analysis of gully sizes in these two subwatersheds are shown in Figure 9. Currently (2016), all mapped gullies, regardless of activity, range in width between approximately 5 feet to 60 feet with a median width of approximately 15 feet.

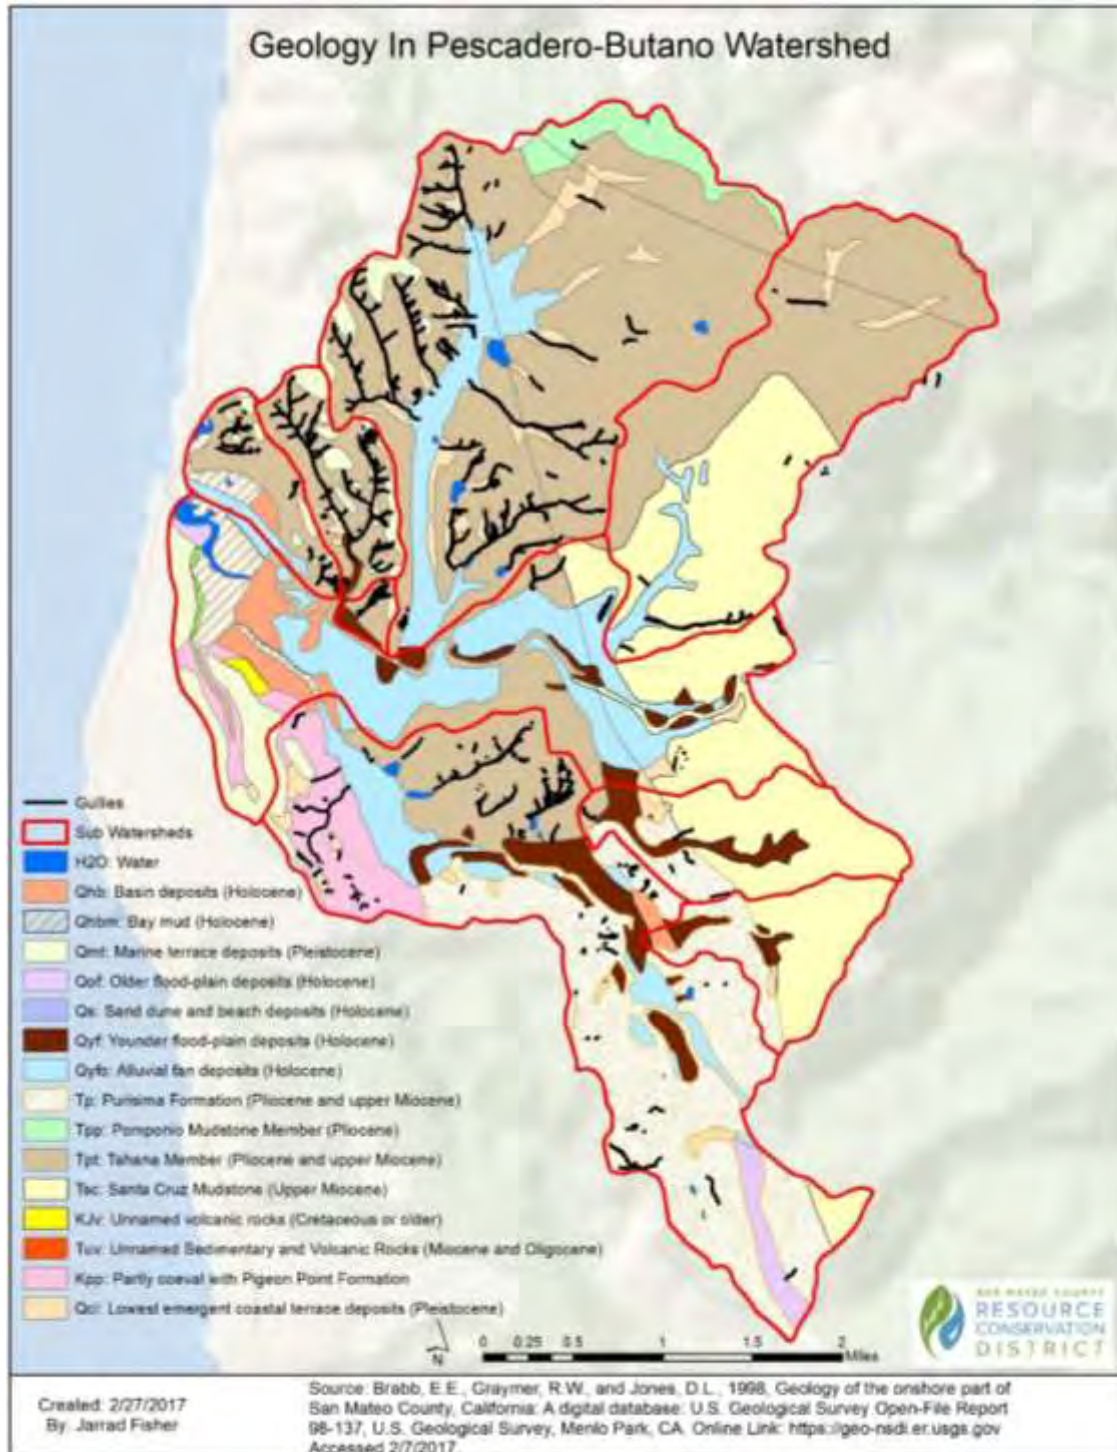
Figure 19. Locations of gullies (RWQCB 2012) in the lower PBW relative to geologic unit. Gully networks are common over the Purisima Formation Tahana Member (Tpt). Shorter, less developed networks are present on the undifferentiated Purisima formation (Tp) and Pigeon Point Formation (Kpp). One notable large gully is seen in the Santa Cruz mudstone (Tsc). Gullying over the Tahana appears concentrated in the coastal portion of this formation within the study area, and decreases further inland.

Figures 19-23 show results of GIS analysis of gully-controlling factors identified in the literature.

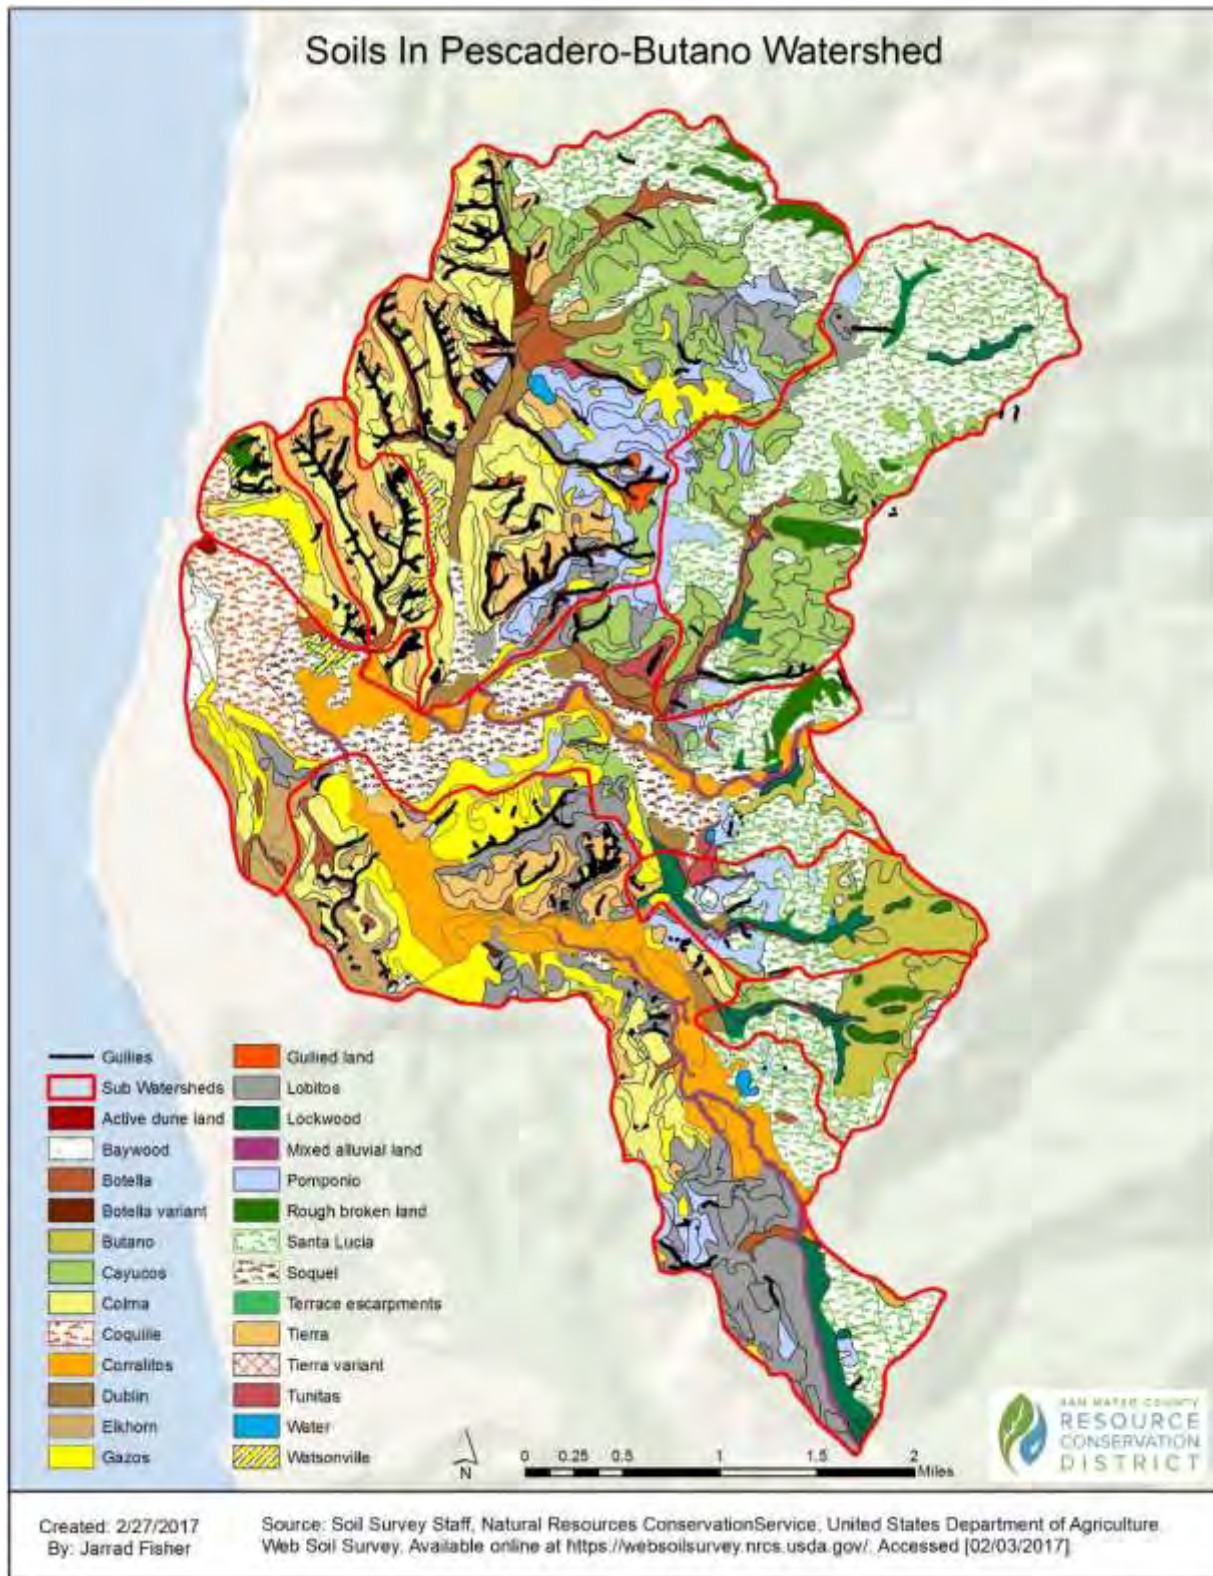
Figure 20. Locations of gullies (RWQCB 2012) in the lower PBW with respect to soil type. Gullies in the northwest subwatersheds (i.e., Tributaries 1 and 2, and Bradley) are primarily found in the Tierra and Colma soil types. In the Lower Butano subwatershed, gullies occur on Tierra, Colma, Lobitos and Gazos soil types.

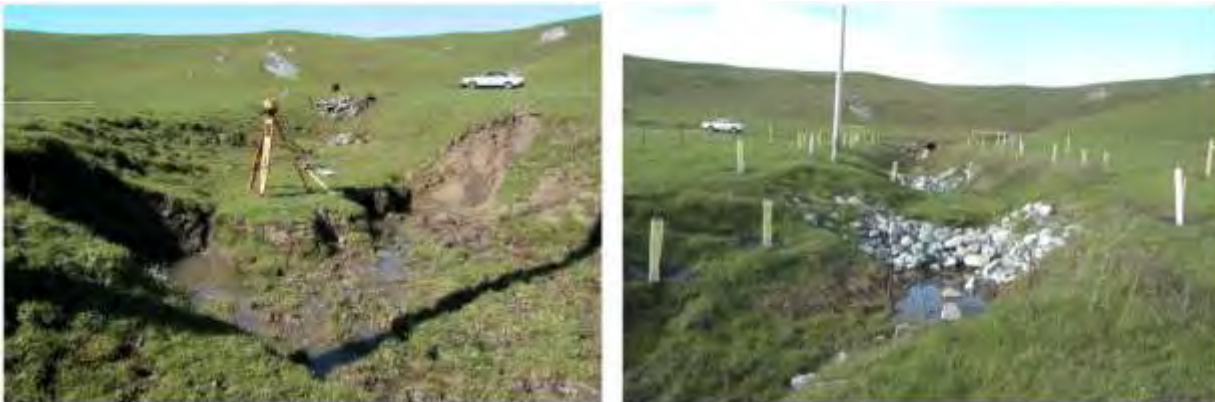
Rock chutes. Treatment of gully with rock chutes. During installation (left) and after (right) (from Marin RCD). In this treatment only the steep scarps of the gully were treated. In some areas the entire gully may need to be armored, requiring substantial quantities of rock

Typically rock chutes are constructed by laying back the gully heads or knickpoints to an acceptable slope to create a well-defined spillway (chute). The chute is then armored with properly sized rock rip rap. In dispersive soils, filter fabric is necessary to prevent or at least minimize subsurface soil piping.

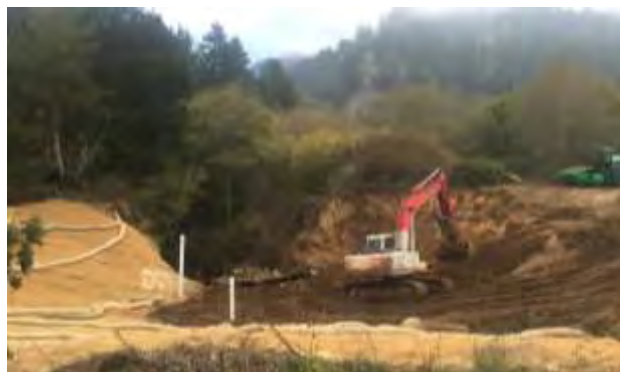
Gully reshaping and infilling. A very large gully in the lower PBW that is being treated with extensive reshaping and infilling. Subdrains (indicated by white cleanout pipes) and a large culvert (not pictured) were installed to manage subsurface and surface water flows at this site.

All reshaping and infill projects require aggressive surface erosion control measures and revegetation, as well as continued maintenance to prevent future erosion and gully formation. Furthermore, in areas that are at risk for subsurface piping, the repairs need to include subdrains along the bottom of the backfilled gully and/or across the head of the gully to intercept groundwater and to convey the water to a stable location.

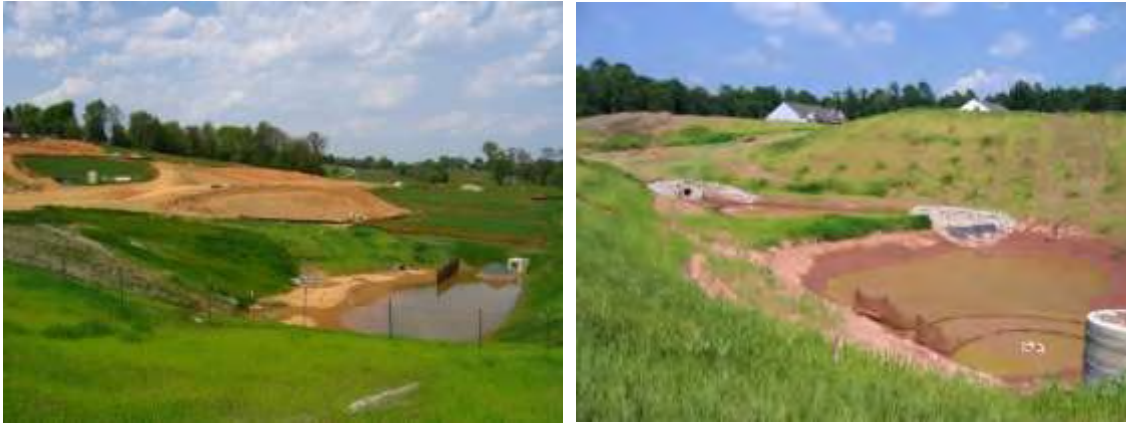
Sediment catch basin. Examples of sediment catch basins. The site drains to pond so that sediment can settle before water is allowed to discharge into nearby creeks.

Catch basins and ponds are used when treatment of upland gullies is not possible, or to contain eroded sediment as the upland gullies heal. Furthermore, in some of the subwatersheds of PBW this may be the most cost effective and environmentally beneficial method of stopping sediment delivery, given the inherent difficulty, cost and construction impacts involved in stabilizing the large number of gullies located on steep ground. Several the agricultural ponds in Butano Creek currently serve this purpose, though not intentionally.
