**An Analysis of Water Circulation in Pillar Point Harbor,
Half Moon Bay, California, based on the
Dye Distribution Study of September 27, 2008**

San Mateo County Resource Conservation District

May 2011

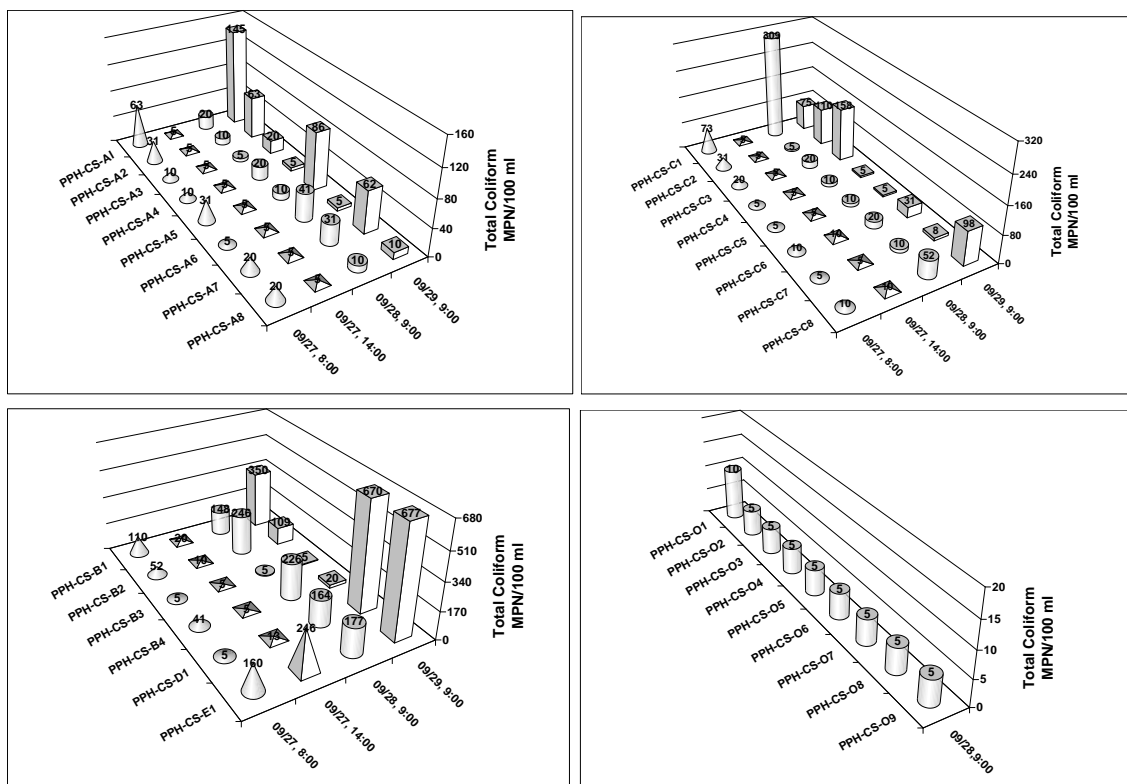
Figure 2: Total coliform concentrations at the dye monitoring sites and control sites (upper left panel: A circle; upper right panel: C circle; lower left panel: B circle and site D and E; lower right panel: control sites outside of the harbor)

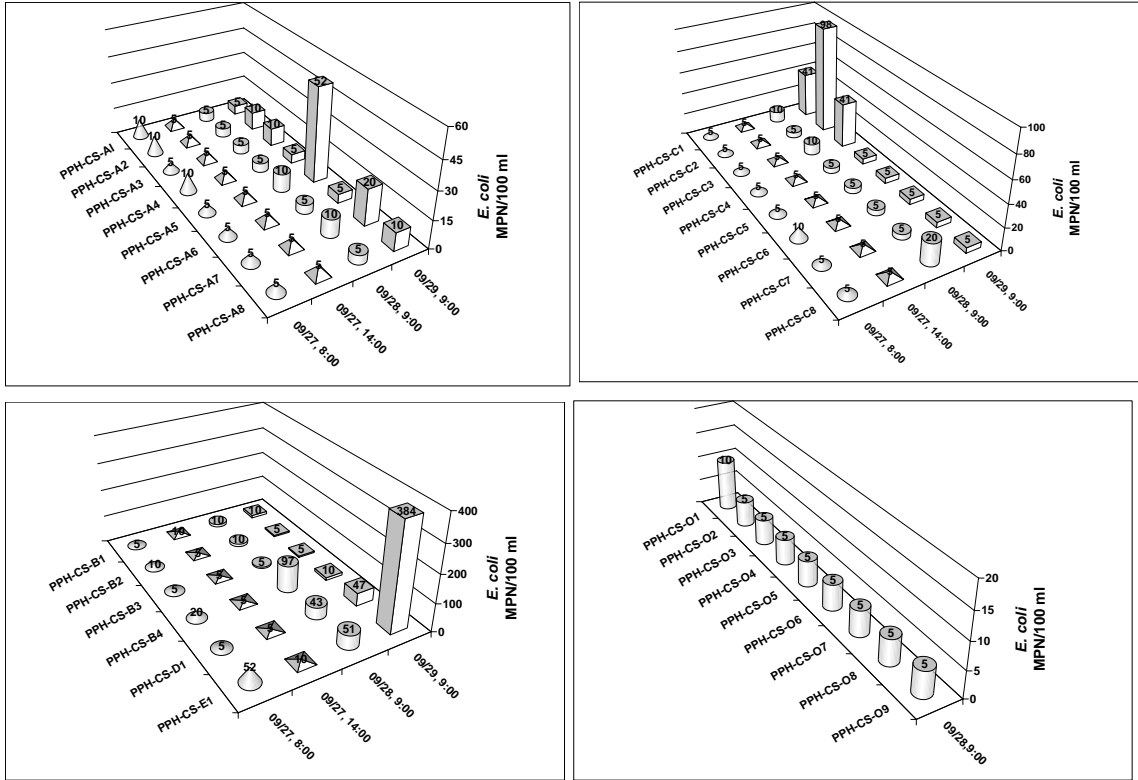
Figure 3: *E. coli* concentrations at the dye monitoring sites and control sites (upper left panel: A circle; upper right panel: C circle; lower left panel: B circle and site D and E; lower right panel: control sites outside of the harbor)

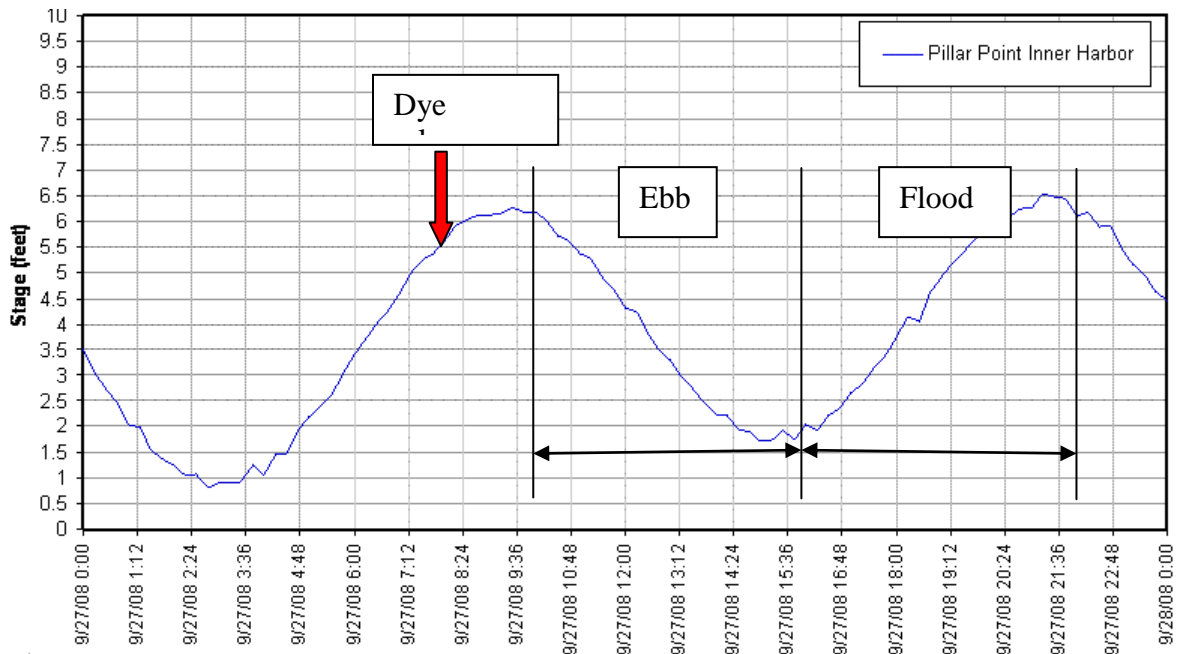
Figure 8: Fifteen-minute tide data for Pillar Point Harbor, San Mateo County, CA, September 27, 2008. Source: Balance Hydrologics Inc.

Fluorescein was released at 8:00 a.m. (27th) almost at the end of flood tide (Figure B-1, Figure 8). In the 10:00 -11:00 a.m. measurement window, a considerable amount of the Fluorescein was found at point C4 but not at the stations C7, C5, and C6. This could possibly be explained as follows: the constituent traveled from the gap between the inner harbor's breakwater (Figure B-3). From 12:00-13:00, in the middle of ebb tide, both Fluorescein mass distributions in zones B and C are carried by the ebb tide into the ocean and move toward the harbor's mouth (Figure B-3 to B-5). By the time span 13:00 to 14:00 (end of ebb tide) a portion of the Fluorescein mass passed the harbor entrance and was likely released into the ocean (Figure B-5). From 14:00 to 17:00 (slack tide) the

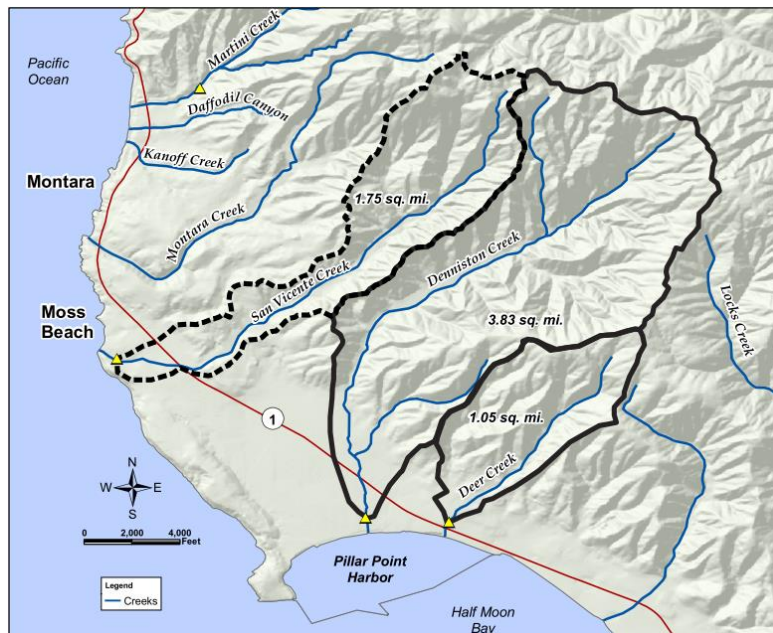
Figure 10: Deer Creek and Denniston Creek watersheds

Two creeks, Deer Creek and Denniston Creek, drain runoff water into the Pillar Point Harbor basin (Figure 10). The former collects the runoff from a 1.05 sq. mile watershed and the latter drains a 3.83 sq. mile watershed (almost 3.5 times larger than the Deer Creek Watershed). Based on the 2008 and 2009 hydrologic records collected in the Prospect Way station, the flow in the larger creek reached a daily peak of 5.5 cfs in January and February of 2008. That is to say the flow in Denniston Creek was less than 1 cfs in 9 out of 12 months during 2008 and 2009.

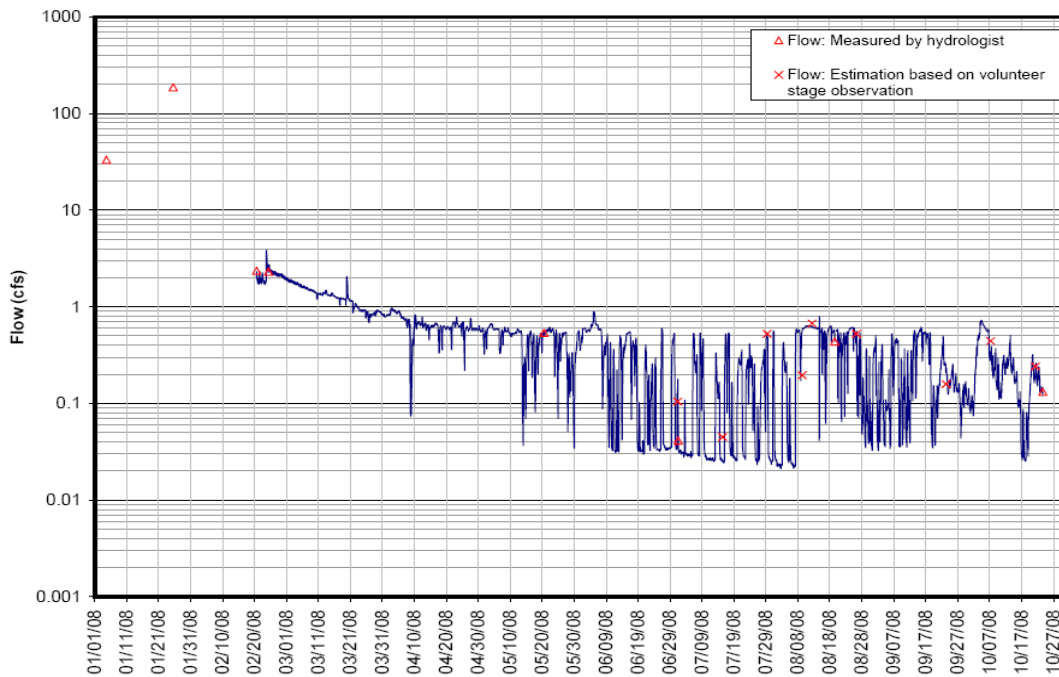
Figure 12: Denniston Creek gage 15-minute flow, San Mateo County, California,
Hydrograph through 10-23-2008. Source: Balance Hydrologics, Inc.

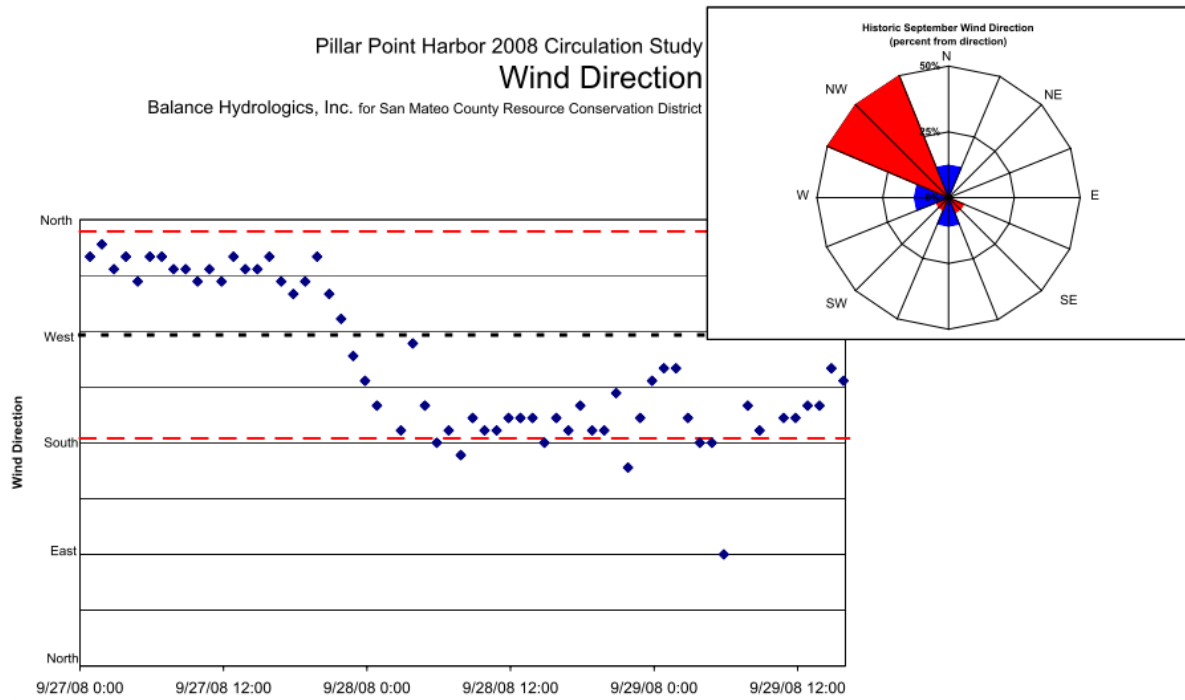
Figure 13: Wind direction observed in the tracer study period (27-29 Sept 2008) and monthly mean wind direction averaged over the period of 1980-2001 (NBDC Station #46012)

where \bar{U} and \bar{D} are the average of preceding consecutive and acceptable hourly wind speed and direction, respectively. U_i and D_i are wind speed and direction at the *i*th hourly data point. As can be seen from Figures 13 and 14, wind duration in the study period (27th to 29th September, 2008) was more than 45 min¹ most of the time. On the other hand since the dimensions of wind fetch in Pillar Point Harbor is relatively short (1.4 km \times 2 km) there is always a fetch-limited situation within the harbor. As recommended by the Coastal Protection Manual (2003) and Sorenson (1993), with these numbers (Fetch length about 1.5 kilometer and minimum duration of one hour) wind wise currents in the range of 1% of the standard 10 m wind speed could be expected in the harbor. From Figure 14 and the basic calculation we have:

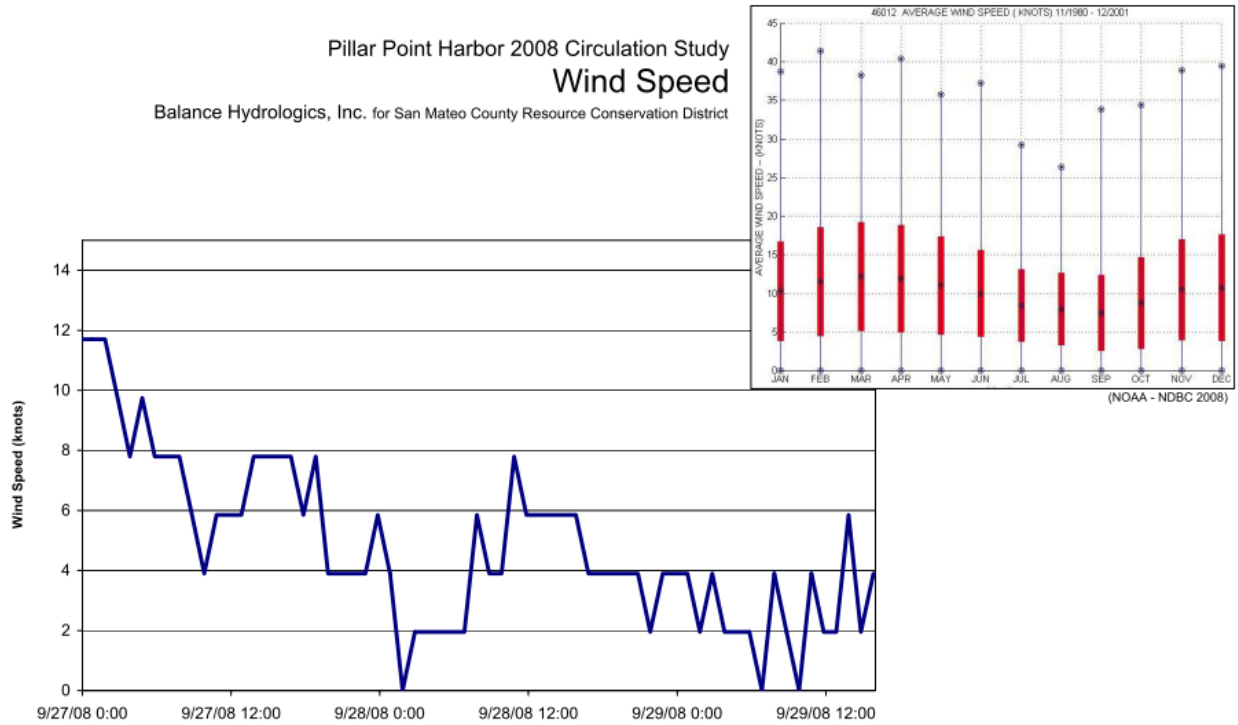
Figure 14: Wind speed observation 27-29, September 2008 and monthly mean wind speed averaged over the period of 1980-2001 (NBDC Station # 46012)

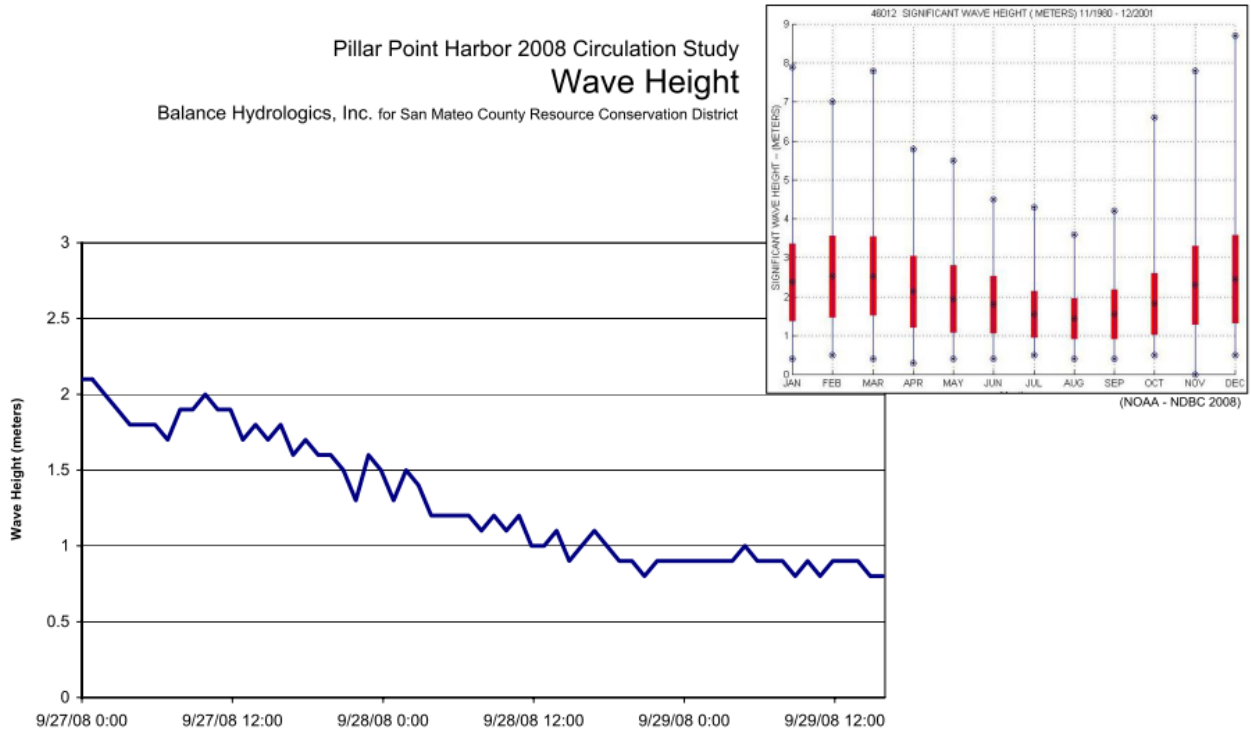
Figure 15: Wave height measured by NBDC station # 40612 (27-29 Sept 2008), H_s in the period of 1980-2001 same buoy station (Top right)
