Solutions for Flooding of Butano Creek on Pescadero Creek Road

Public Meeting - November 17, 2014

Solutions to Flooding on Pescadero Creek Road

cbec, inc. eco engineering with assistance from Stillwater Sciences

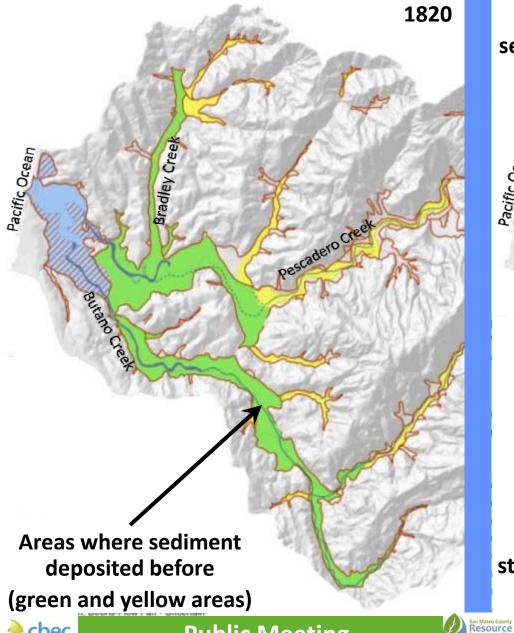
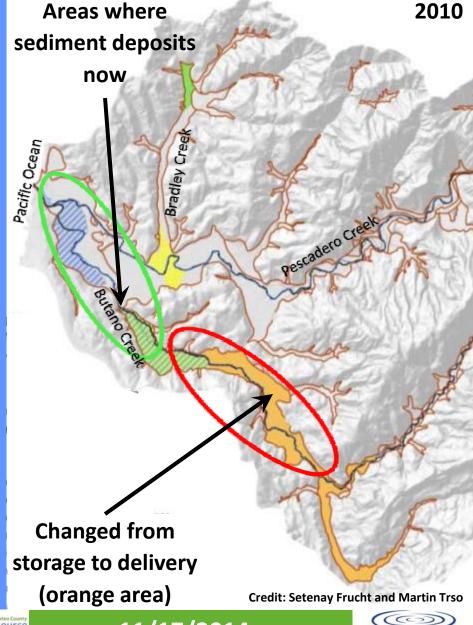
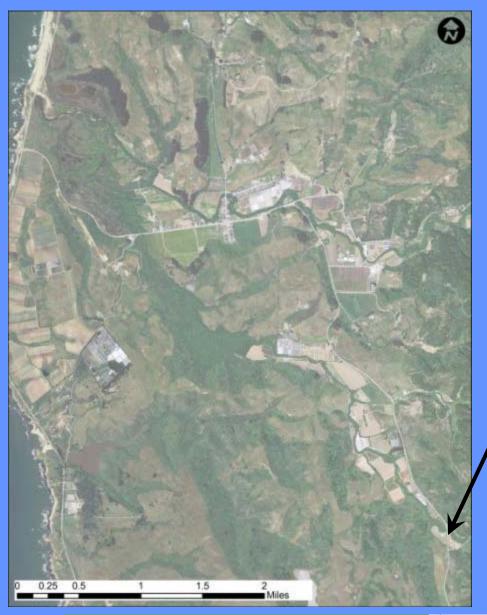
Change in Areas Where Sediment Gets Deposited

Looking downstream at the channel at this location

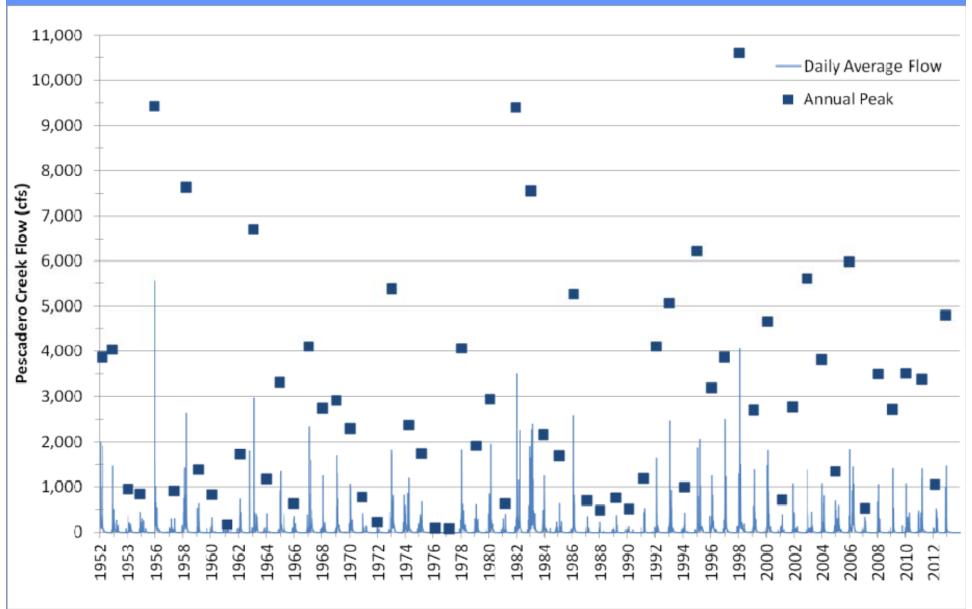
Pescadero Creek Daily Average Flows and Flood Peaks

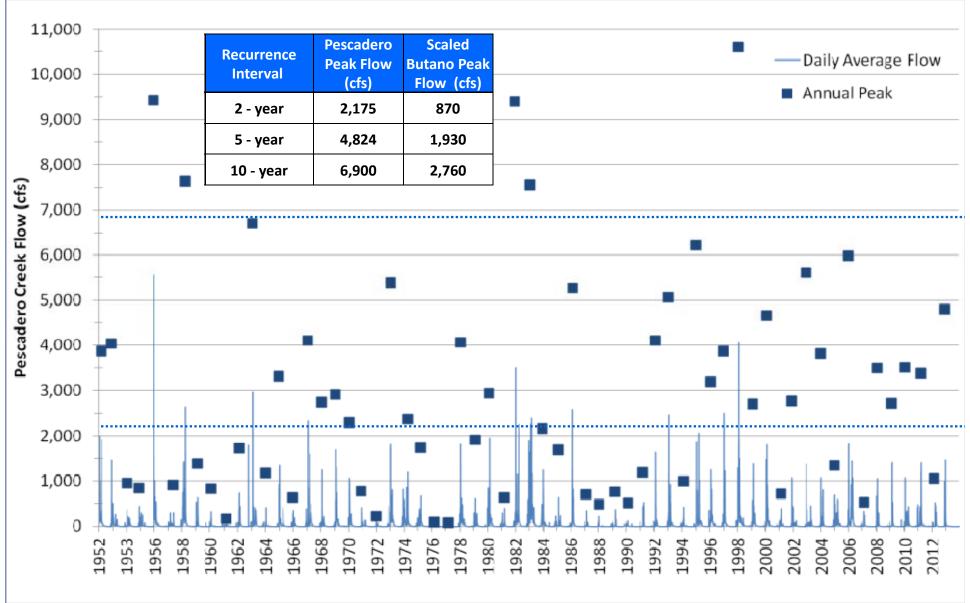
Pescadero Creek Daily Average Flows and Flood Peaks

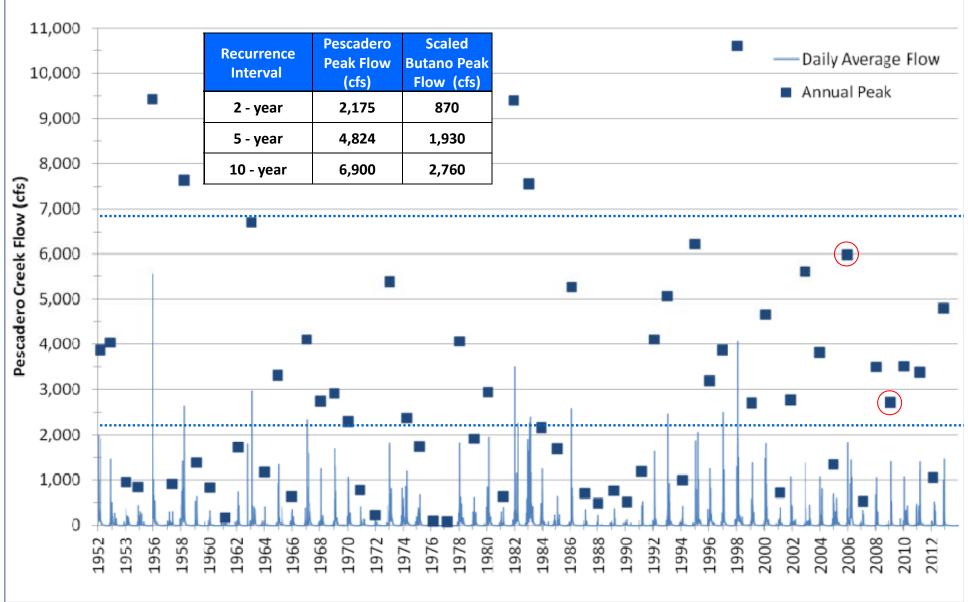
Pescadero Creek Daily Average Flows and Flood Peaks

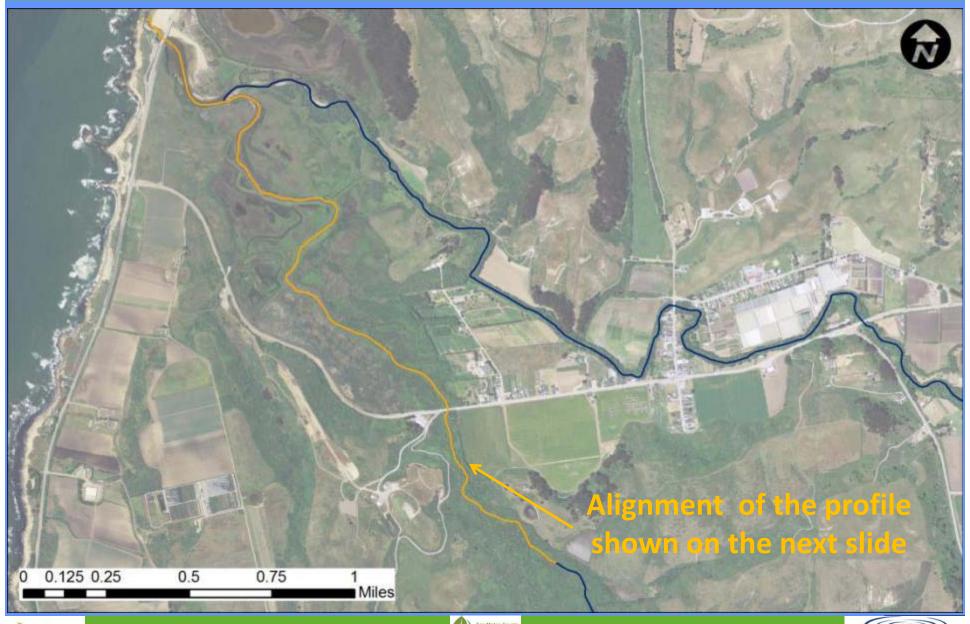
Butano Creek Profile

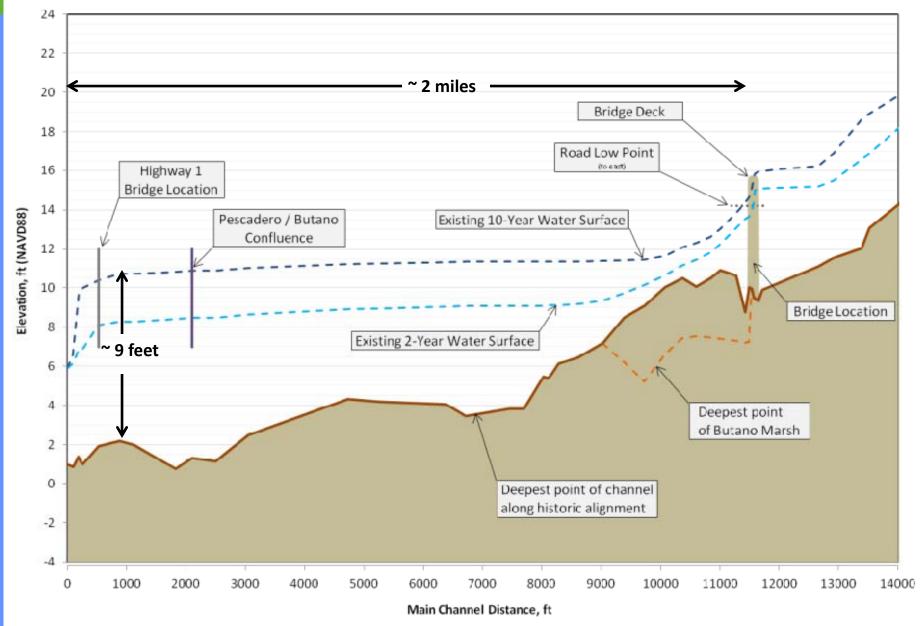
Peak Water Surface Profiles - Existing Conditions

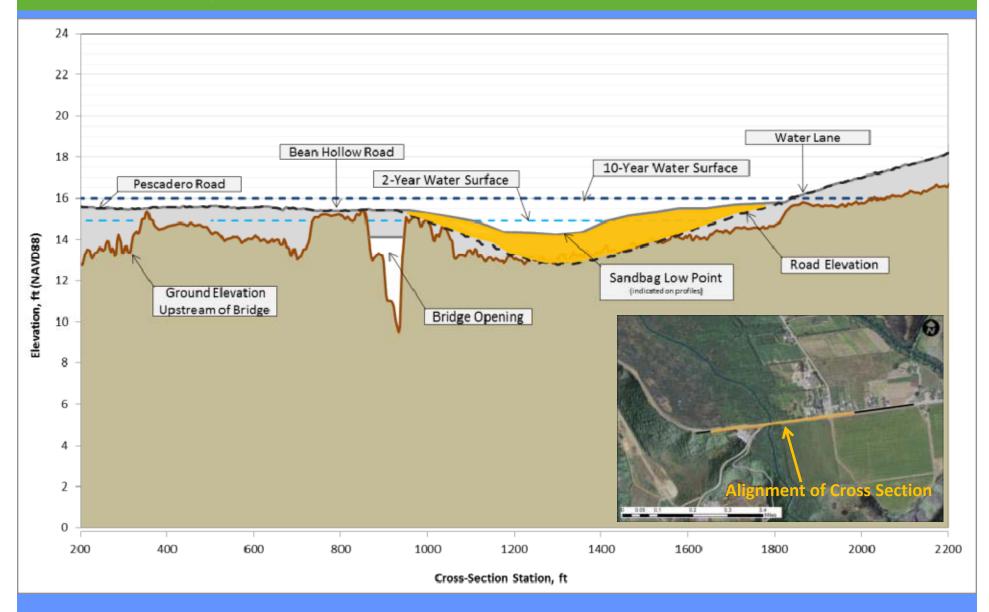
Looking Downstream at Pescadero Creek Road

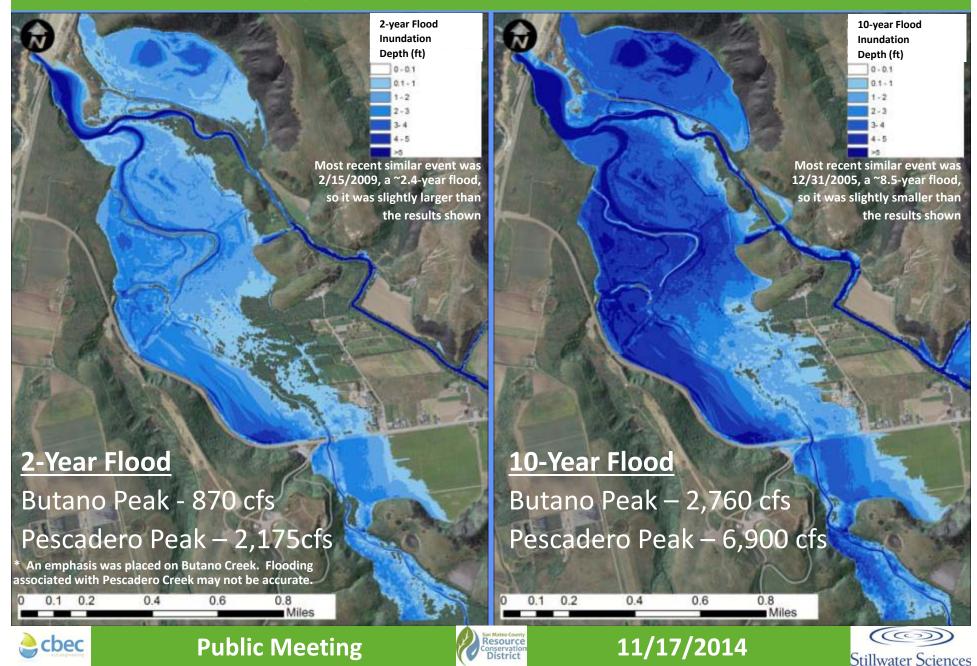
Existing Condition Flooding Extents

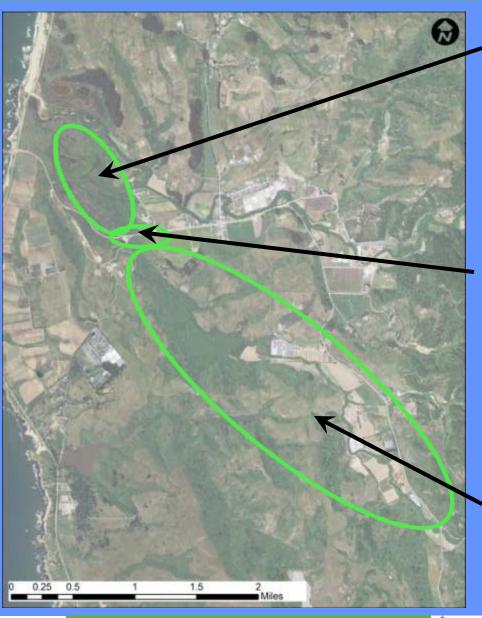
Components of a Solution

Downstream of the bridge

Near the bridge

Upstream of the bridge

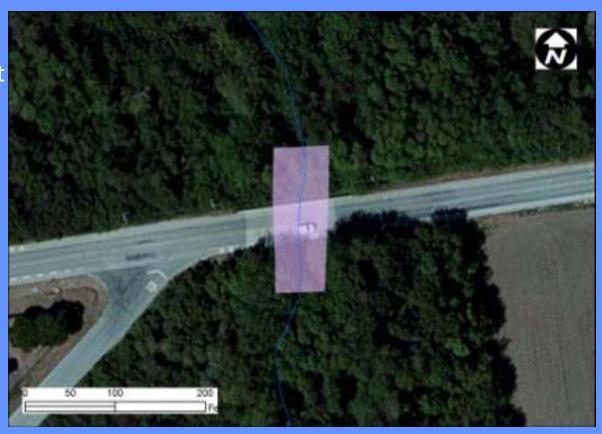
Dredge within Right of Way

Extent: 50 ft upstream and downstream

- Dimensions: 10 ft deep X 50 ft wide (500 ft²)

- Area: 7000 ft²

- Volume: 3000 yd³

- Reduces amount of frequent flooding
- 2 year event would not overtop sandbags, but could flood road from downstream
- Dredged area fills in rapidly during the first significant flood event (~2 year or larger)

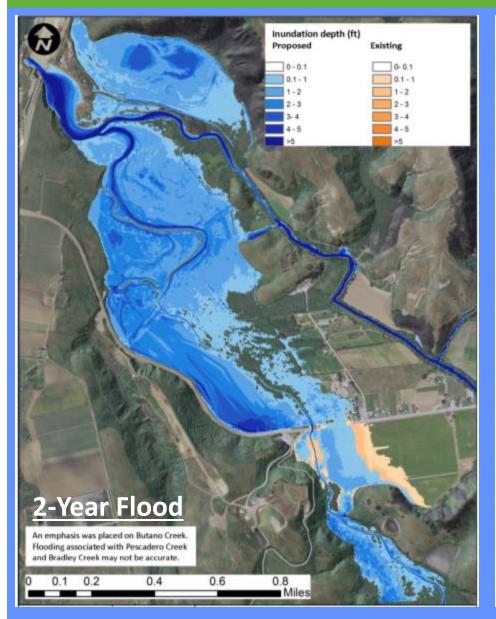
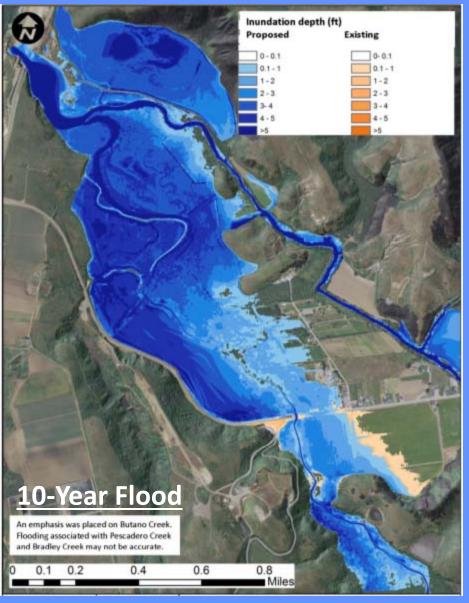
Dredge within ROW – Inundation Right After Dredging

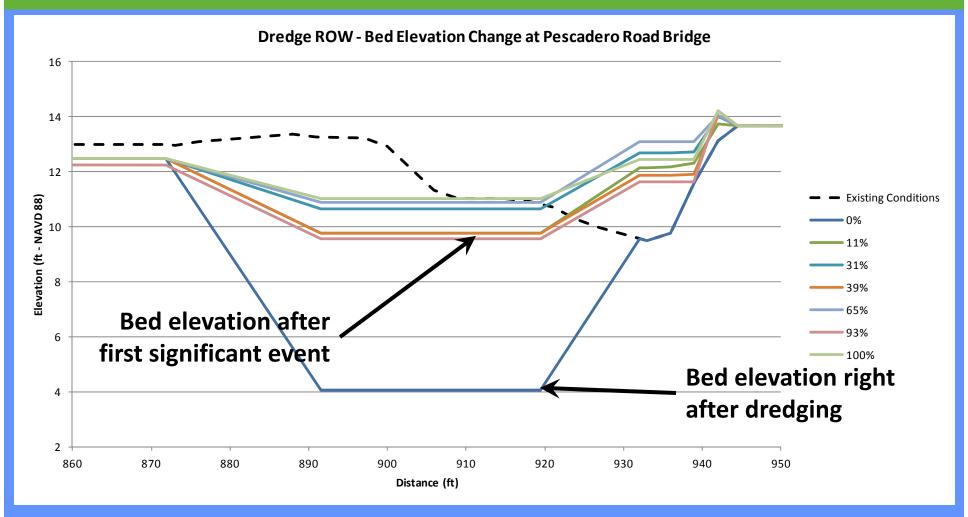
Dredge within Right of Way – Change through Time

Benefits from dredging will not last long unless upstream sediment reduction actions are taken

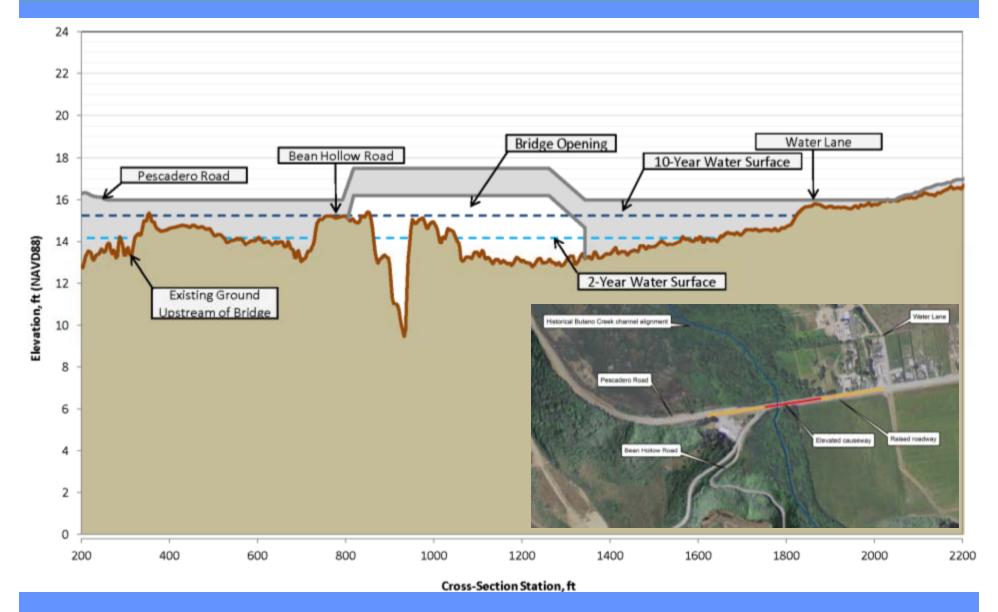
Causeway

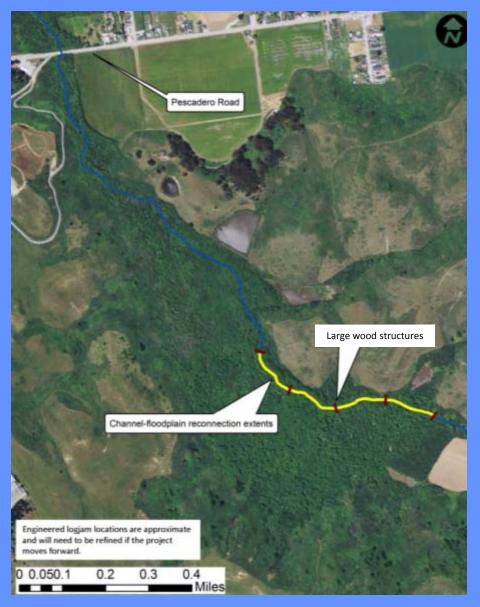
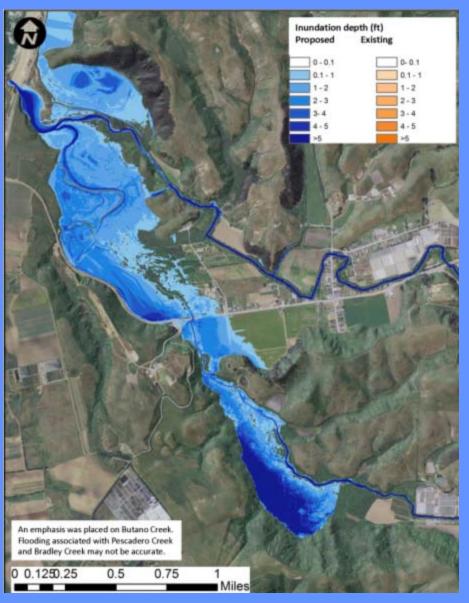
Floodplain Reconnection & Restoration
