**James V. Fitzgerald ASBS Pollution Reduction Program  
Upland BMPs: Low Impact Development (LID) Projects  
Pre- and Post-Construction Photo Documentation - January 20<sup>th</sup> 2016**

**LID Site #2 – Cooperator ID #202.0409.01**

**Site Information : 130 Wienke Way, Moss Beach, California**

**Project Summary**

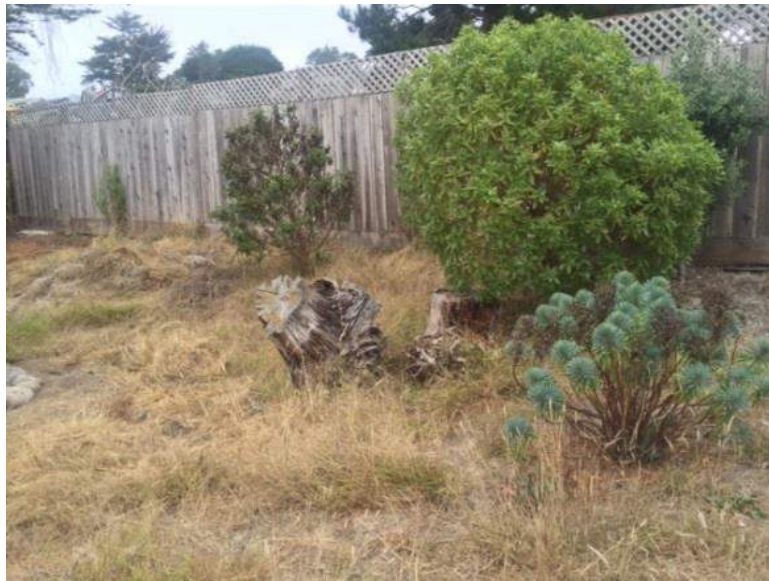
Future site of bioswale alongside of property towards Highway 1

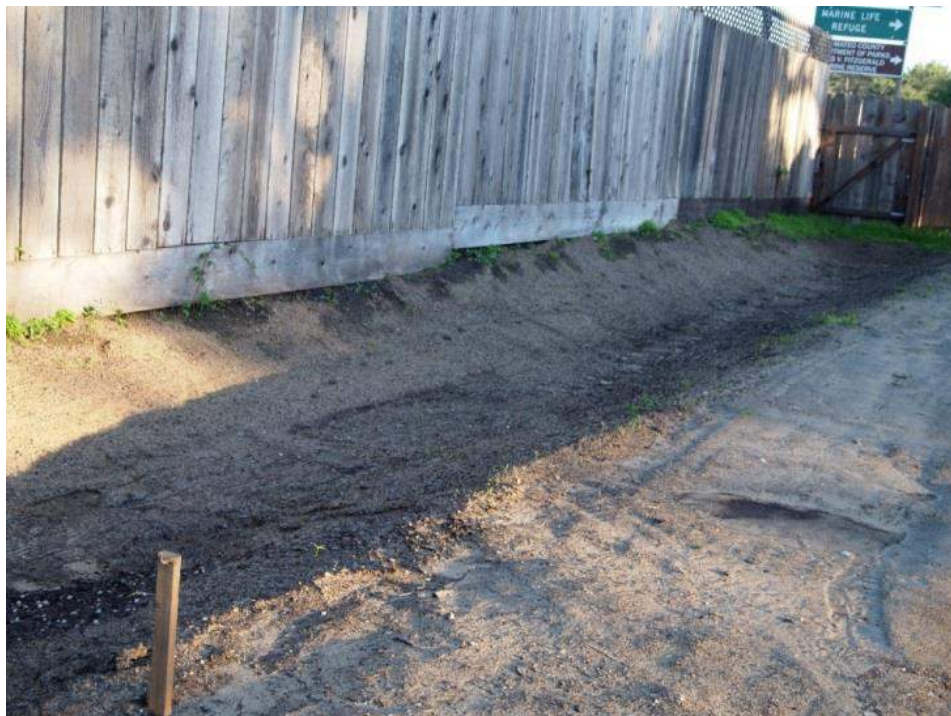
Filling in trench with biosoil mix

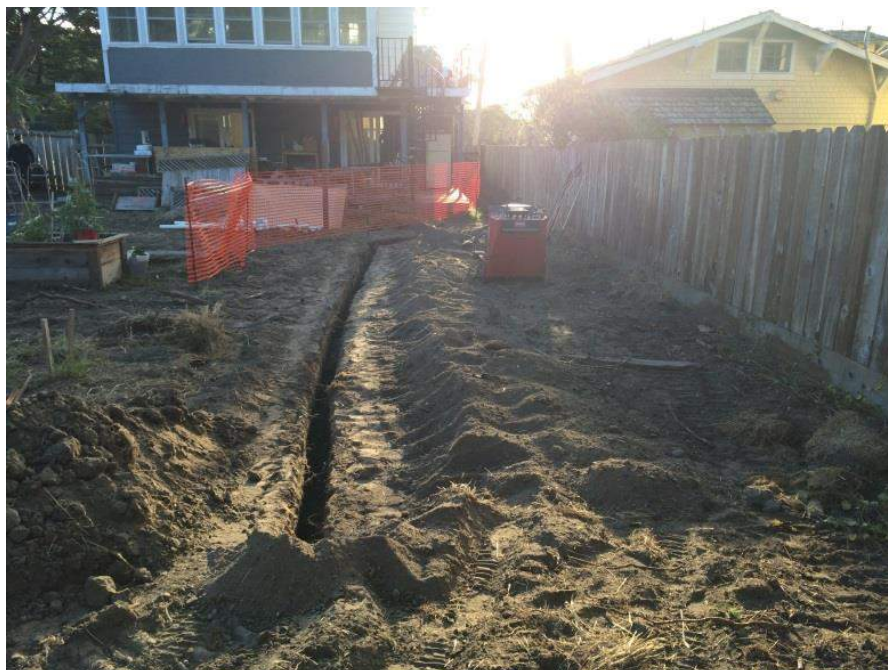
Trenching for pipes beneath the three-tiered rain garden

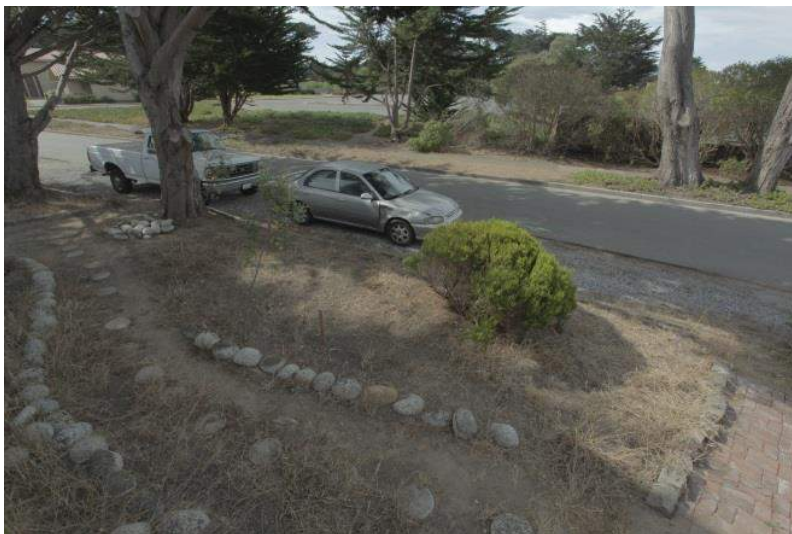
Future site of rain garden in front of western house

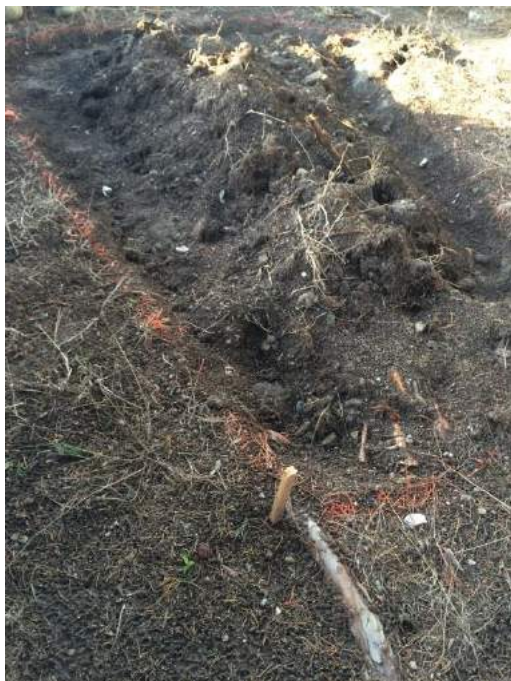
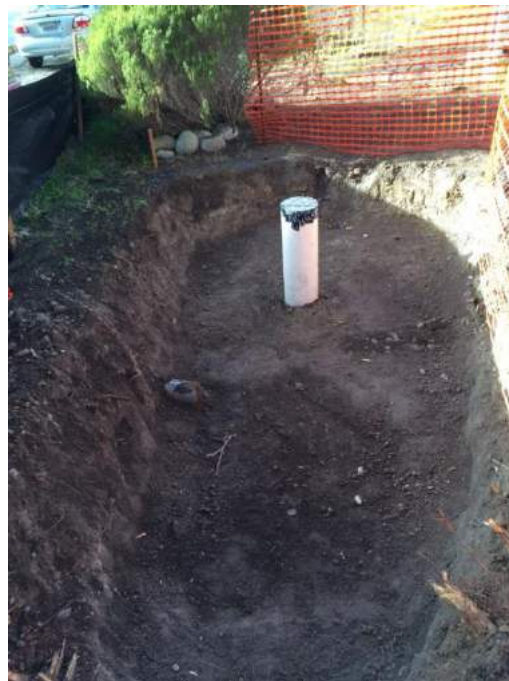
Excavating and laying pipes for western rain garden

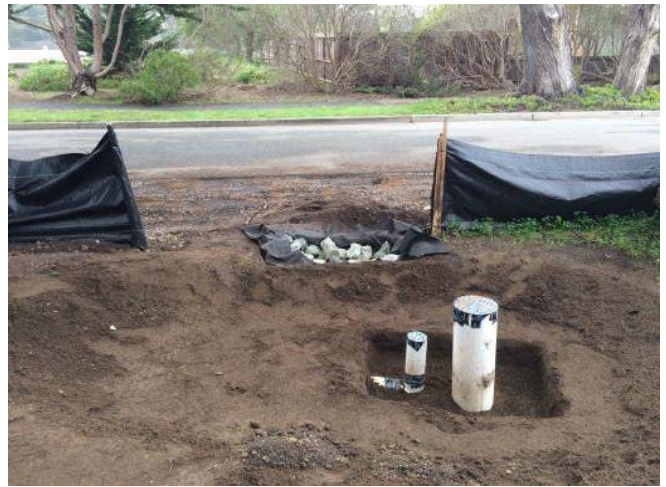
Piping for roof runoff and leading to western rain garden

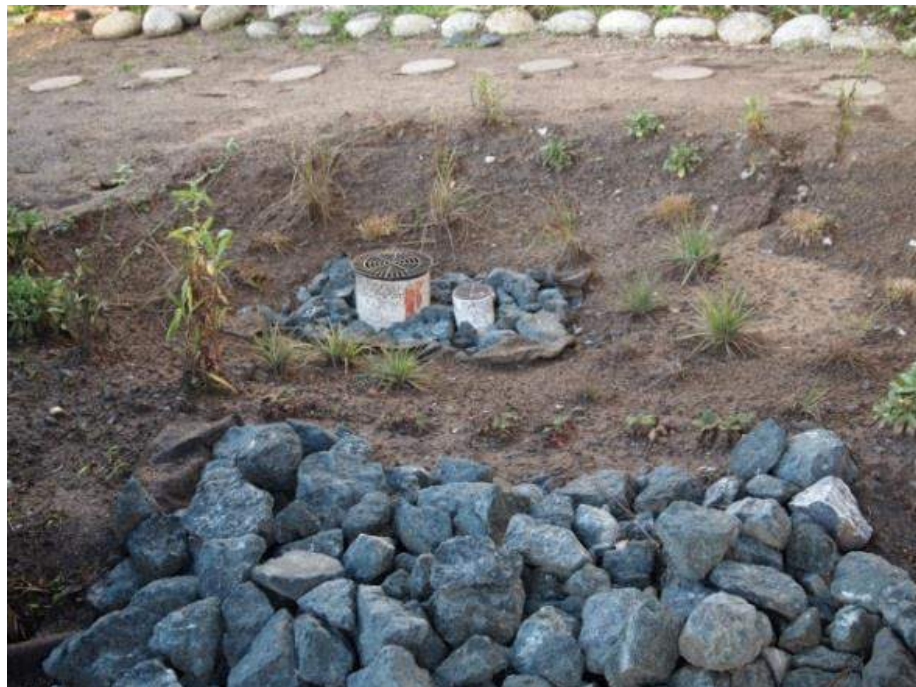
Western rain garden

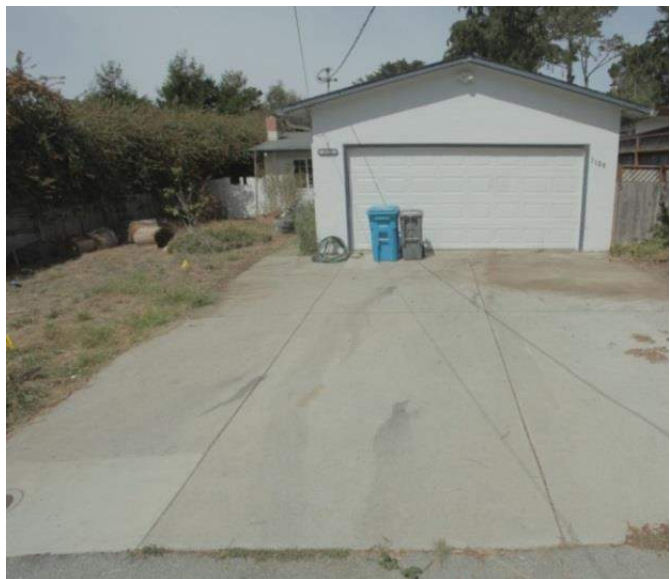
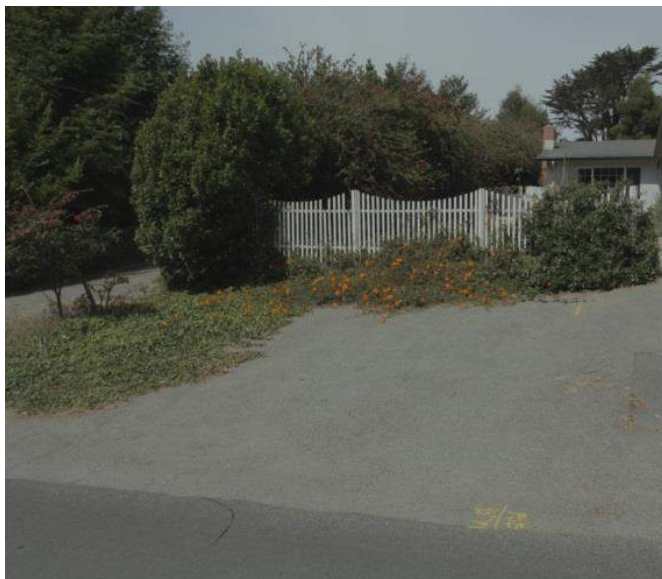
Concrete driveway before permeable asphalt installed    Side of driveway to be removed and vegetated

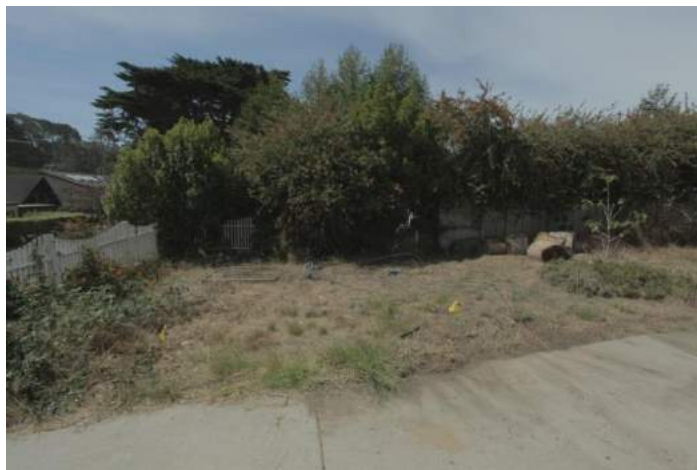
Large stump to be removed from driveway (left) and future rain garden area (right)

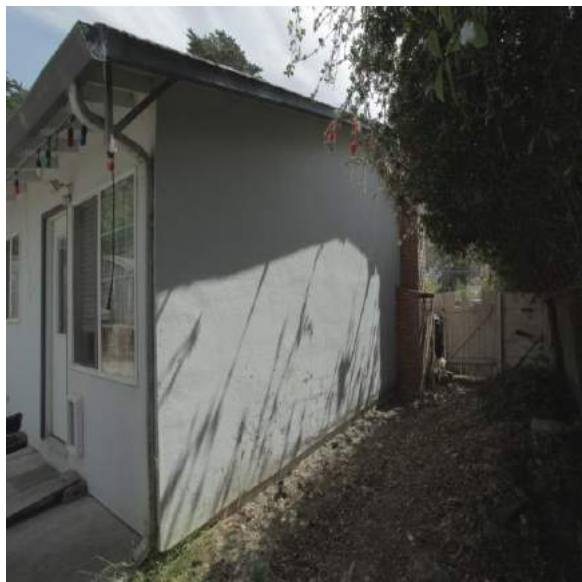
Future site of rain water tanks

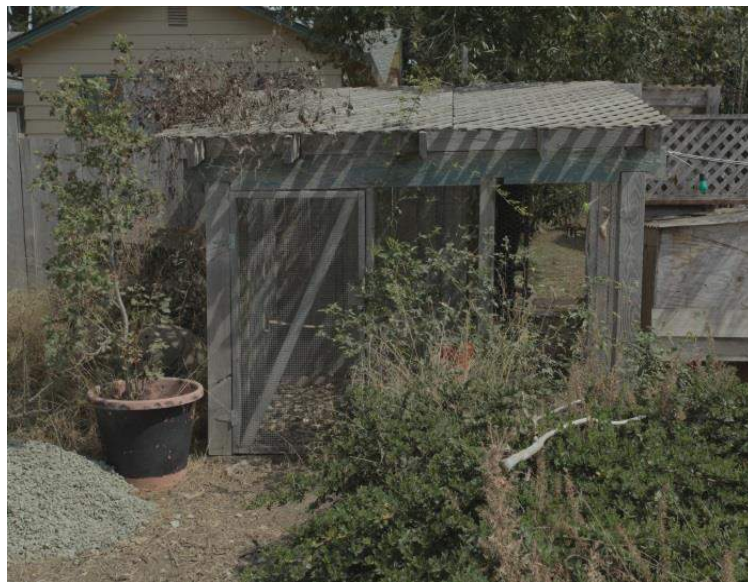
Chicken coop roof without plastic roof

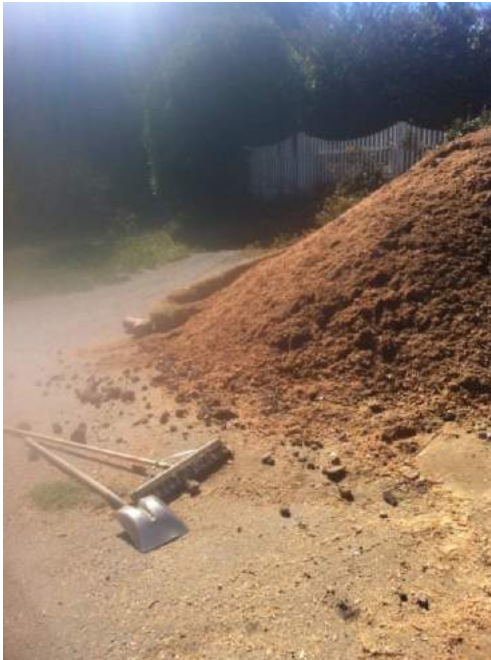
Stump removal from driveway

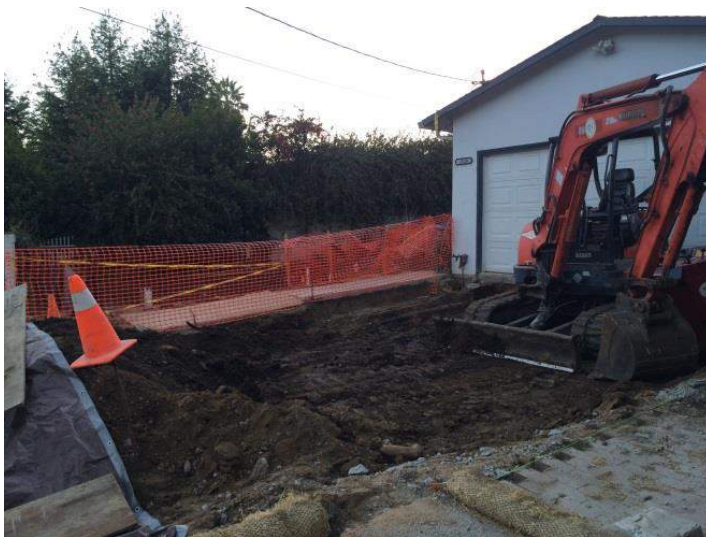
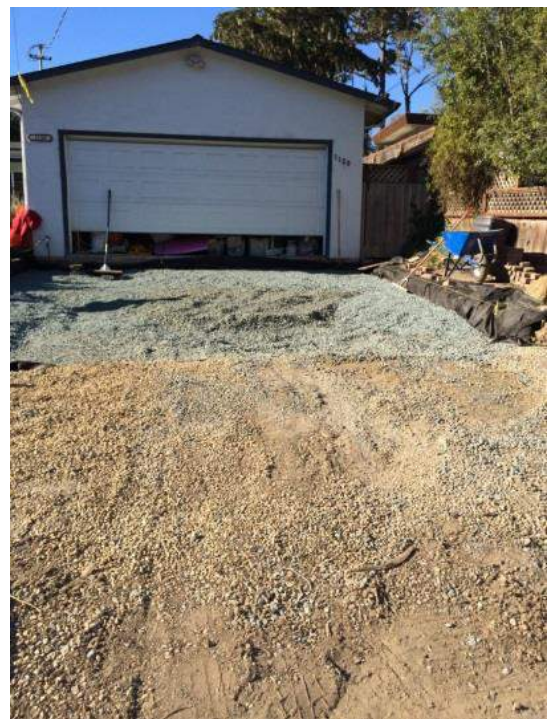
Removal of concrete driveway and installation of base layers

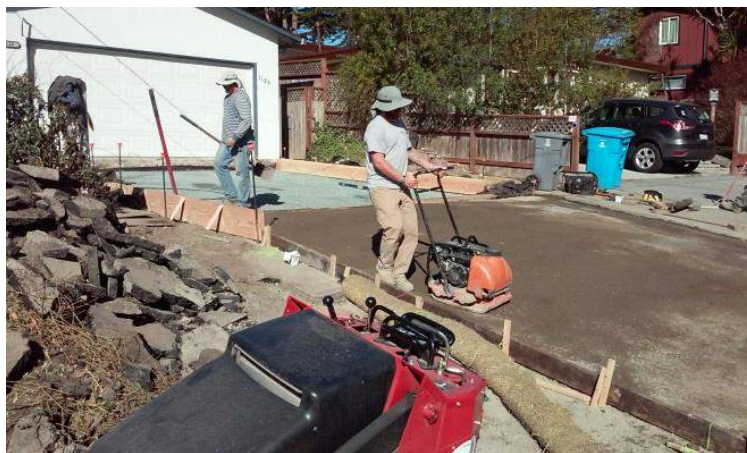
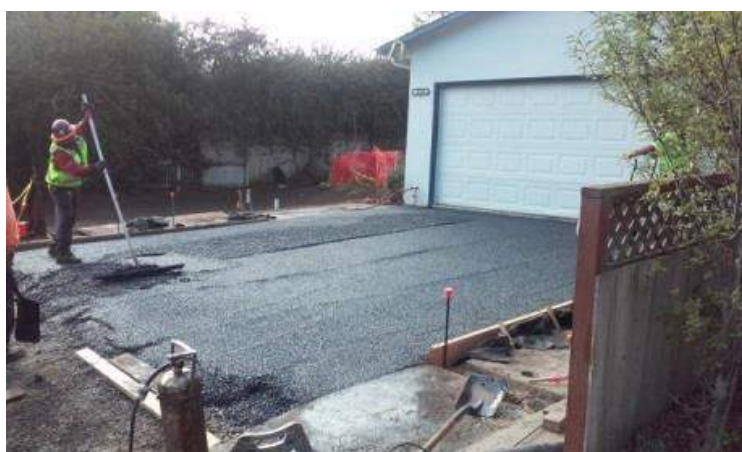
Installation of asphalt driveway with permeable section on top and regular asphalt on bottom

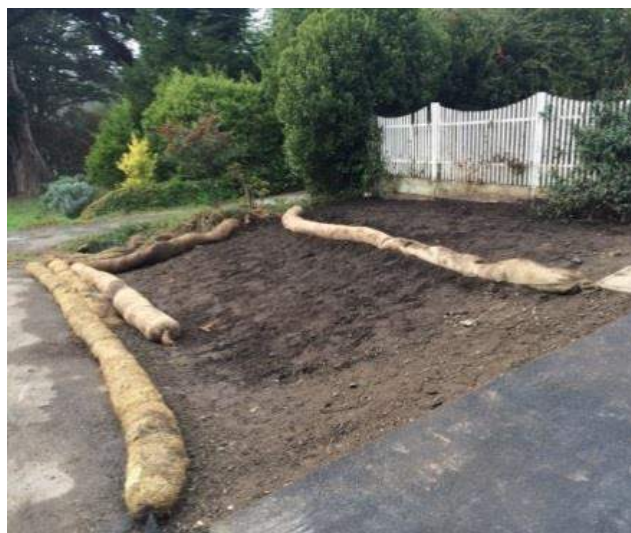
Side driveway area with asphalt removed and erosion control mats installed for vegetation

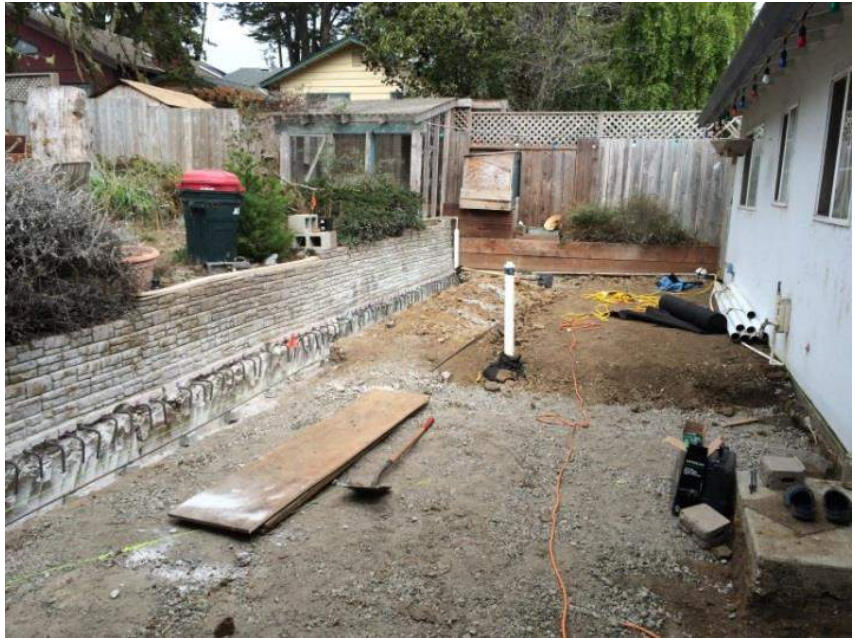
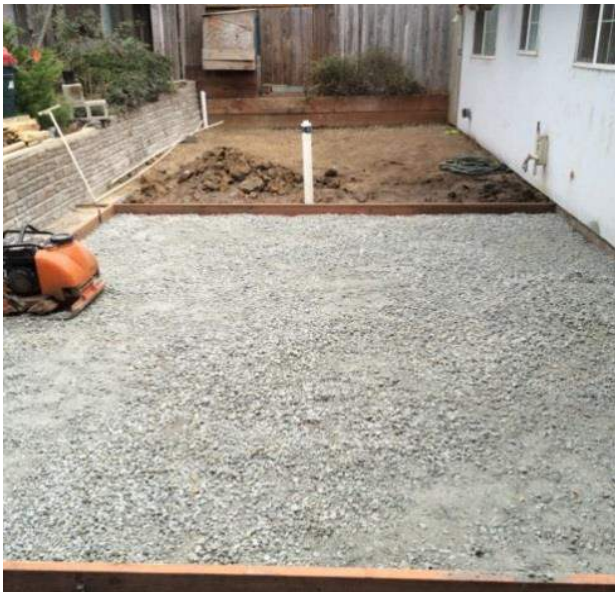
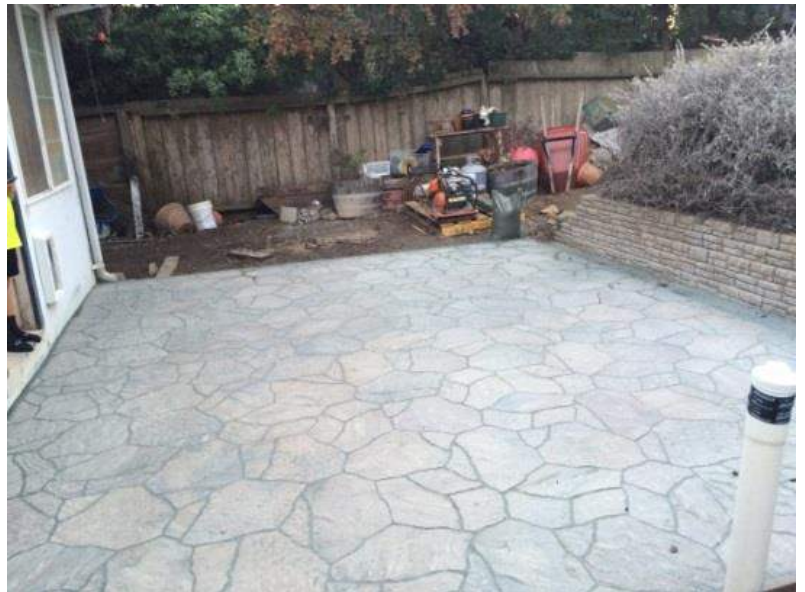
Backyard patio concrete removal and installation of drainage features

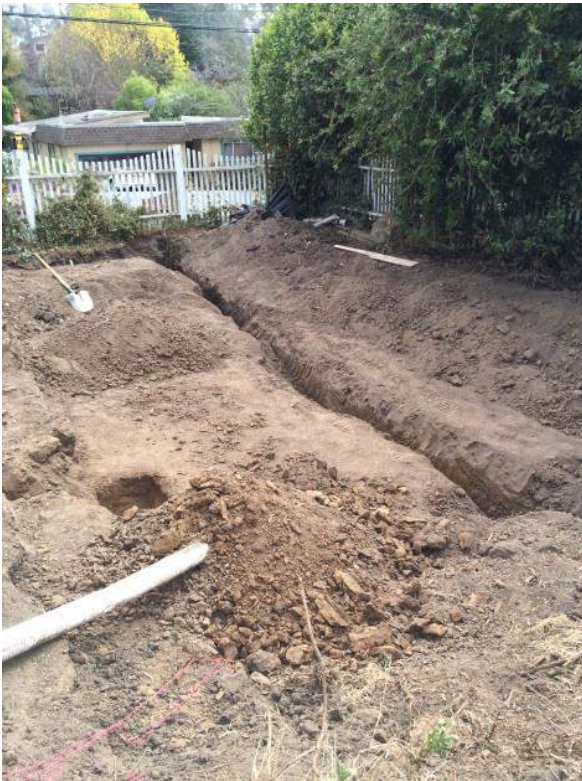
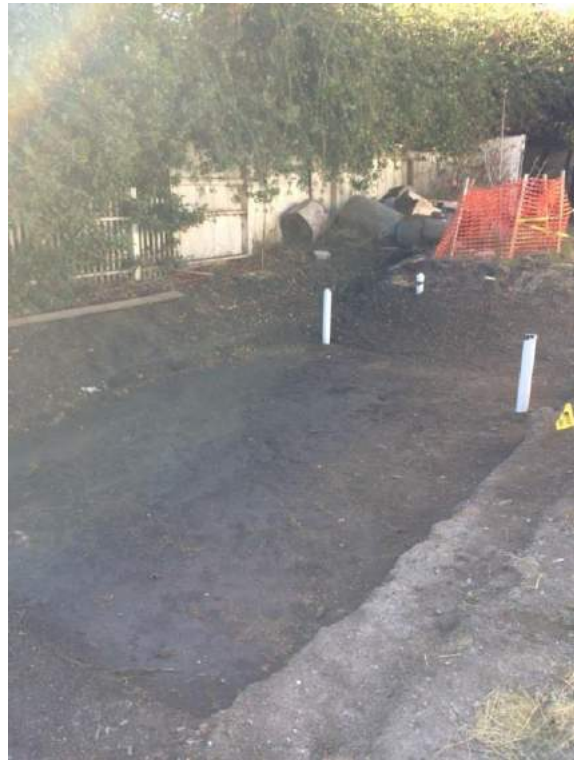
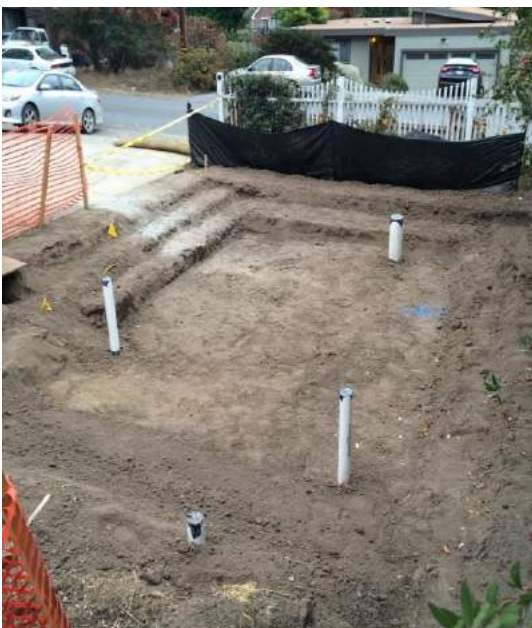
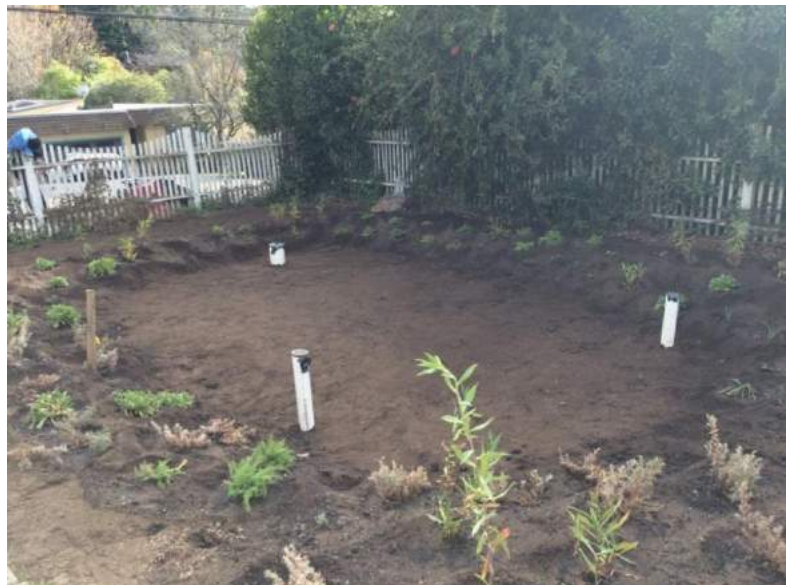
Installation of rain garden

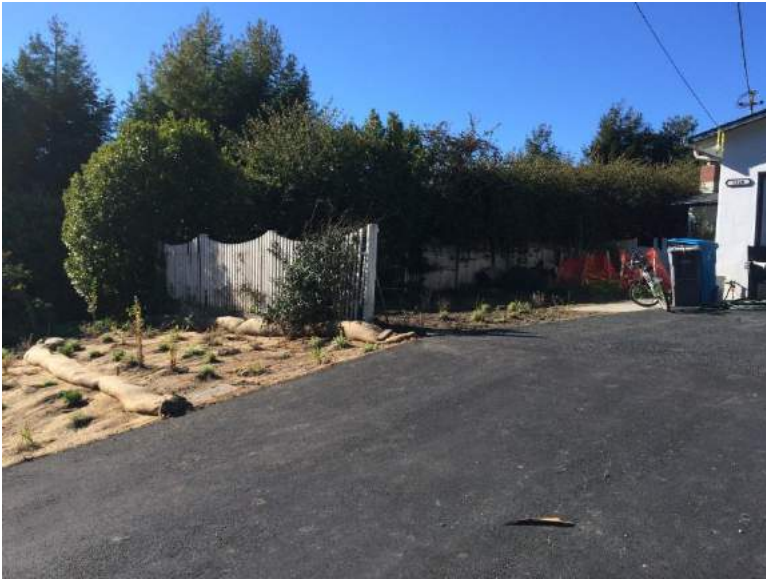
Permeable and impermeable asphalt driveway

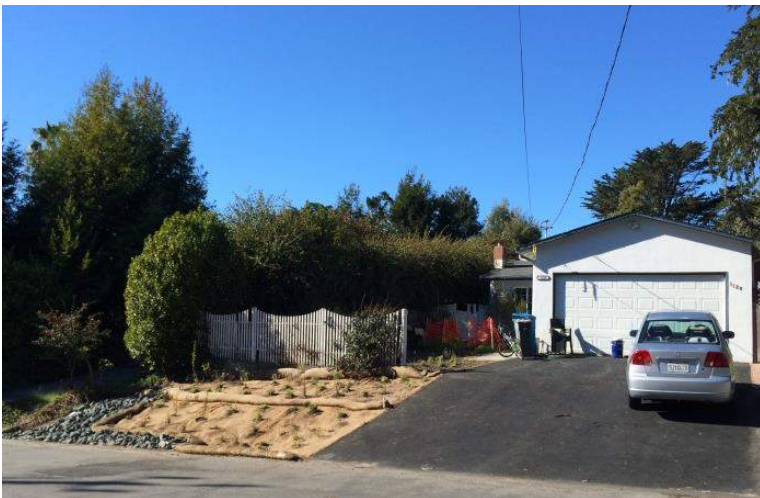
Revegetated side driveway with rain garden drainage outlet and riprap

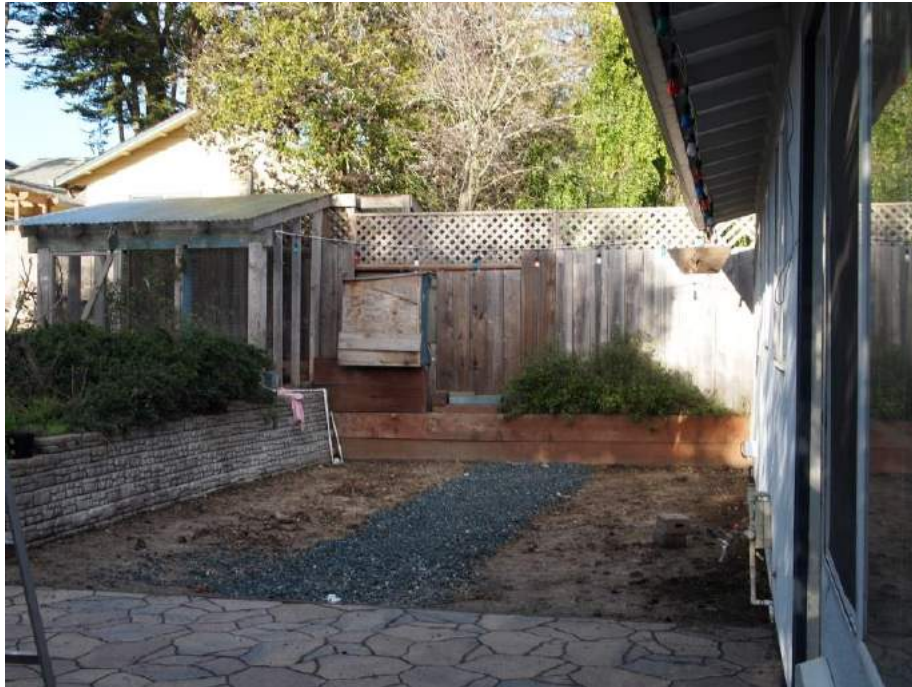
Backyard patio area

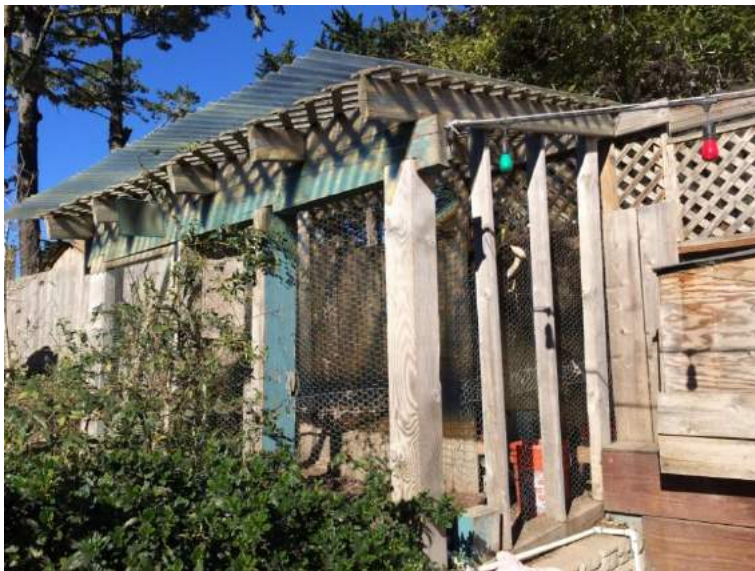
Chicken coop with roof structure

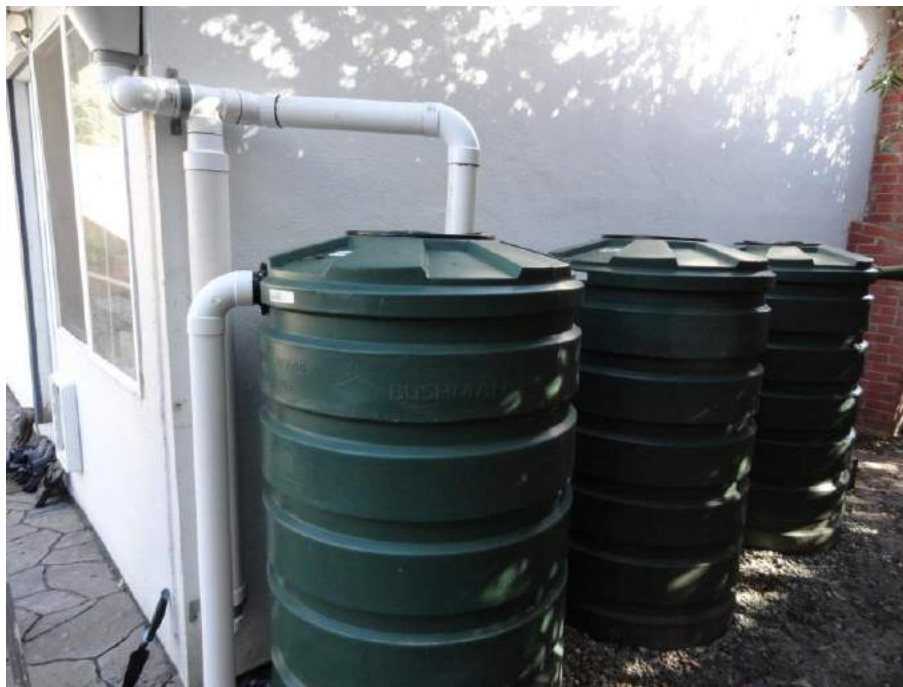
Rain water tanks with overflow to the rain garden

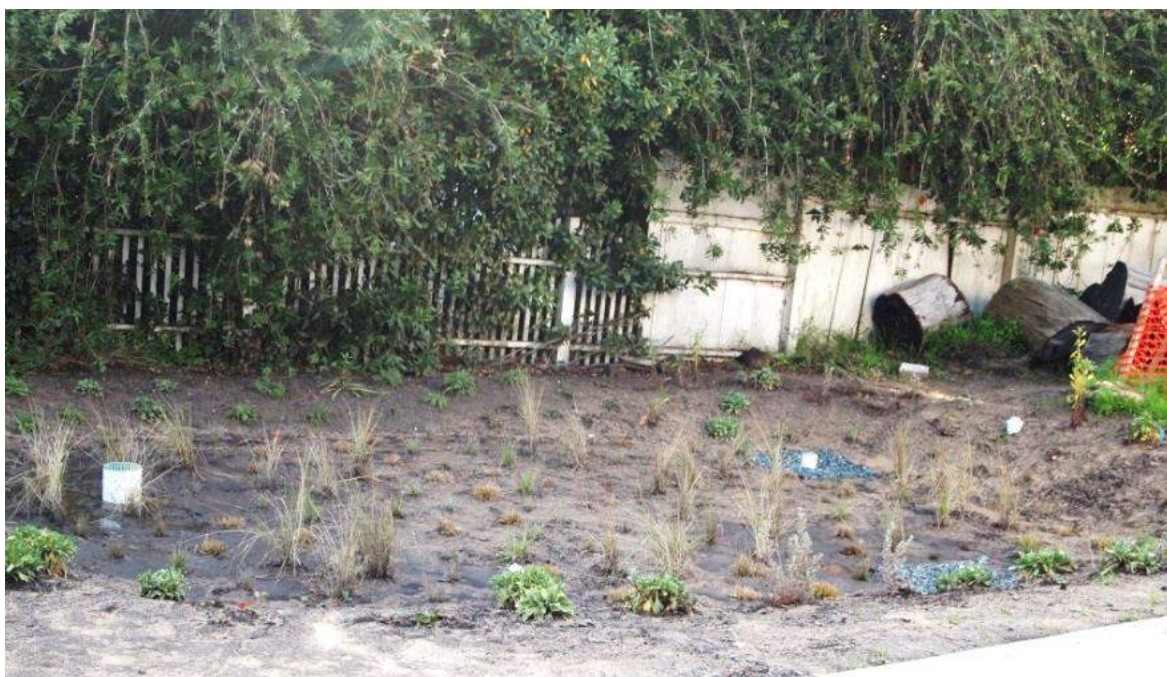
Rain garden with overflow from tanks, and drainage from backyard, north side yard, and driveway

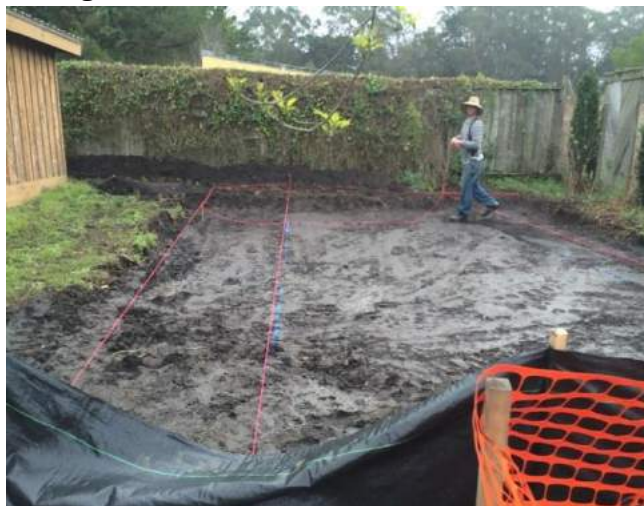
Grading of rain garden and piping installation

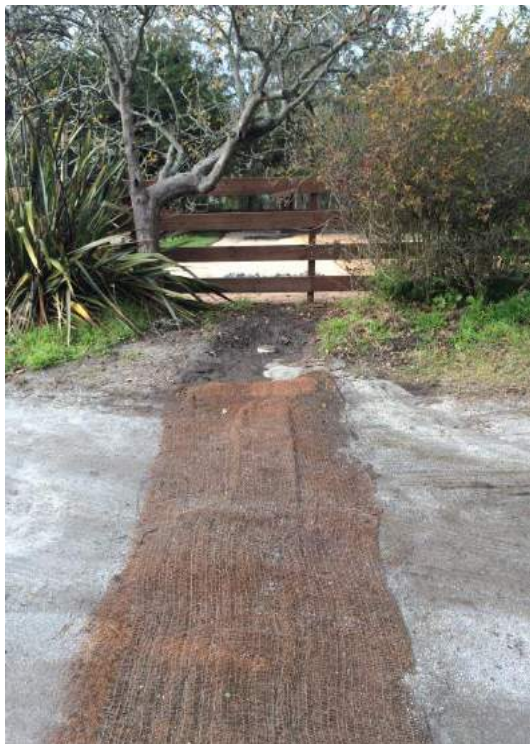
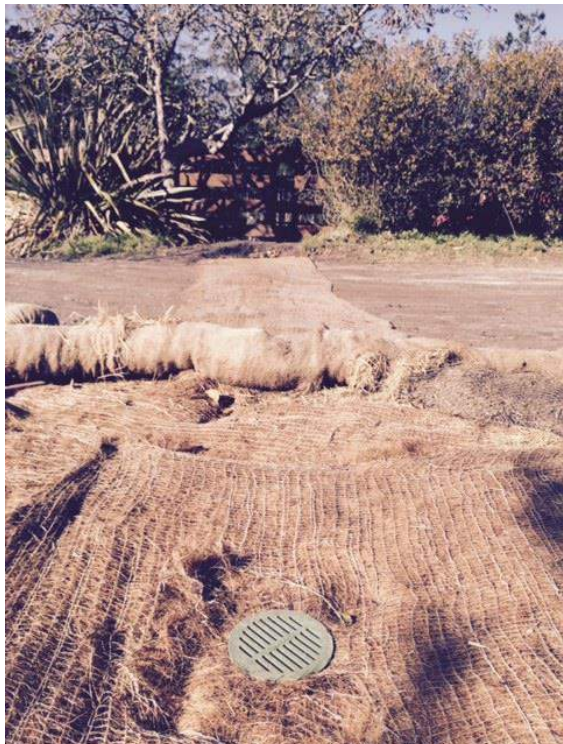
Installing drainage road inlet with temporary erosion control mats leading to the bioswale

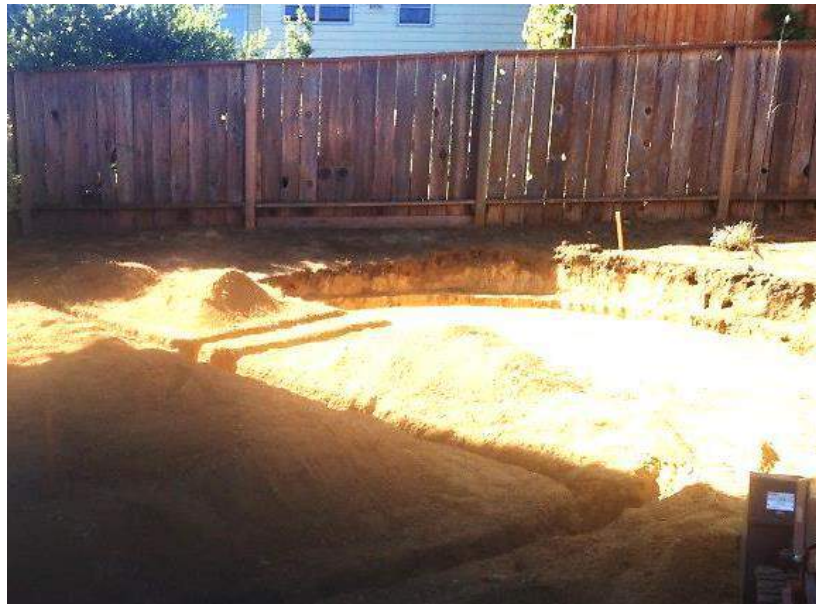
Northeast side of property showing location of rain water tanks and piping for downspouts/swale

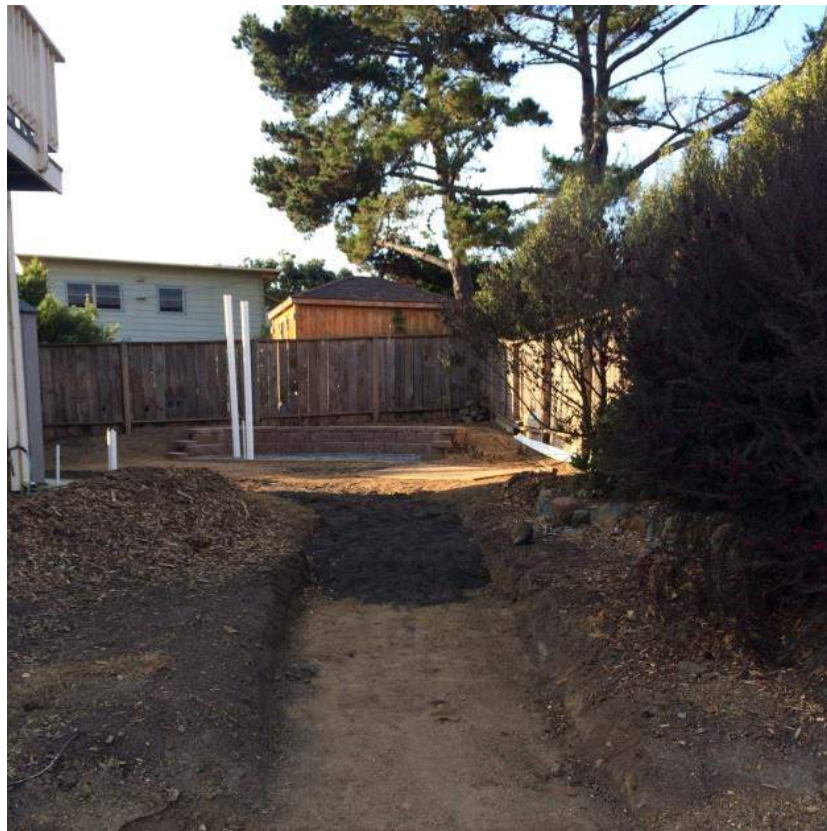
Upstream section of the bioswale/rain garden system

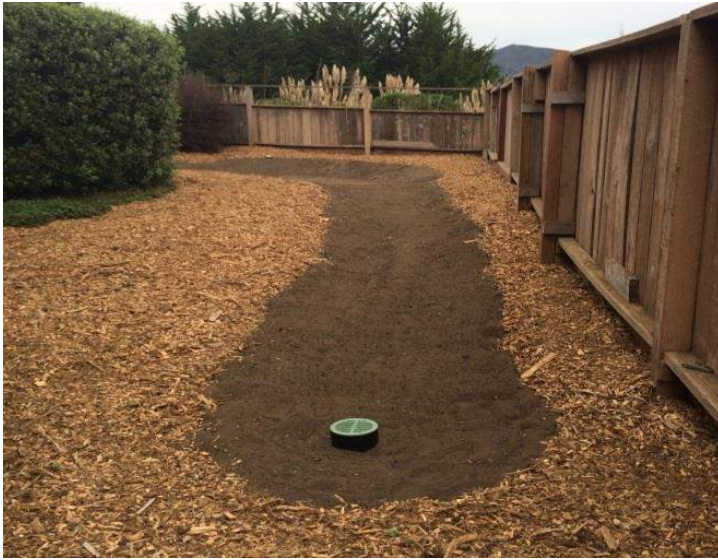
Downstream section of bioswale/rain garden system

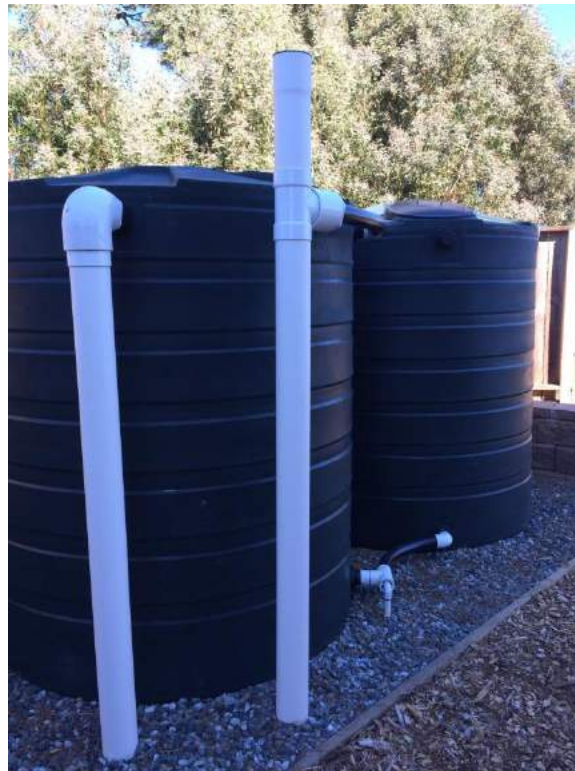
Rainwater tanks on north side of the property

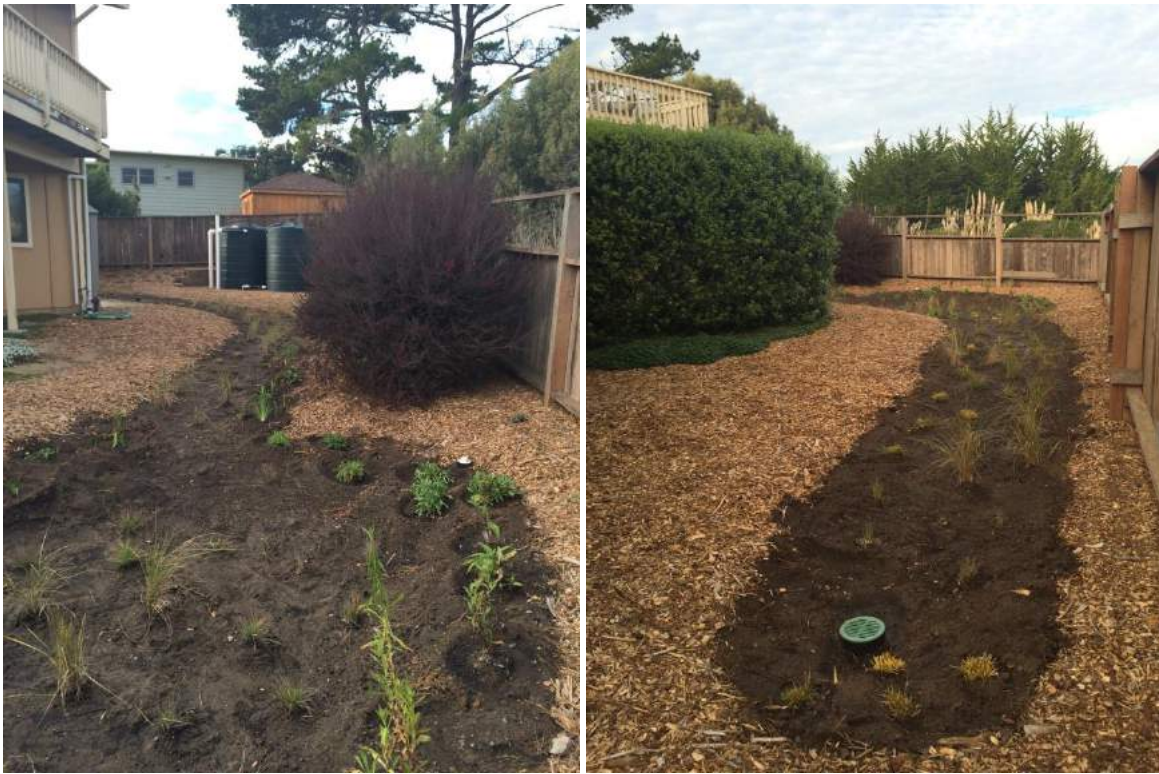
Bioswale/rain garden system

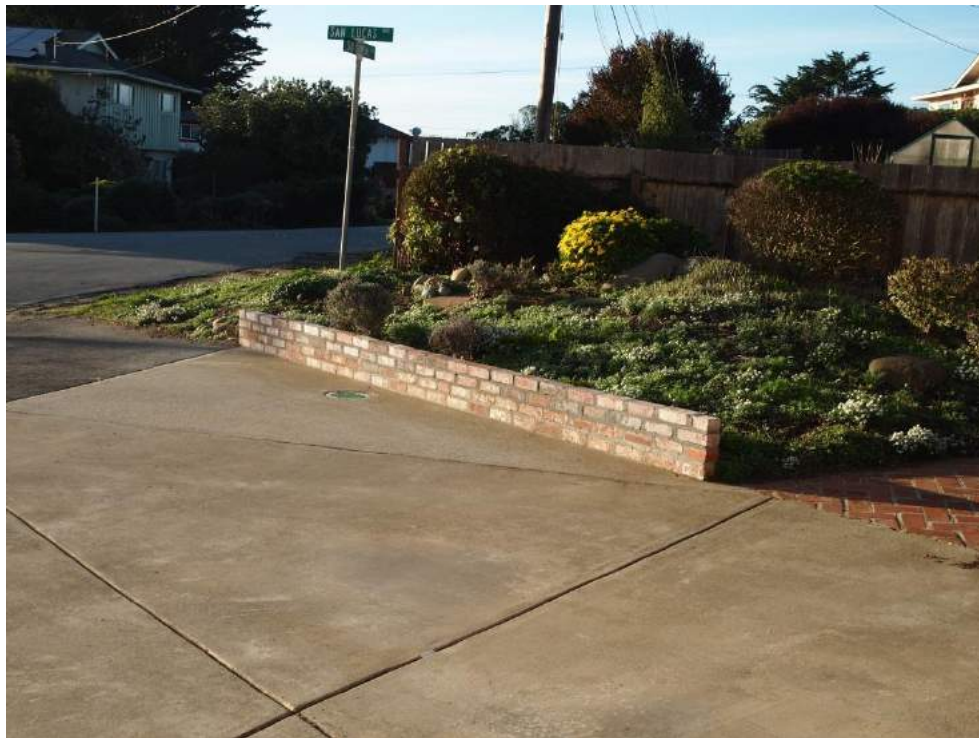
West side of property showing new brick wall/erosion control structure

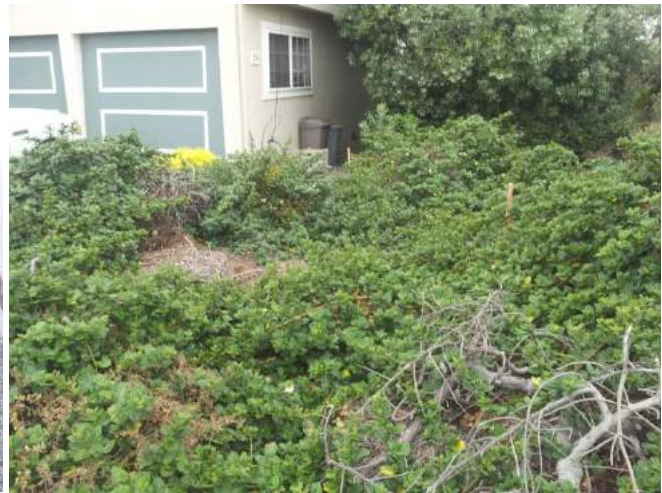
Rain garden area with tree to be removed (left) and bioswale area to be connected to rain garden (right)

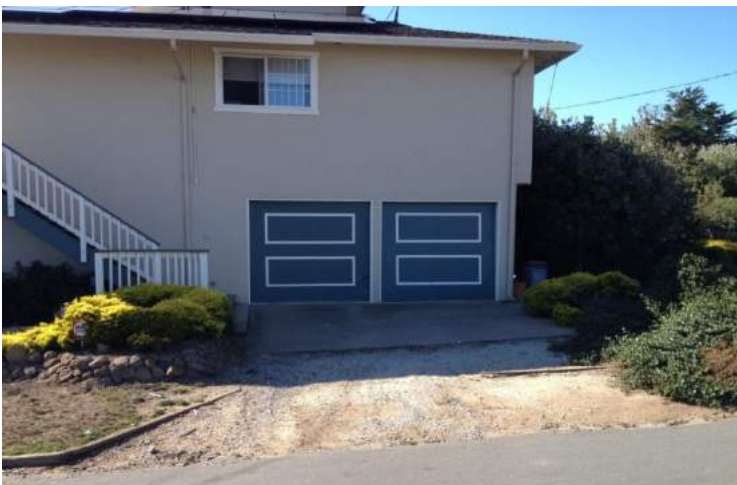
South side of property showing driveway (left) and area for driveway underdrain and outlet (right)

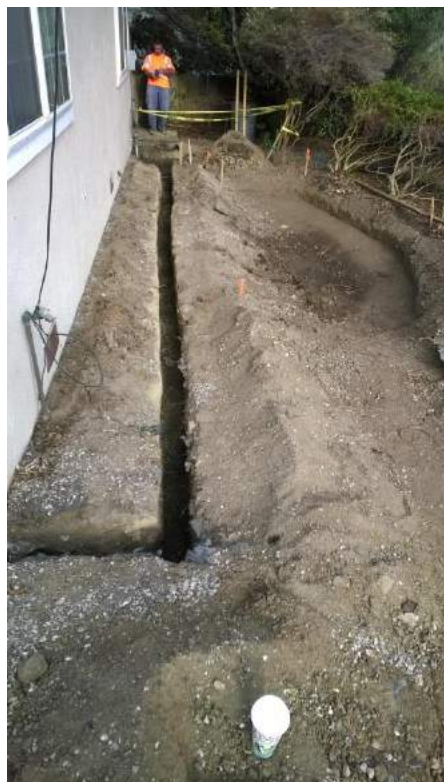
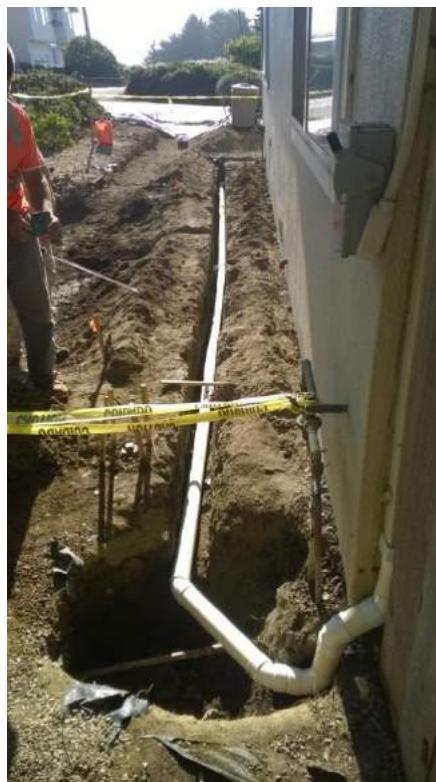
Piping from downspouts to rain garden

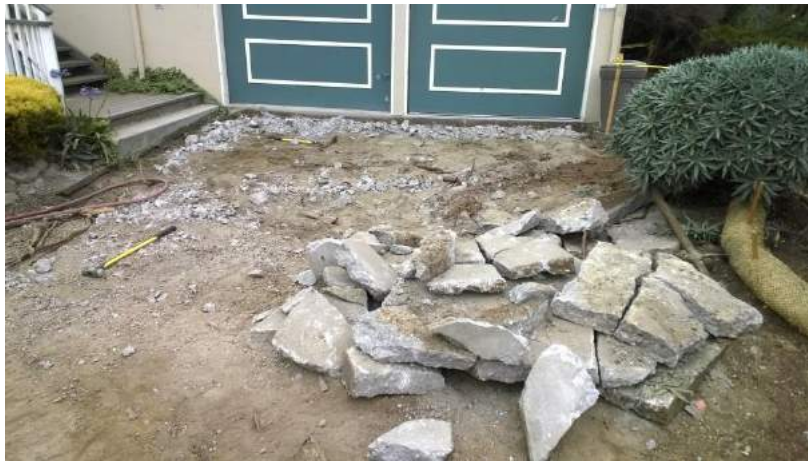
South side of property showing permeable asphalt work on driveway

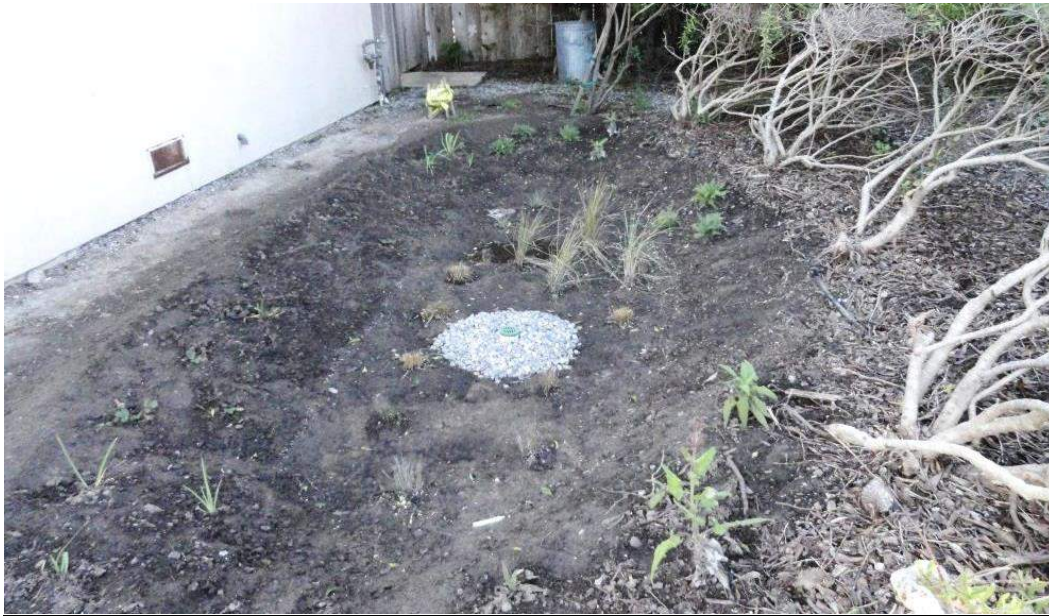
Rain garden on north side of house

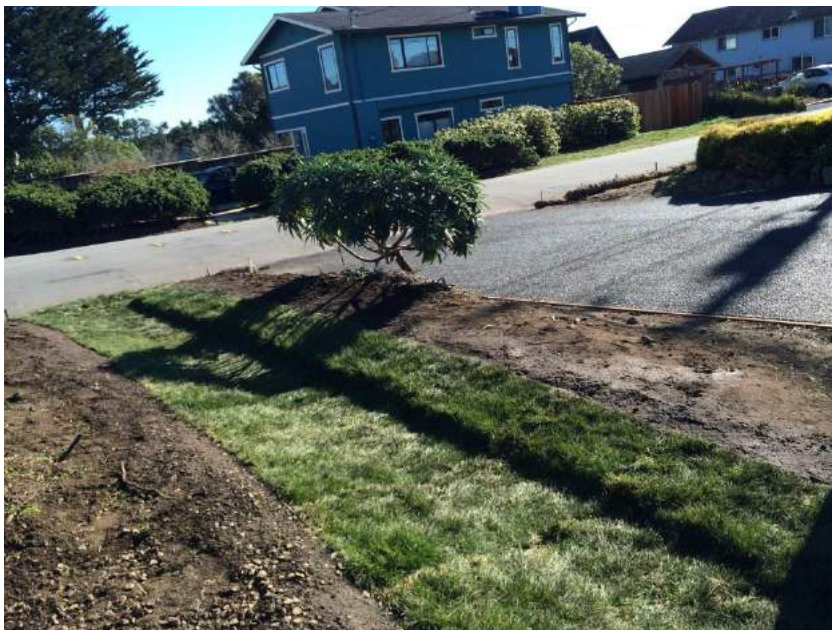
Bioswale with sod (left) and connection of the swale and rain garden (right)

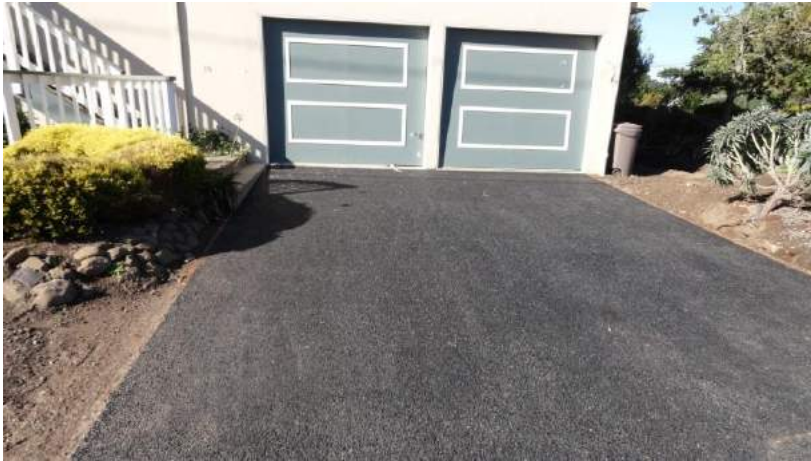
Permeable asphalt driveway (left) and underdrain and outlet for driveway (right)
