**James V. Fitzgerald ASBS Pollution Reduction Program  
Upland BMPs: Low Impact Development (LID) Projects  
Pre- and Post-Construction Photo Documentation - January 20<sup>th</sup> 2016**

**LID Site #2 – Cooperator ID #202.0409.01**

**Site Information : 130 Wienke Way, Moss Beach, California**

**Project Summary**

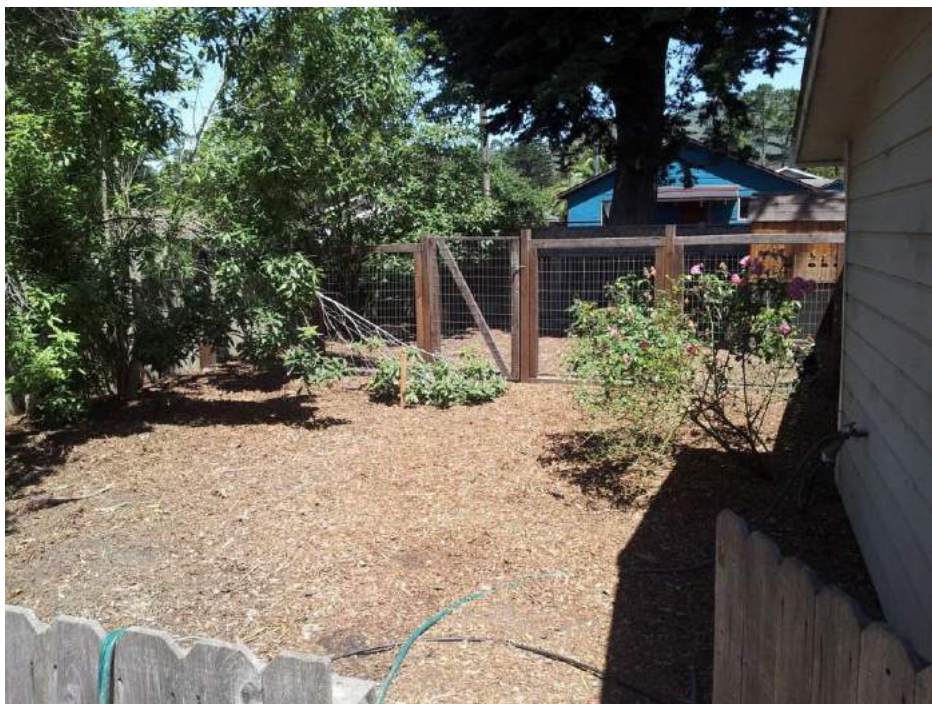
Northwest side of property showing future rain garden area and chicken coop without roof

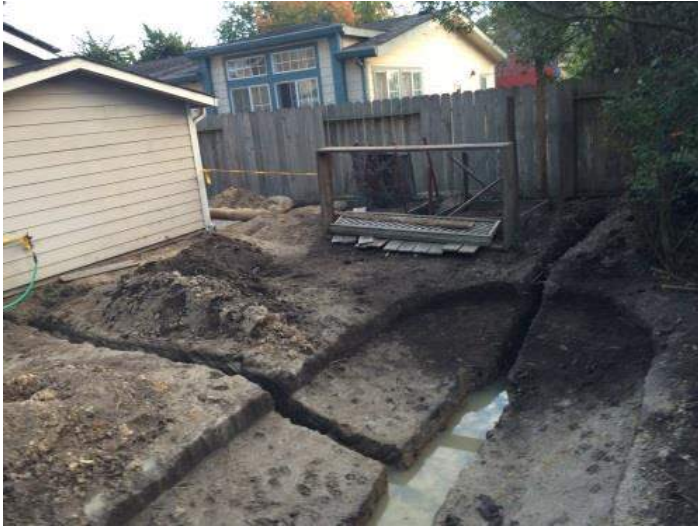
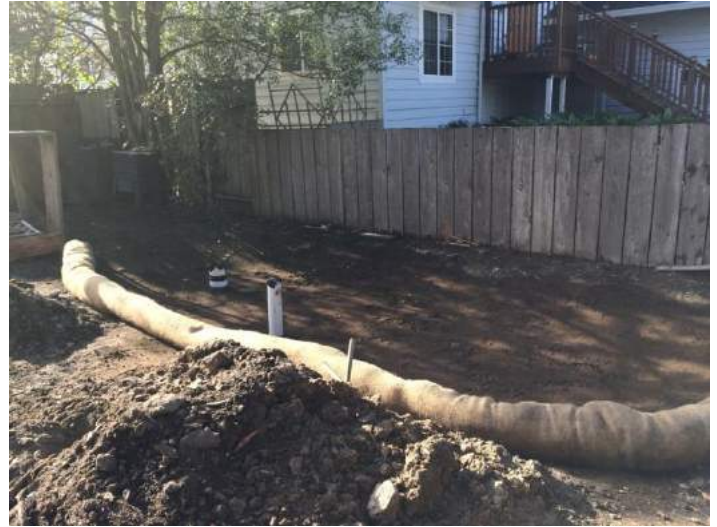
Rain garden installation with piping from shed and around to south side of property

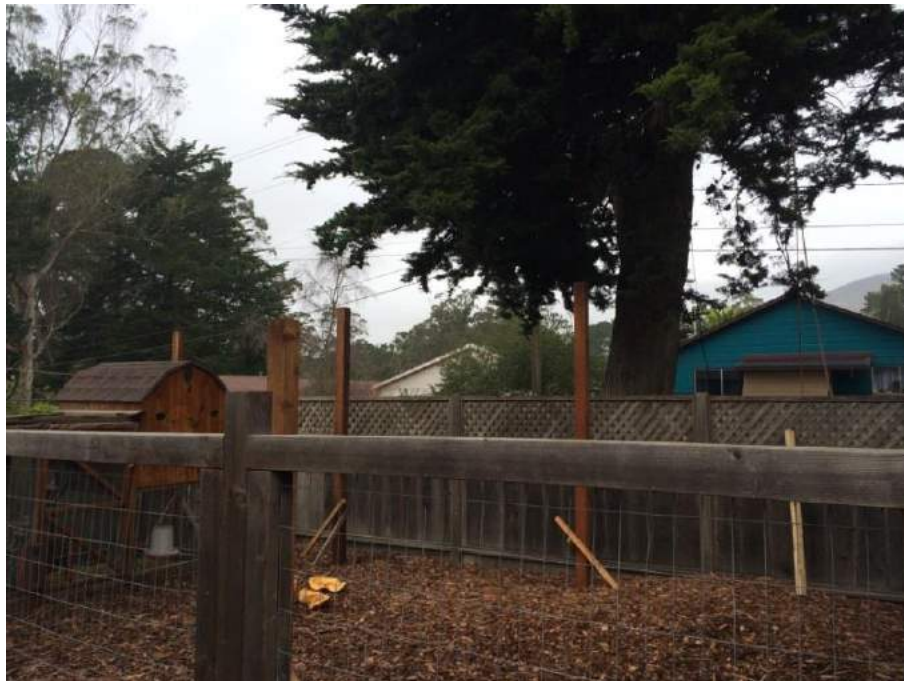
Wooden posts for chicken coop roof structure

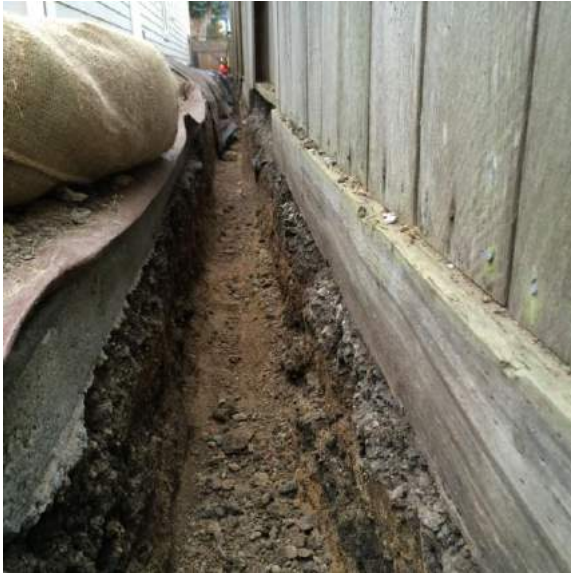
Trench for drain line from rain garden (left) that leads to gravel drainage outlet at road (right)

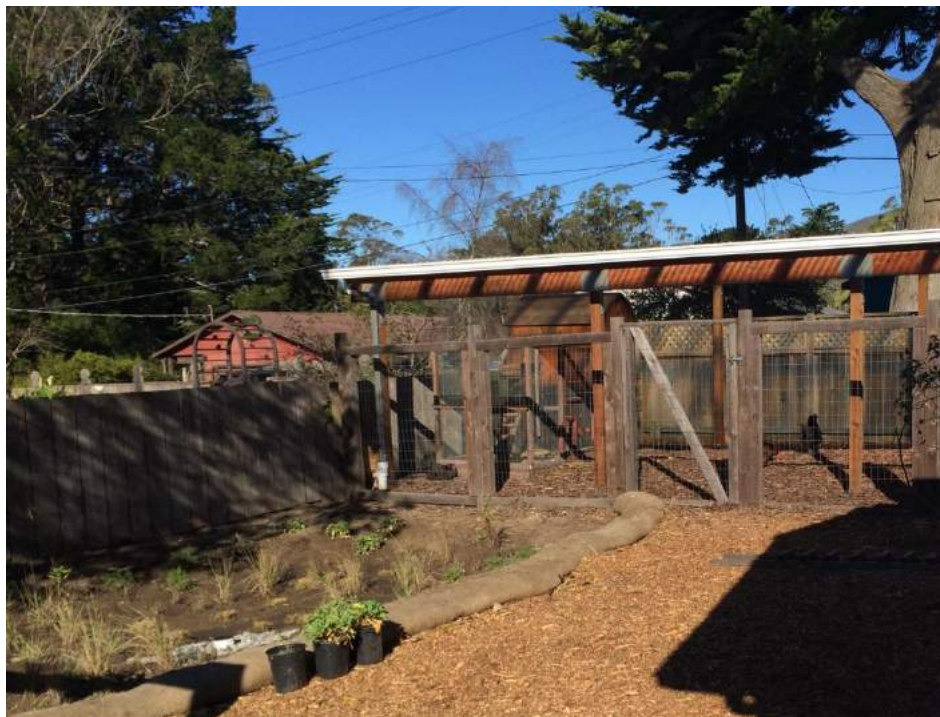
Rain garden and chicken coop roof

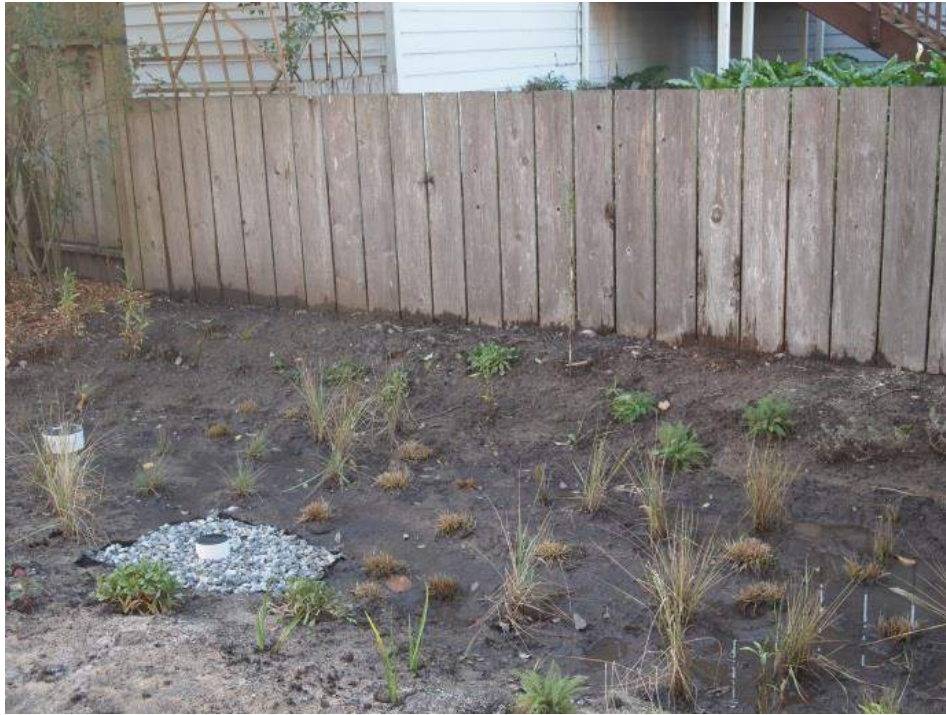
Rain garden with runoff from chicken coop roof and shed

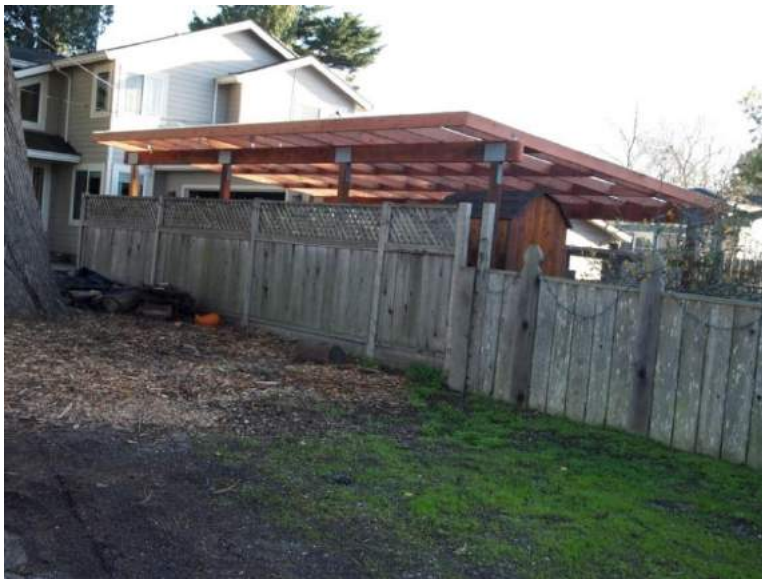
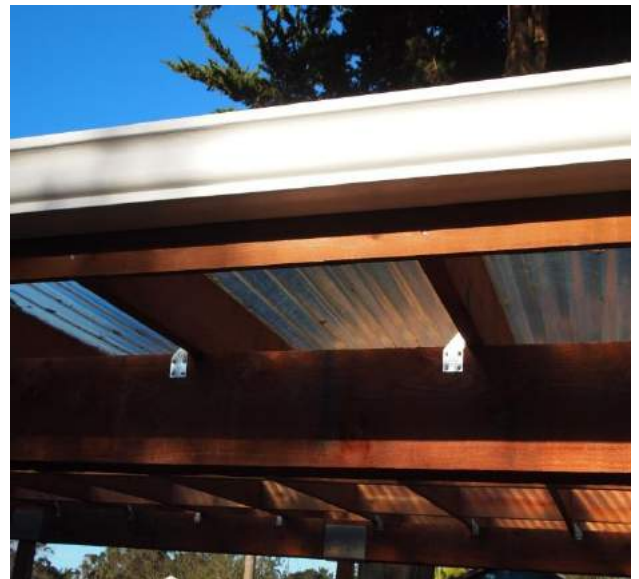
Redwood chicken coop roof with corrugated plastic panels and gutters

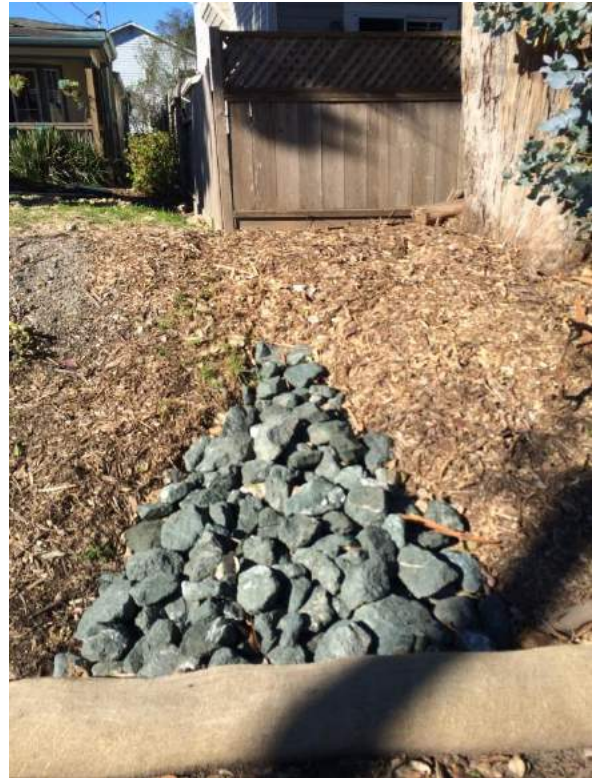
South side of property with drain line under rock (left) leading to gravel drainage outlet with riprap (right)

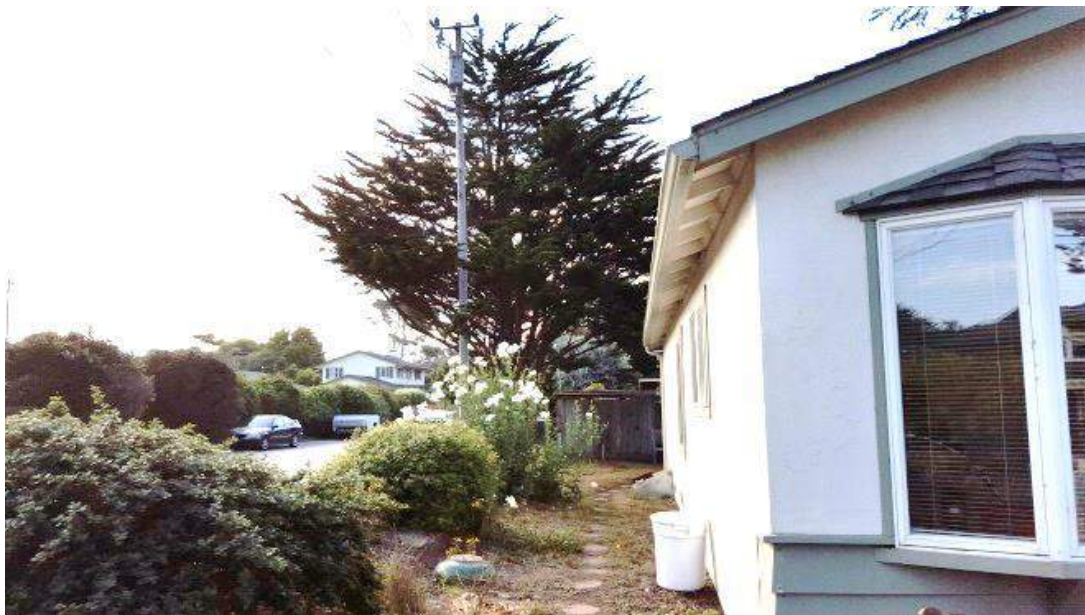
North side of property and future location for rain water tanks

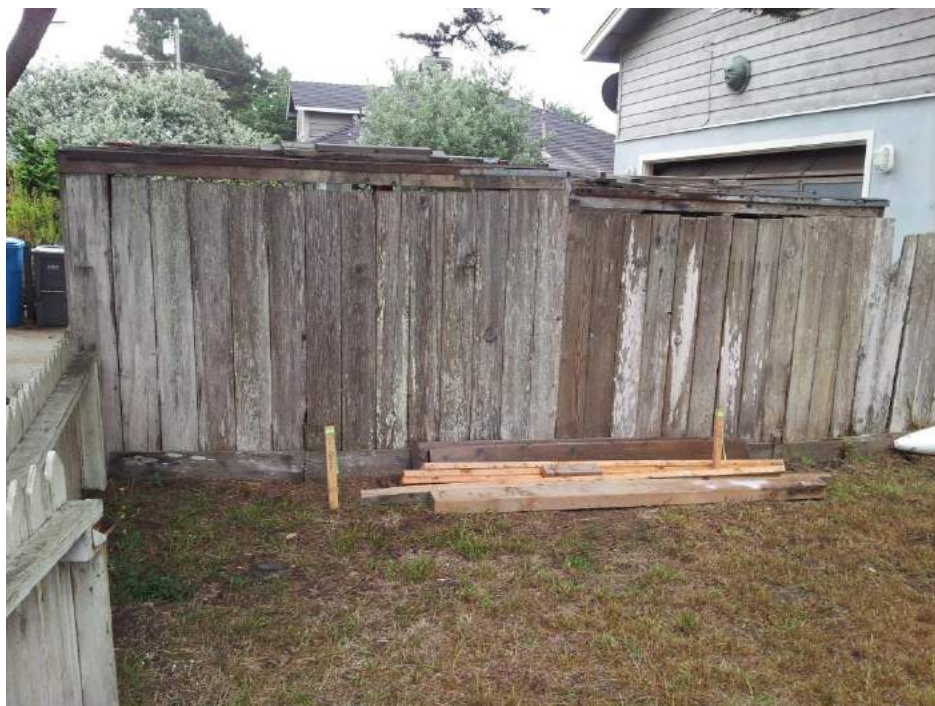
East side of property and future location for rain garden

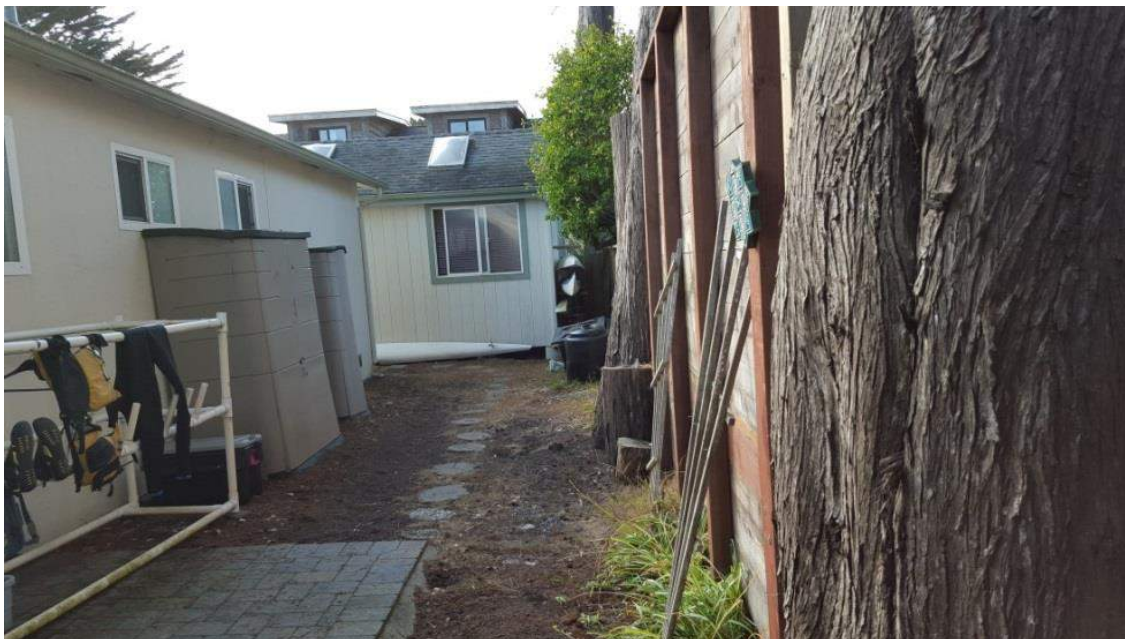
South side of property and future location for rain water tanks and bioswale

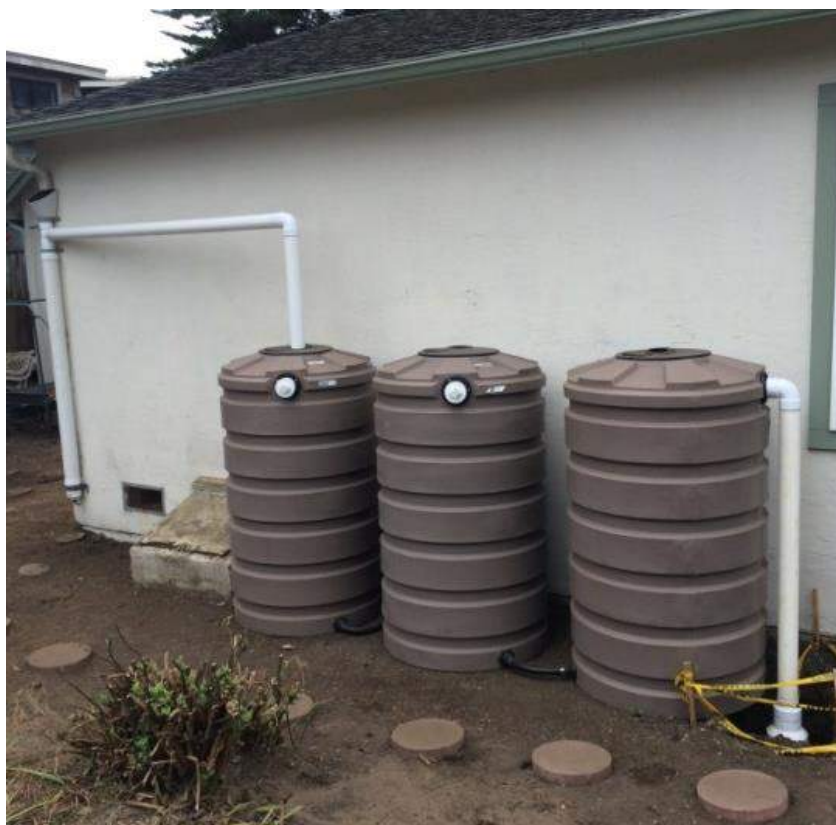
Rain water tanks on north side of property that overflow to the east rain garden

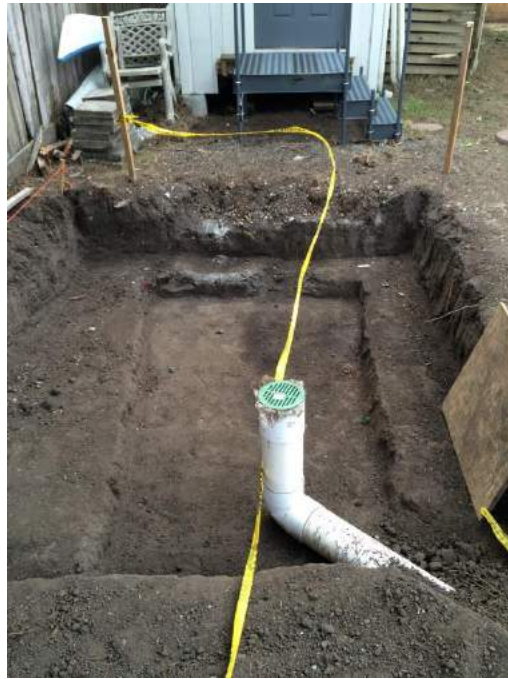
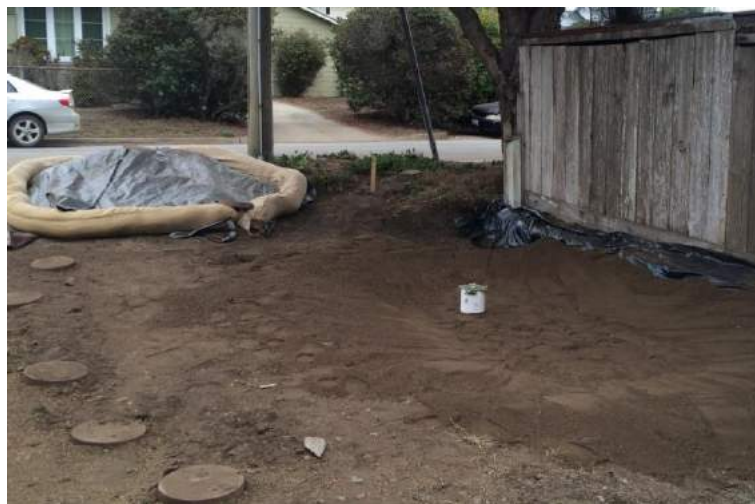
East rain garden installation

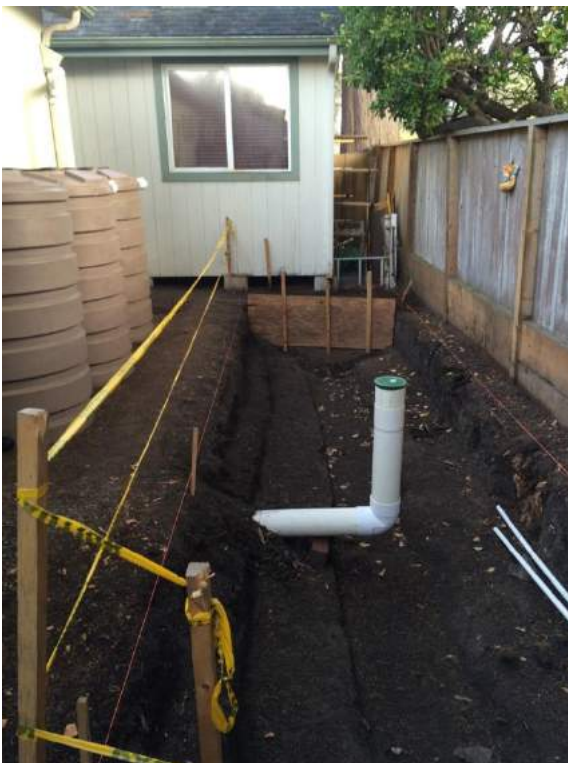
Installation of rain water tanks and rain garden on south side of house

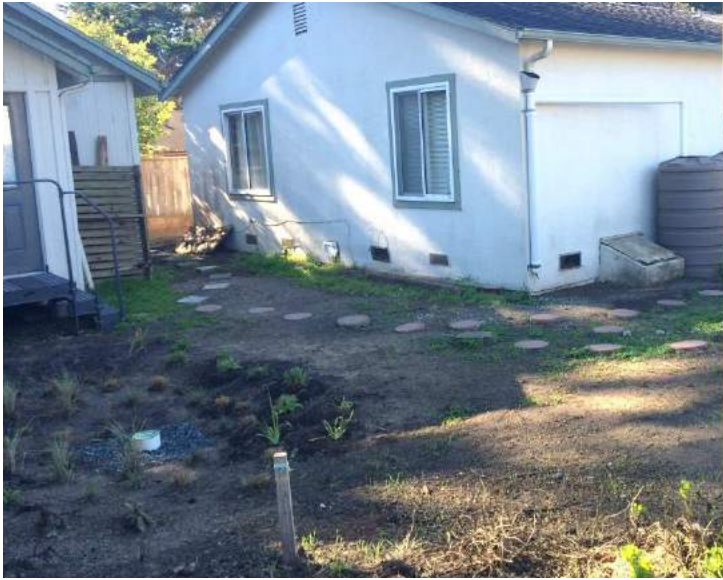
Rain water tanks and rain garden on east side of property

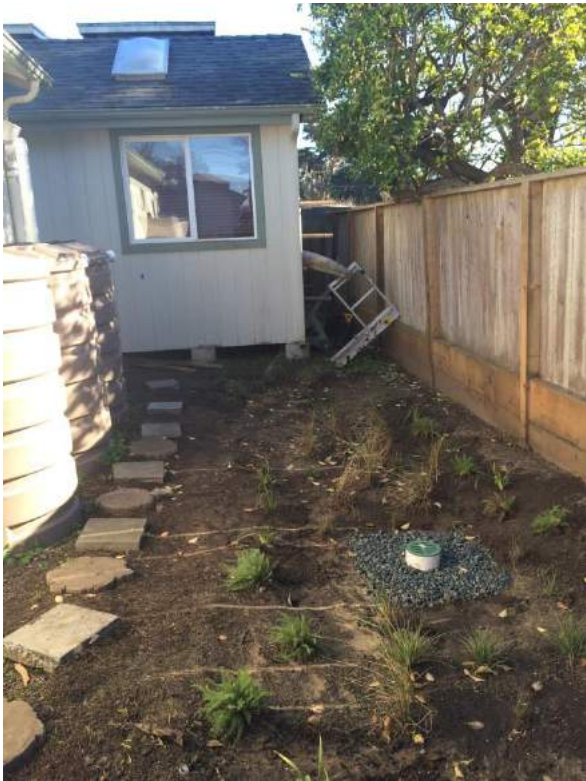
Rain water tanks and rain garden on south side of property
