# SAN PEDRO CREEK AND PACIFICA STATE BEACH FECAL INDICATOR BACTERIA TMDL STATUS AND MONITORING REPORT WATER YEAR 2017

### IN COMPLIANCE WITH PROVISION C.14 OF THE MUNICIPAL REGIONAL STORMWATER PERMIT

March 15, 2018

Prepared by the County of San Mateo and City of Pacifica

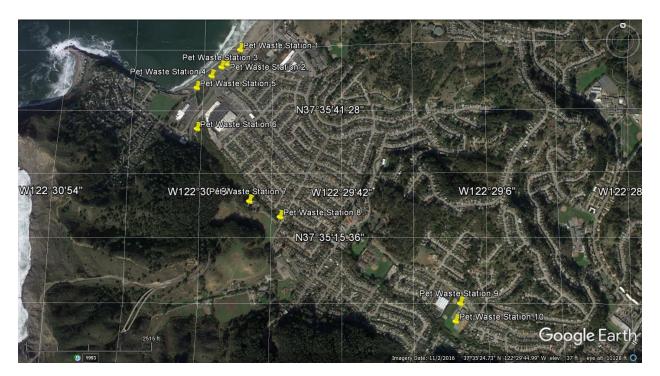
Figure 1. San Pedro Creek and Pacifica State Beach Pet Waste Stations

The City of Pacifica installed 10 new dog waste clean-up signs, waste bag dispensers and trash cans at high priority locations within the TMDL Project Area. The high priority sites were determined via visual inspections of popular dog walking areas and their potential to discharge improperly deposited pet waste to San Pedro Creek and Pacifica State Beach. The locations are listed on Table 1 and shown on Figure 1.

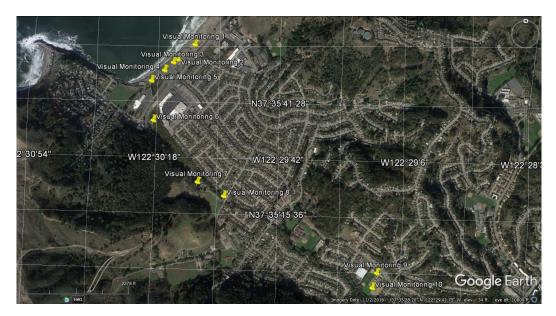
Figure 2. San Pedro Creek and Pacifica State Beach Visual Monitoring

In February 2017, The City of Pacifica developed and implemented a visual inspection and cleanup plan for high dog waste accumulation areas along San Pedro Creek and its tributaries. The locations of visual inspection and cleanup areas are listed on Table 2 and shown on Figure 2. Visual inspection completed in March, April and November 2017 found no pet waste left in the walking pathways. Visual inspection completed in September 2017 found pet waste left in two (2) of the ten (10) the walking pathways. Visual inspection completed in January 2018 found pet waste left in three (3) of the ten (10) the walking pathways.

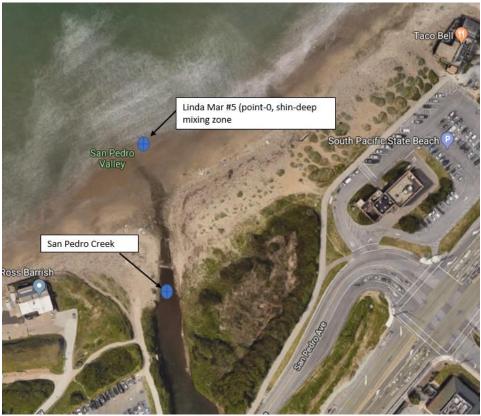
Figure 7: Compliance monitoring sampling sites

This report includes an analysis of compliance monitoring conducted in WY 2016 and WY 2017, as WY 2016 data was not analyzed in last year's status and monitoring report. In WY 2016 and WY 2017, County Environmental Health performed weekly compliance monitoring on behalf of the City and the County at Pacifica State Beach (Linda Mar Station #5) and the mouth of San Pedro Creek (Creek Mouth). See Figure 7 for a map of sampling locations. Ocean water samples from Linda Mar beach were analyzed for total coliform, enterococci, and *E. coli* (in place of fecal coliform). Creek mouth samples were analyzed for *E. coli* and total coliform. Monitoring data from Linda Mar and the Creek Mouth is entered by County Environmental Health into the State Water Board's Beach Watch database on a weekly basis.

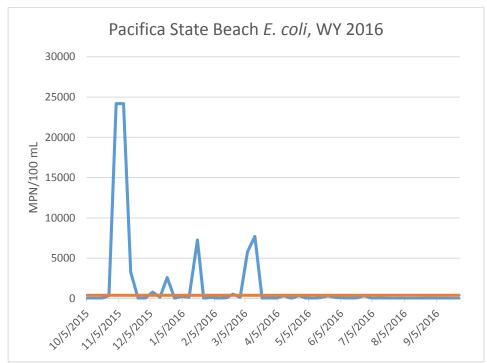
Figure 8: Pacifica State Beach E. coli, WY 2016 Note: the orange line shows the water quality threshold of 400 MPN/100 mL

All of the five highest *E. coli* concentrations occurred during winter wet weather. The lowest *E. coli* concentrations all occurred during summer dry weather.

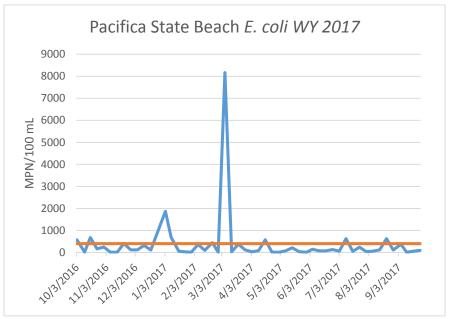
Figure 9: Pacifica State Beach E. coli, WY 2017 Note: the orange line shows the water quality threshold of 400 MPN/100 mL

Four of the five highest *E. coli* concentrations occurred during wet weather. The lowest *E. coli* concentrations all occurred during dry weather.

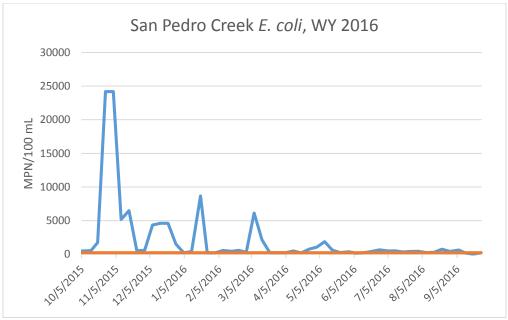
Figure 10: San Pedro Creek E. coli, WY 2016 Note: the orange line shows the water quality threshold of 235 MPN/100 mL

*E. coli* concentrations exceeded water quality objectives throughout the year. The dry weather, summer data shows that the average background *E. coli* concentration is about 300 to 500 MPN/100mL.

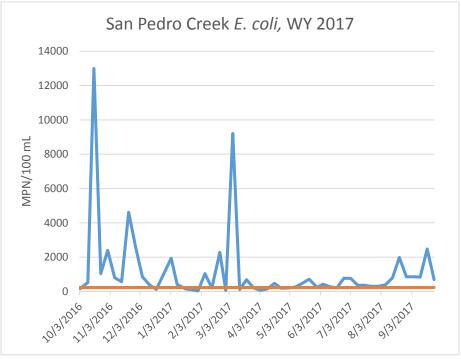
Figure 11: San Pedro Creek E. coli, WY 2017 Note: the orange line shows the water quality threshold of 400 MPN/100 mL

*E. coli* concentrations exceeded water quality objectives throughout the dry weather, summer period. The dry weather, summer data shows that the average background *E. coli* concentration is about 300 to 500 MPN/100mL. There were a couple major increases in *E. coli* concentrations in the summer, during dry weather: 1989 MPN/100 mL on 8/21/17 and 2481 MPN/100 mL on 9/18/17.

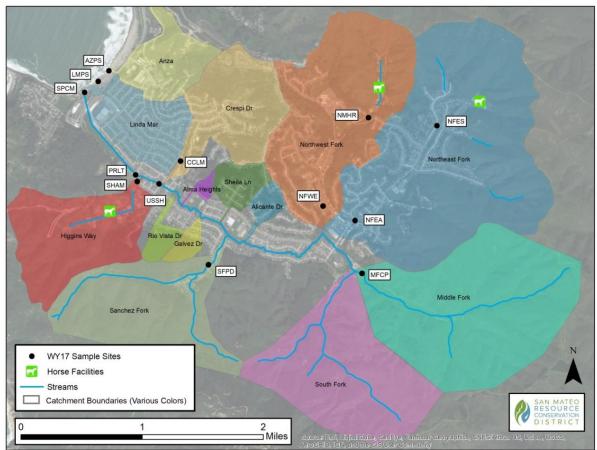
The San Pedro Creek watershed is comprised of numerous catchments including five main tributaries with perennial flows fed by springs. These are the Northwest Fork, the Northeast Fork, the Middle Fork, the South Fork, and the Sanchez Fork (Fig 1). There is also a small unnamed intermittent tributary in the southwest portion of the watershed that runs through Shamrock Ranch, and is then culverted underground to join the main stem of the creek. The Middle Fork, the South Fork, and the Sanchez Fork are largely open channel streams with vegetated banks and drain open space, such as San Pedro Valley County Park. The Northeast and Northwest Forks consist of several streams in the headwaters that drain open space and horse facilities and are then conveyed into the stormwater system in the urban areas of Pacifica. The Northeast Fork and Northwest Fork and Northwest Fork eventually join together and discharge to the main stem of the creek upstream of the bridge on Linda Mar Blvd. In the northwest portion of the watershed,

there is also flow from about 300 acres of urban land that is conveyed to two pump stations (Linda Mar and Anza) and is then pumped to the Calera Creek Water Recycling Plant or to Pacifica State Beach.

Figure 1. San Pedro Creek watershed catchments, tributaries, sample sites, and horse facilities.

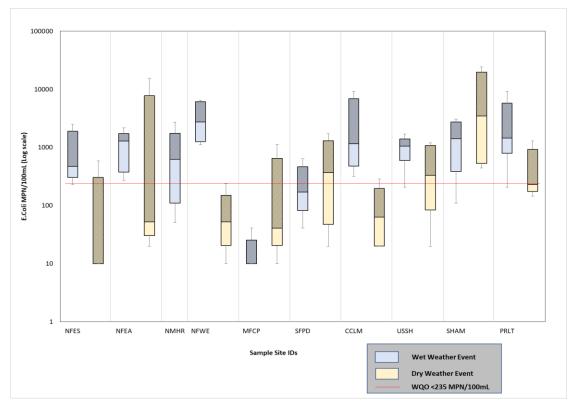
Over half of the samples (57%) exceeded the *E. Coli* WQO of 235 MPN/100 mL. Most exceedances of the WQO occurred during the wet season (73%), while 39% of samples exceeded the WQO during the dry season (Fig 2). Few upstream/downstream trends were observed as the sample sites were along the main stem, various forks, and in different types of systems such as concrete channels, storm drains, and open stream channels. However, it is clear that *E. Coli* increased in the wet season between sites in the Northwest Fork (NMHR and NFWE), and between sites on the main stem (USSH and PRLT). On the other hand, *E. Coli* typically did not differ substantially between the Northeast Fork sample sites (NFES and NFEA).

Figure 2. E. Coli by event type at WY17 sample sites.

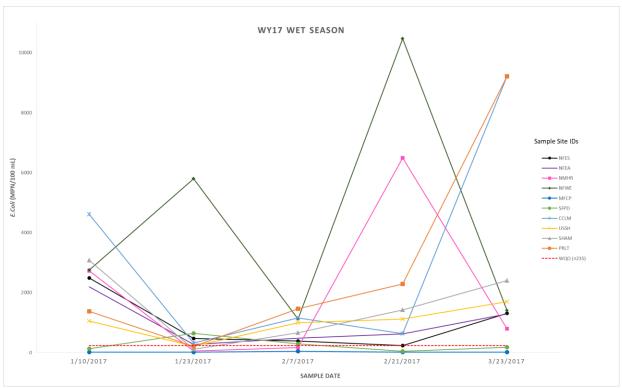
In WY17, Crespi Canal (CCLM) and the downstream sites in the North Forks (NFWE and NFEA) exceeded the WQO during every wet season sampling event, and NFWE had some of the highest values (Fig 3). SHAM and the Sanchez Fork (SFPD) both exceeded the WQO more during the dry season than wet season, and SHAM exceeded the WQO during all dry season sampling events and had some of the highest values (Fig 4). There was also a sample event in the dry season (8/23/17) where all sample sites exceeded the WQO, including the Middle Fork (MFCP), and this was the only time this site exceeded the WQO.

Figure 3. E. Coli by sample date in the wet season of WY17.

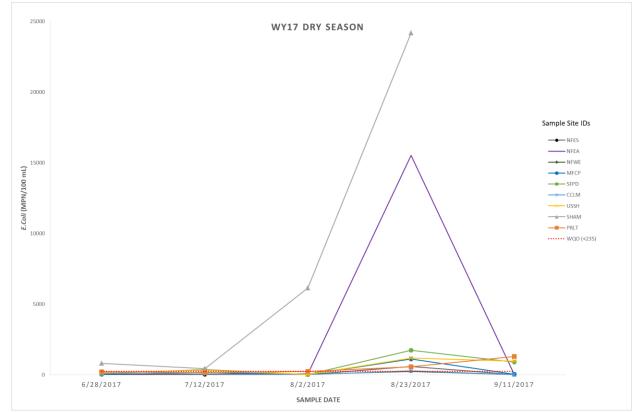
Figure 4. E. Coli by sample date in the dry season of WY17.

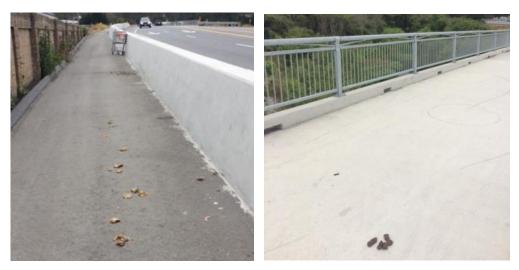
Figure 5. Horse manure (left) and dog waste (right) on the walking path near Highway 1 and the mouth of the creek.

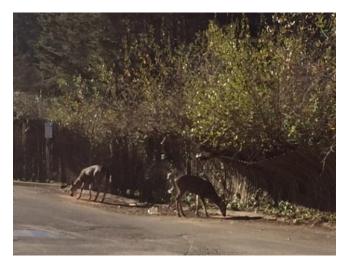
**Figure 6.** Deer in the parking lot of the Sun Valley Shopping Center sifting through food/trash. This is close to where both North Forks combine and then join the main stem of the creek.

San Pedro Creek also supports a variety of wildlife in both open space and urban areas (Fig 6). Historic microbial source tracking data indicate that domestic animals and wildlife, primarily birds, were the most prominent sources of bacteria in the watershed (~75% uncontrollable sources). In WY17, the Universal marker was detected in 100% of samples while the other markers were detected at a rate of 81% or lower. This suggests sources of fecal indicator bacteria other than humans, horses and dogs such as raccoons, rodents, deer, and birds.

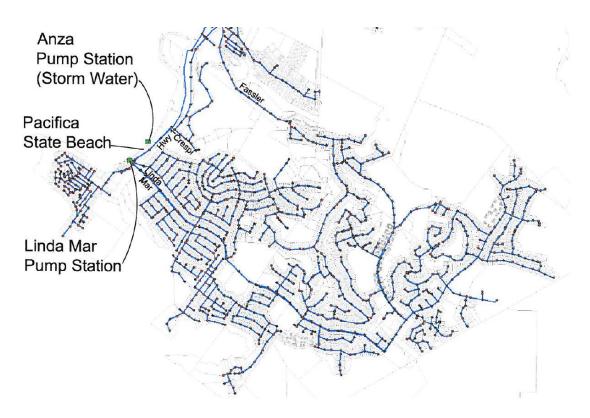
The City of Pacifica's sewer system in the San Pedro Creek watershed.
