DRAFT Minutes of the Special Meeting of the Board of Directors Wednesday, April 9, 2025 Location: 80 Stone Pine Road, Suite 100, Half Moon Bay, CA 94019 and via Zoom

Re: Consideration of Grading Exemption for Pescadero Creekside Garden Project

PLAN for GRX Submittal with RCD for Pescadero Creekside Garden Project Pescadero, CA 94060

CASE NUMBER VI02024-00152 APN 086-042-100 CORNER OF STAGE ROAD AND NORTH STREET PROJECT ASSESSMENT & REPORT

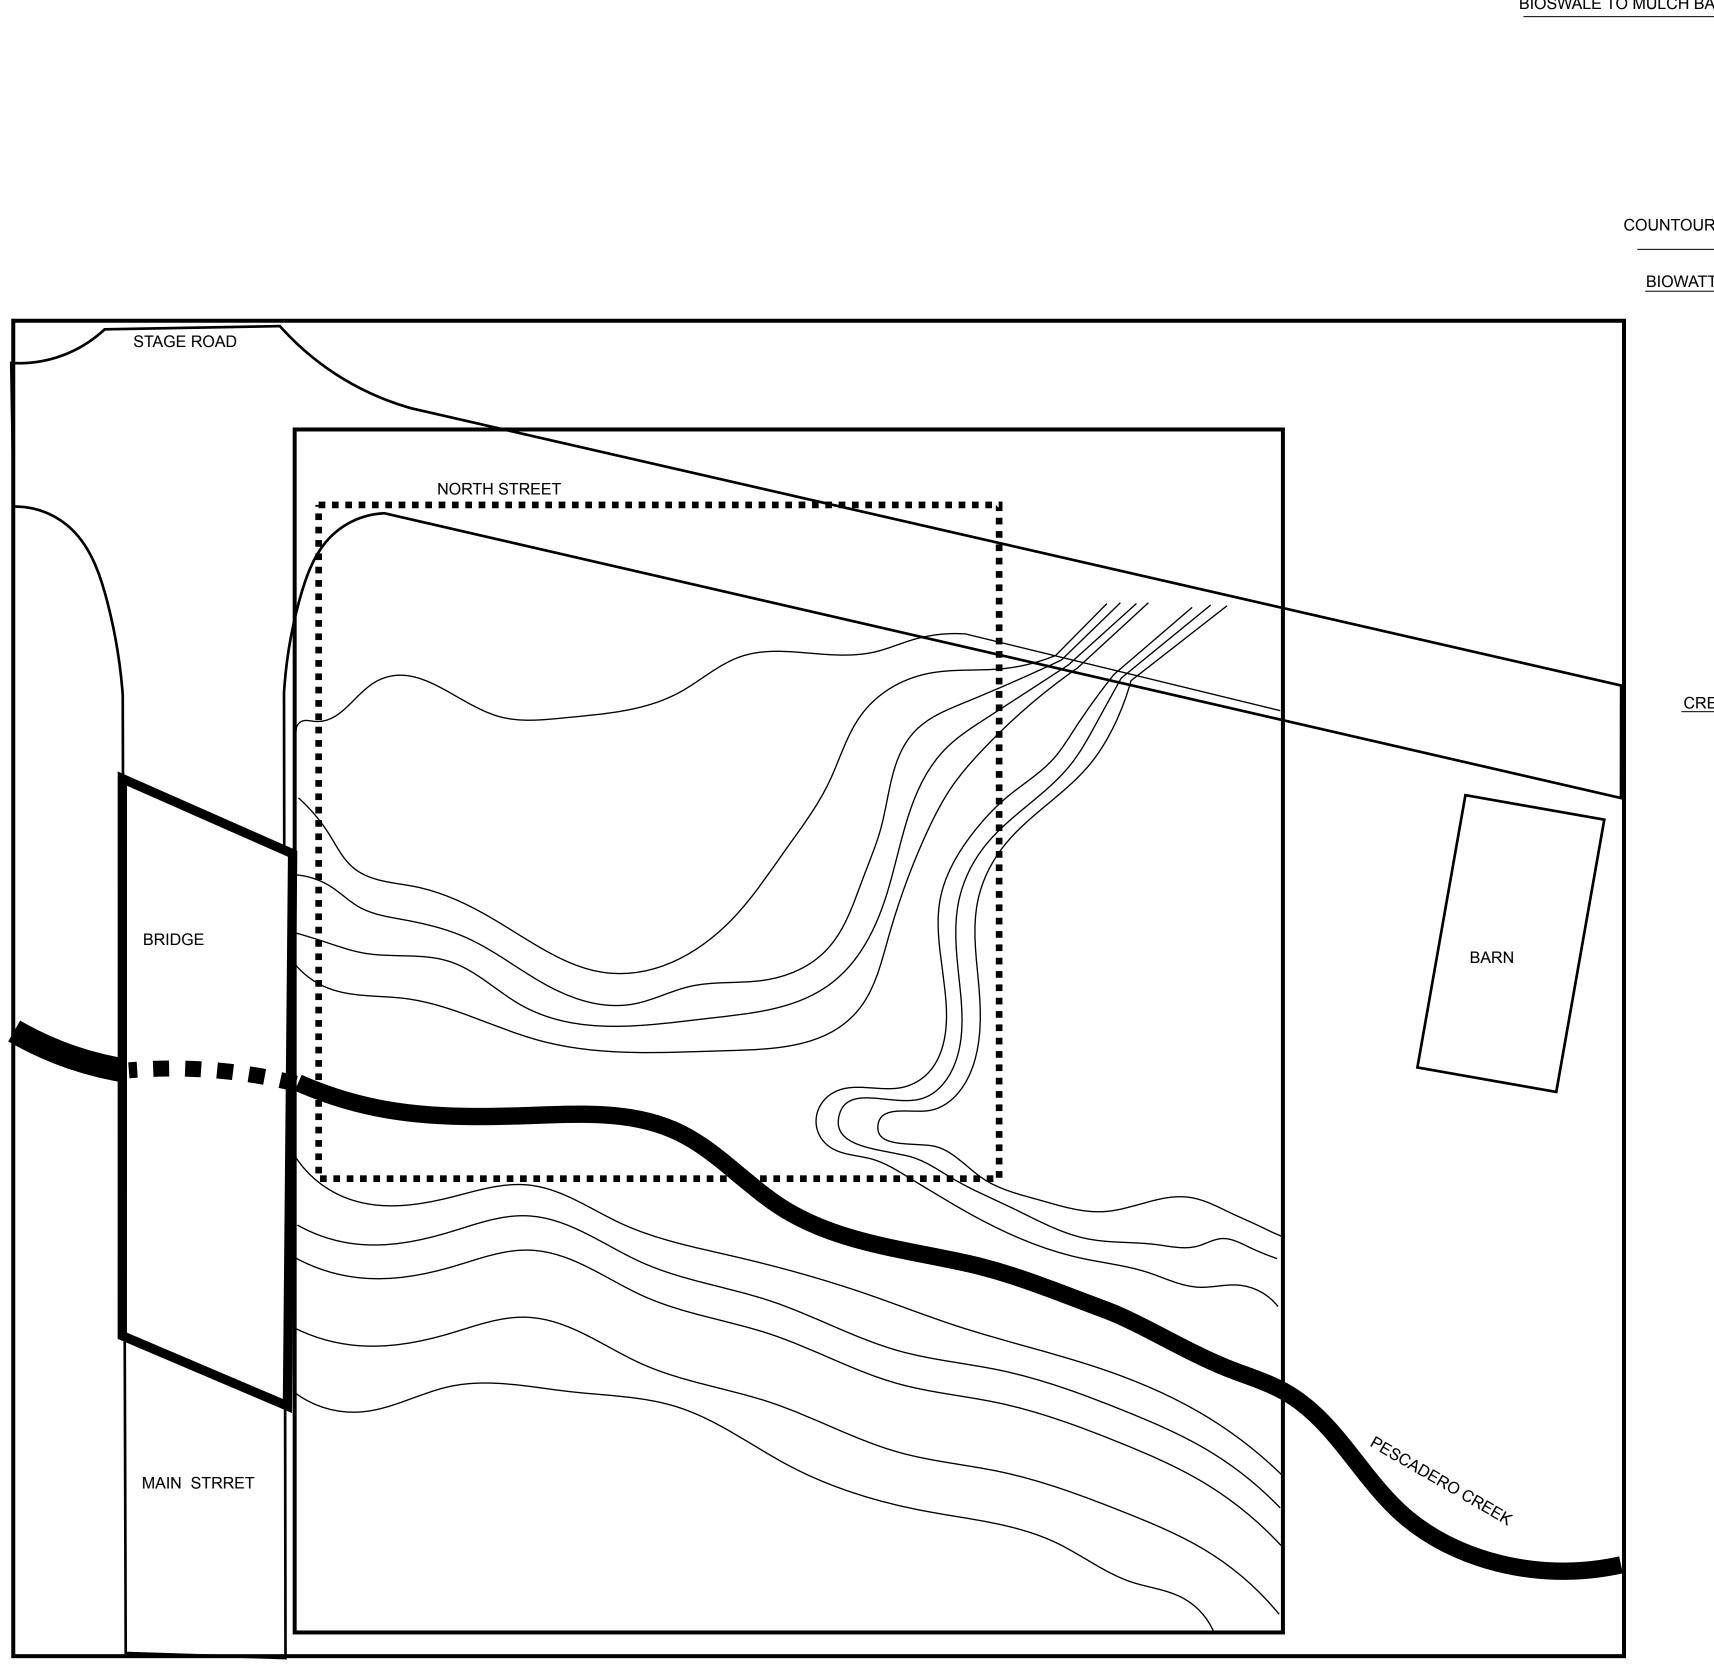
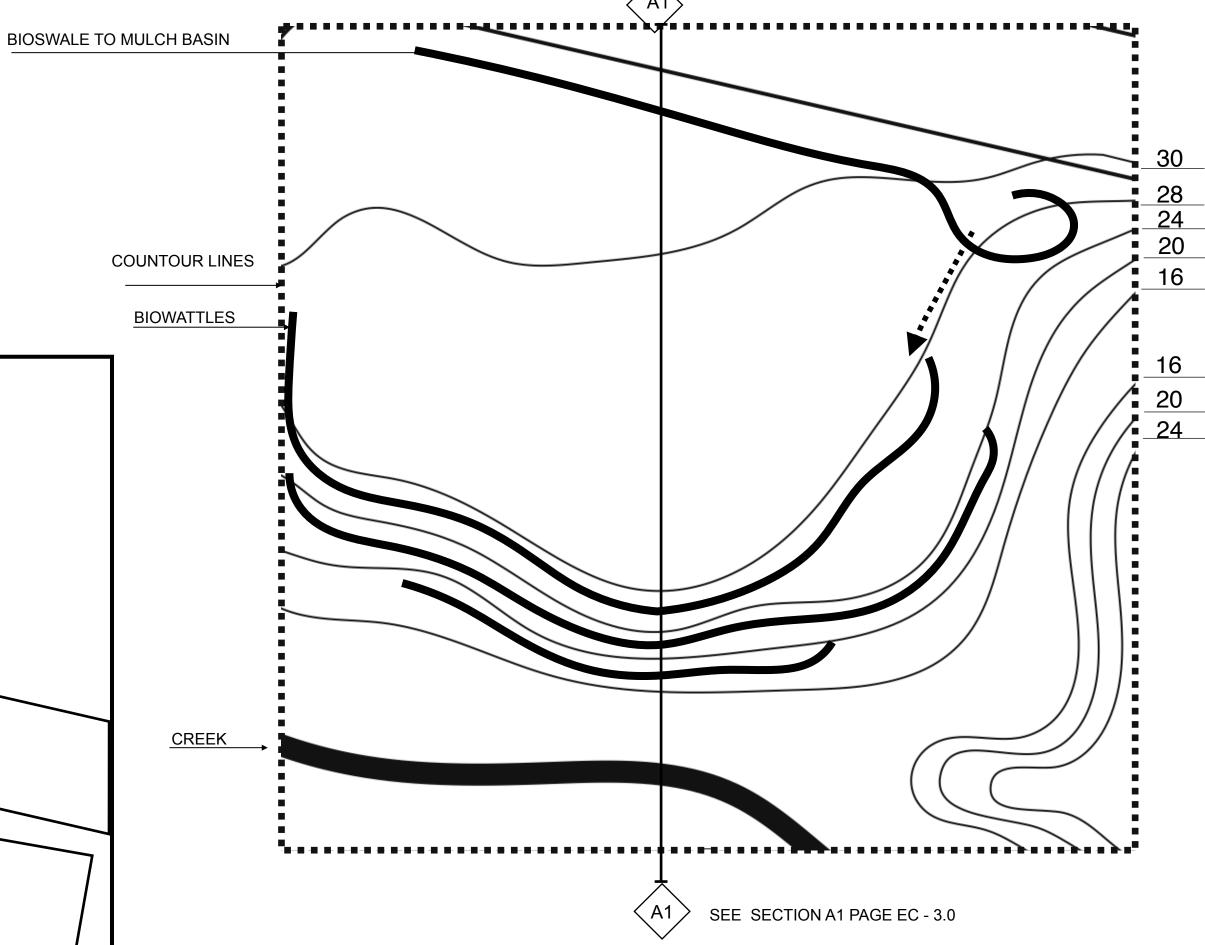
EC - 2.0

1. BIOSWALE TO MULCH BASIN IS TO INCEPT ALL RUNOFF FROM THE ROARD - NORTH STREET THAT WOULD FLOW ONTO PROPERTY AND DISCHARGE ALL MOMENTUEM INTO A MULCH BASIN THAT ALLOWS FOR STORMWATER AND SEDIMENT AS WELL AS CONTAMINENTS TO BE FILTERED - THE OVERFLOW OF THE MULCH BASIN IS LINED WITH ROCK AND EXITS THE BACK END FURTHER MITIGATING ANY POSSIBILTUY FOR EROSION .

2.THIS SPILL WAY PLACEMENT IS DELINATED BY DASHED ARROW AND IS TO BE CONSTRUCTED AT 36' WIDE BY 8' DEEP

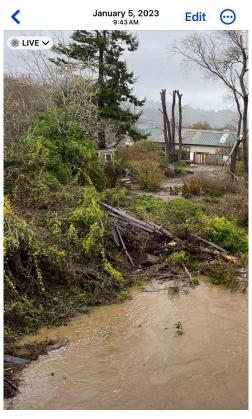
After Flood receded at bank and erosion over ½ of the site was eroded by the flooding - bottom left January 2023

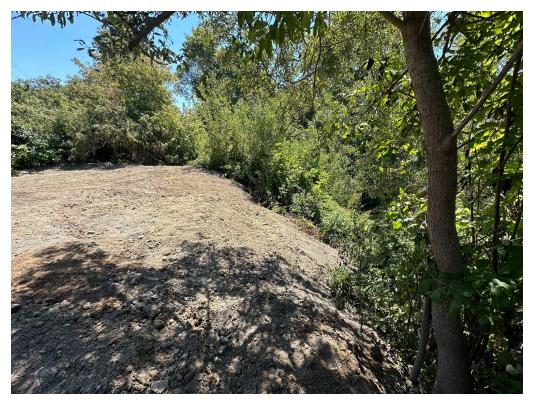
Bank to be stabilized and erosion control put in place.

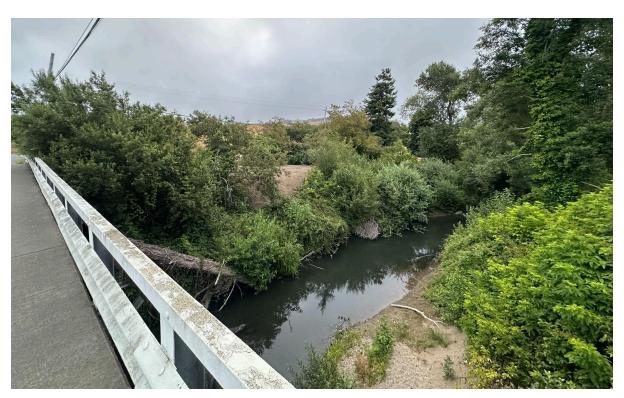
View of the site from the bridge - with two down trees on bottom left that were not removed from country during flood event remediation

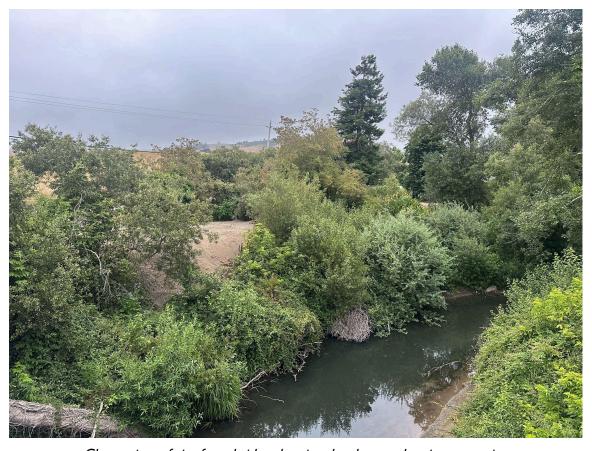
Closer view of site from bridge showing the slope and native vegetation

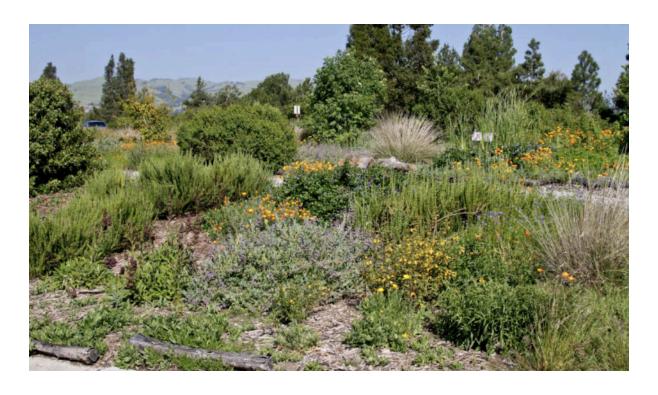
Examples of native plantings on slope and along spillways

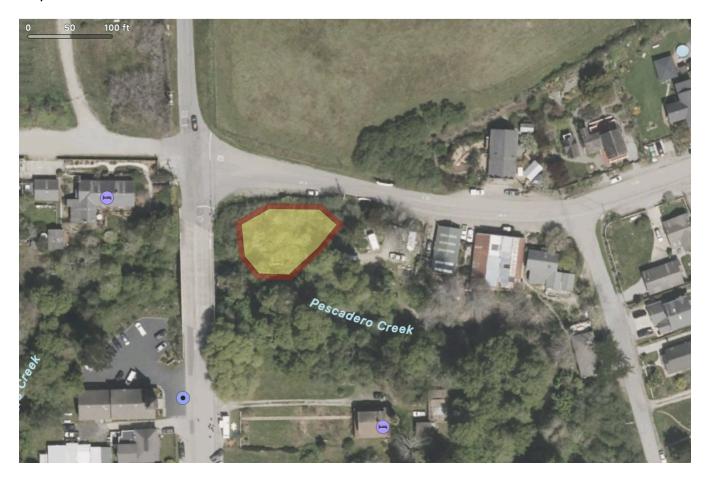
Proposed area of work

Steps to be implemented are in two phases in which Erosion control and drainage are done with

Phase one: Immediate bank stabilization adjacent to creek to establish grass and cover soil prior to 10/15/24 - completed
