Date: March 20, 2025
To: Board of Directors
From: Kellyx Nelson
Re: Consideration of Grading Exemption for Pescadero Creekside Garden Project

PESCADERO CREEKSIDE GARDEN

**PLAN for GRX Submittal with RCD for
Pescadero Creekside Garden Project
Pescadero, CA 94060**

CASE NUMBER VI02024-00152
APN 086-042-100
CORNER OF STAGE ROAD AND NORTH STREET
PROJECT ASSESSMENT & REPORT

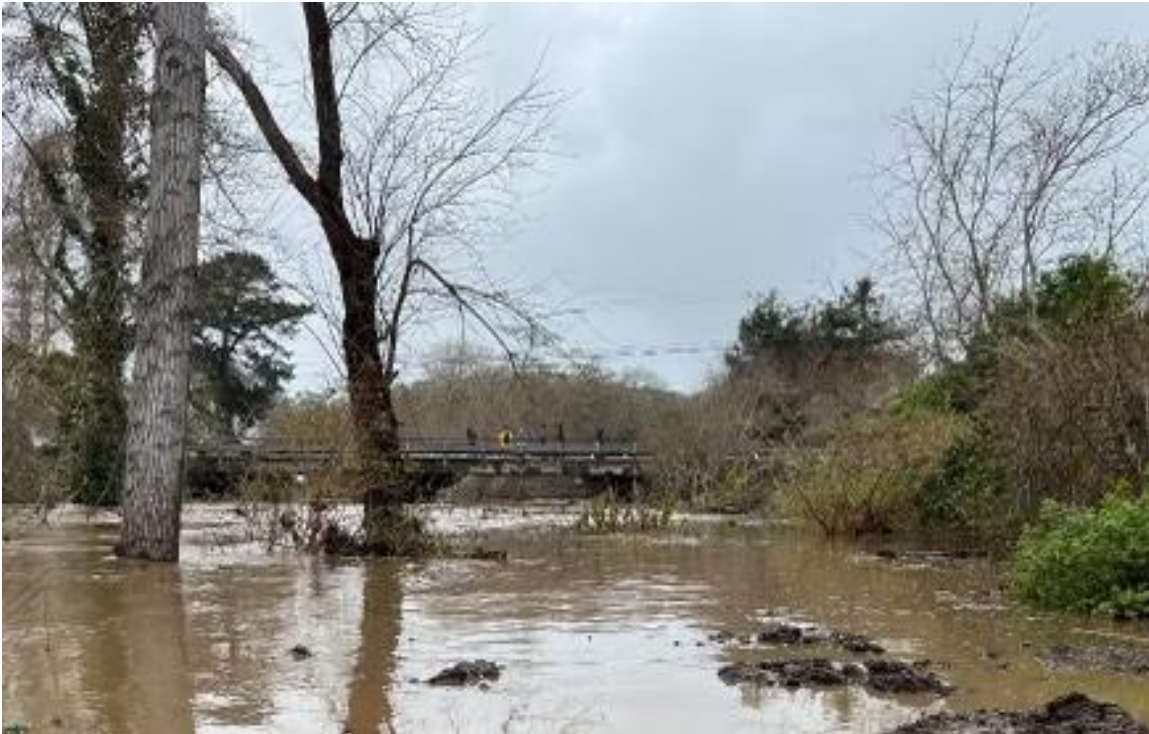
*Flood event from site looking west towards bridge on Main Street
January 2023*

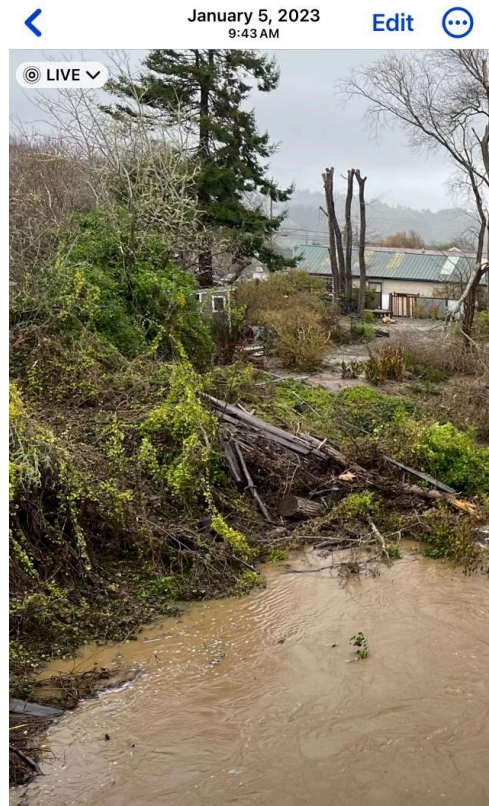
*After Flood receded at bank and erosion
over ½ of the site was eroded by the flooding - bottom left
January 2023*

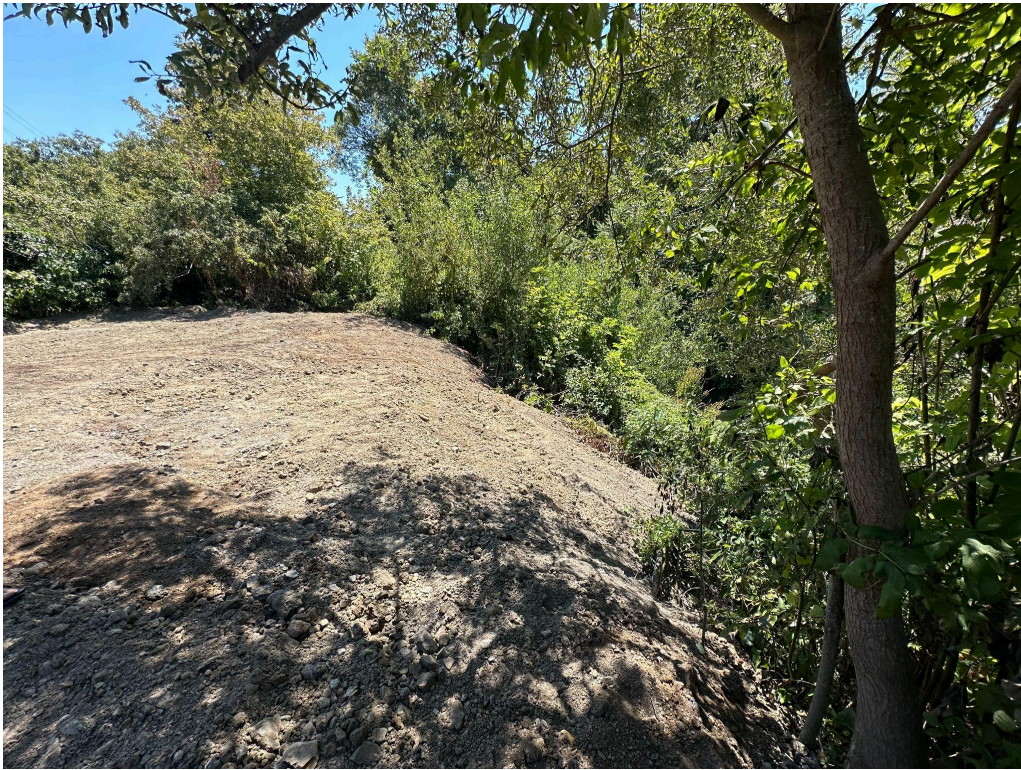
Bank to be stabilized and erosion control put in place.

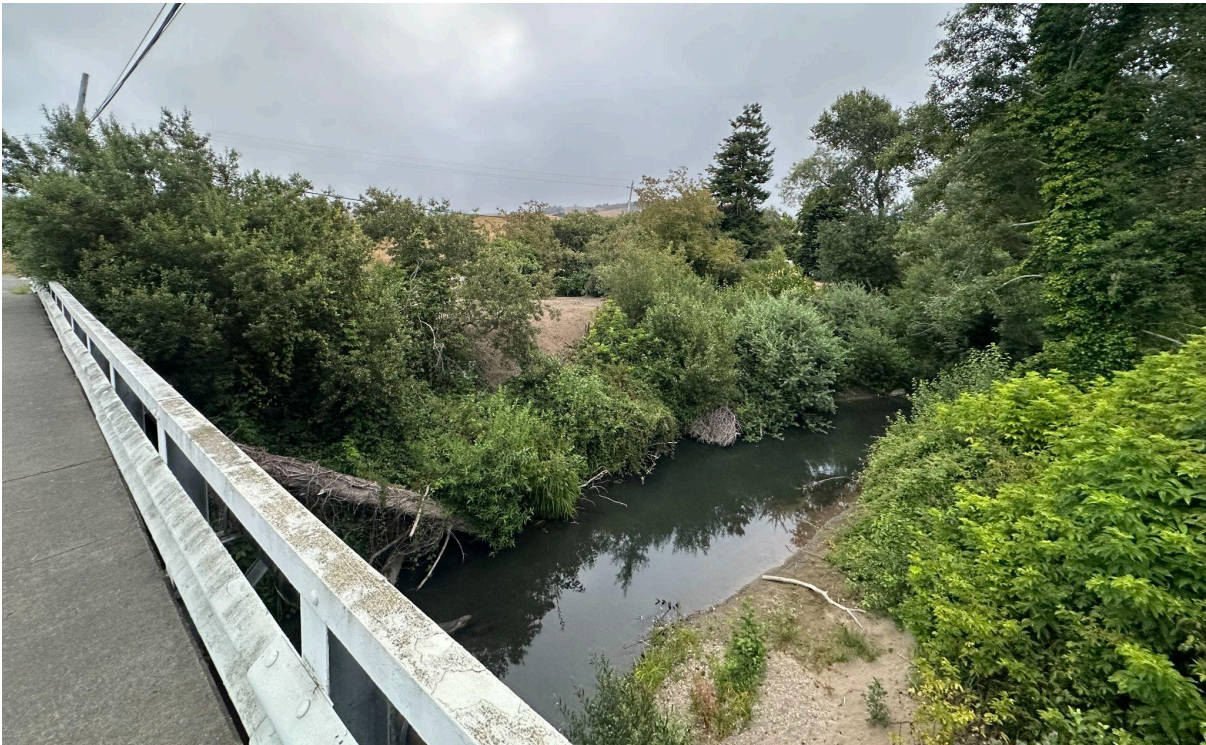
View of the site from the bridge - with two down trees on bottom left that were not removed from country during flood event remediation

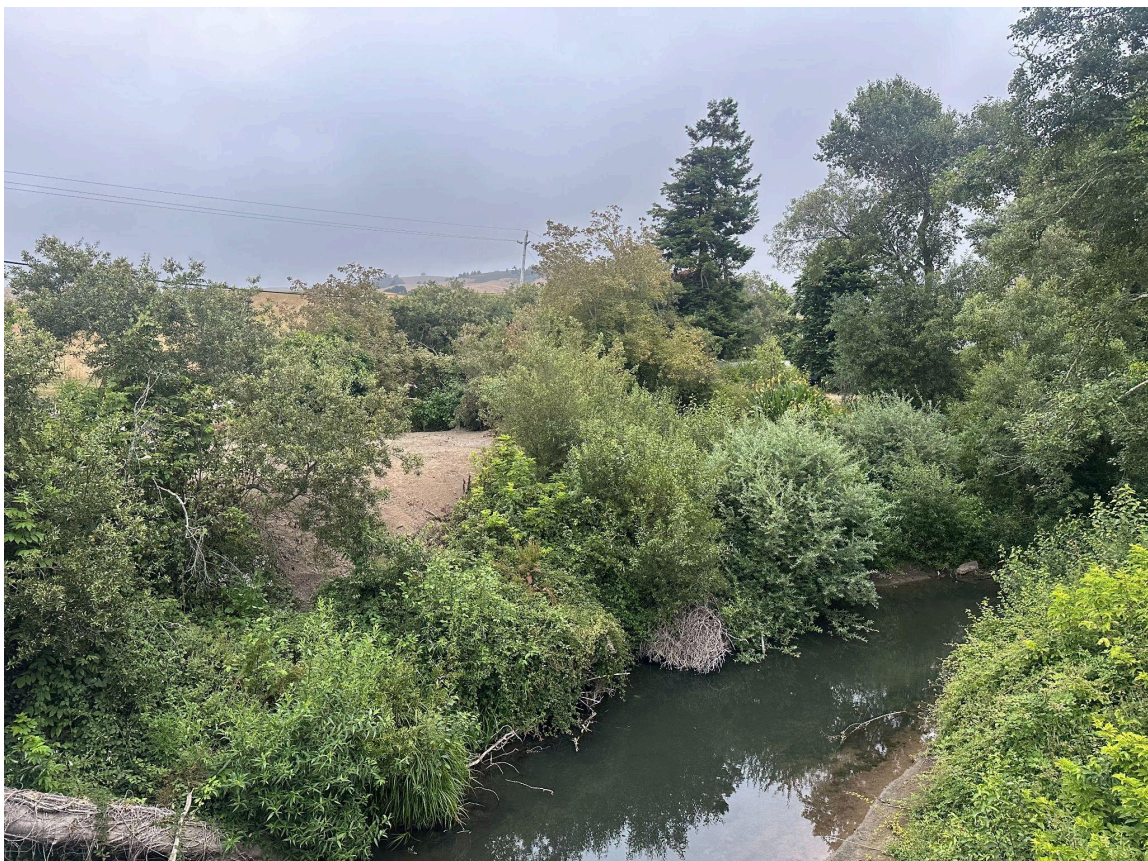
Closer view of site from bridge showing the slope and native vegetation

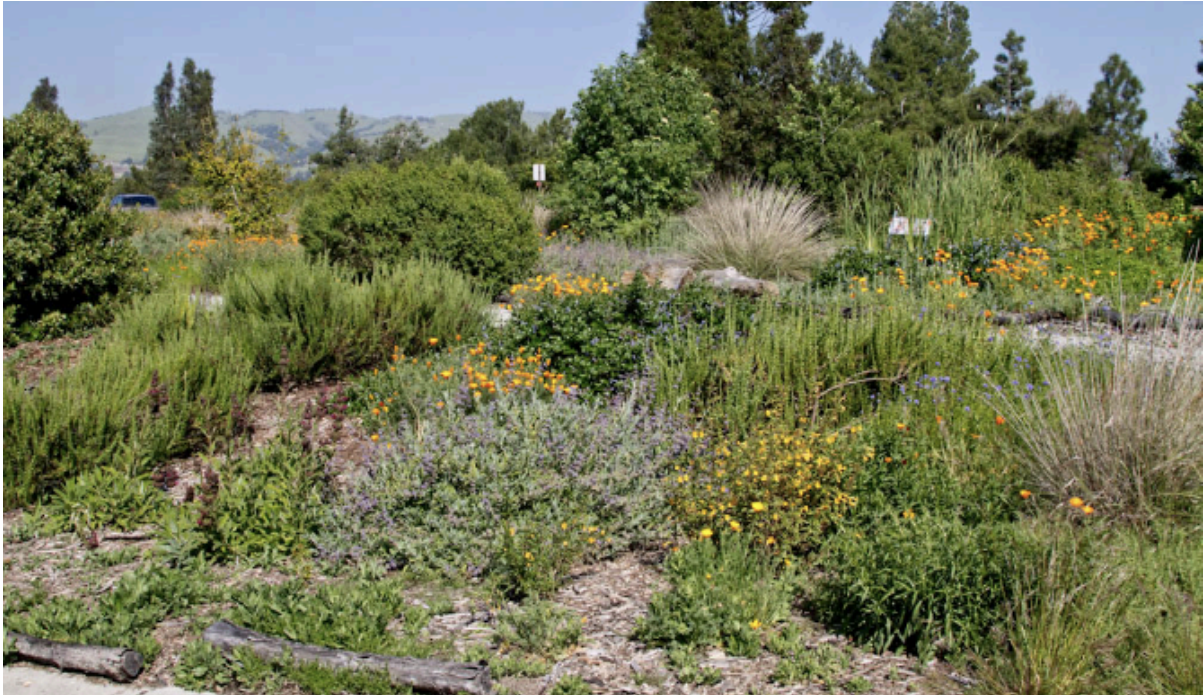
Examples of native plantings on slope and along spillways

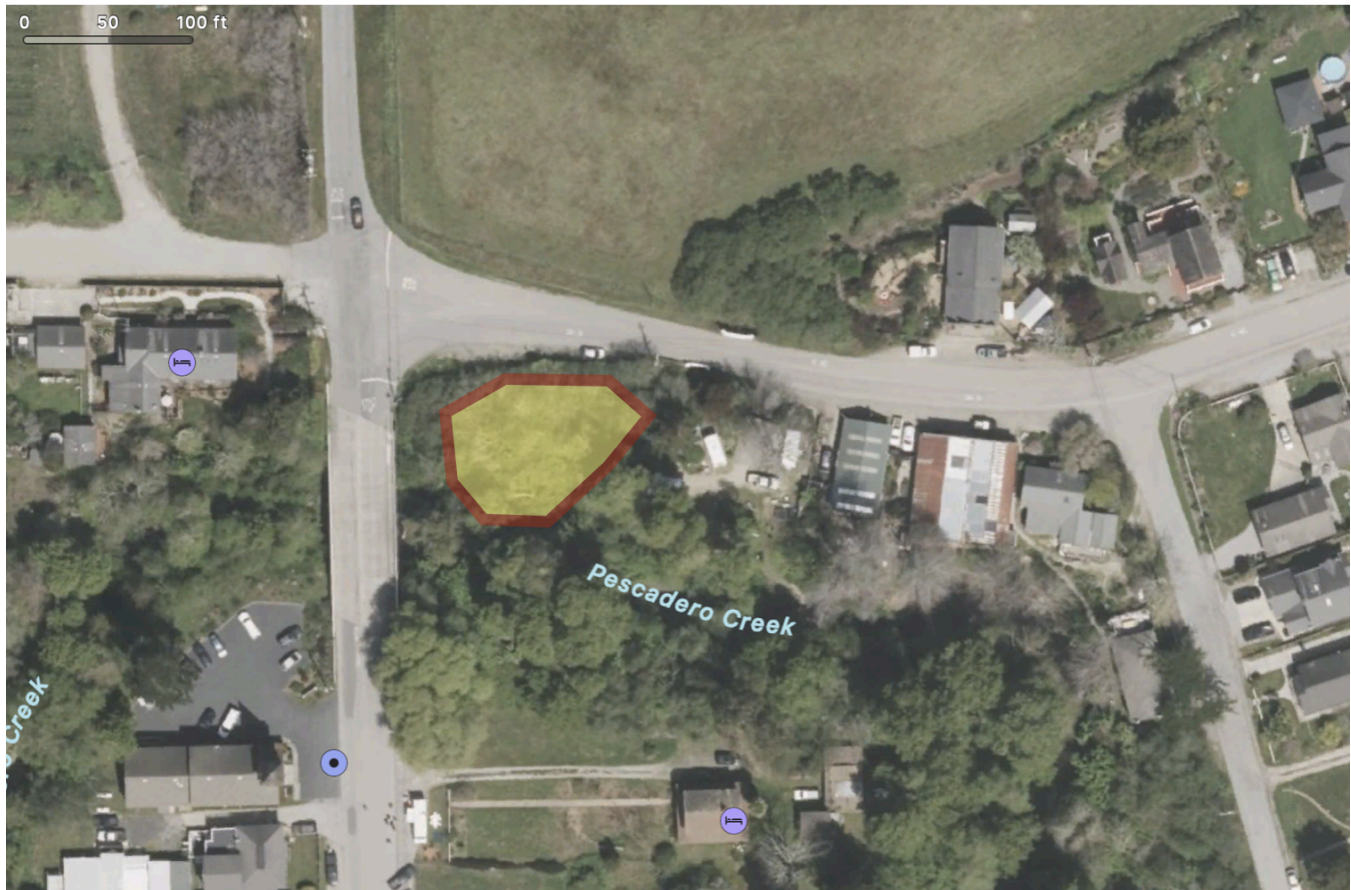
Proposed area of work

Steps to be implemented are in two phases in which Erosion control and drainage are done with

Phase one: Immediate bank stabilization adjacent to creek to establish grass and cover soil prior to 10/15/24 - completed
