February 18, 2016 CIWQS Place ID No. 810706 Regulatory Measure ID 398842 Corps File No. 2014-00418S

Subject: Conditional 401 Water Quality Certification for the Coastside County

Water District Property Rural Roads Improvement Project, City of Half

Moon Bay, San Mateo County

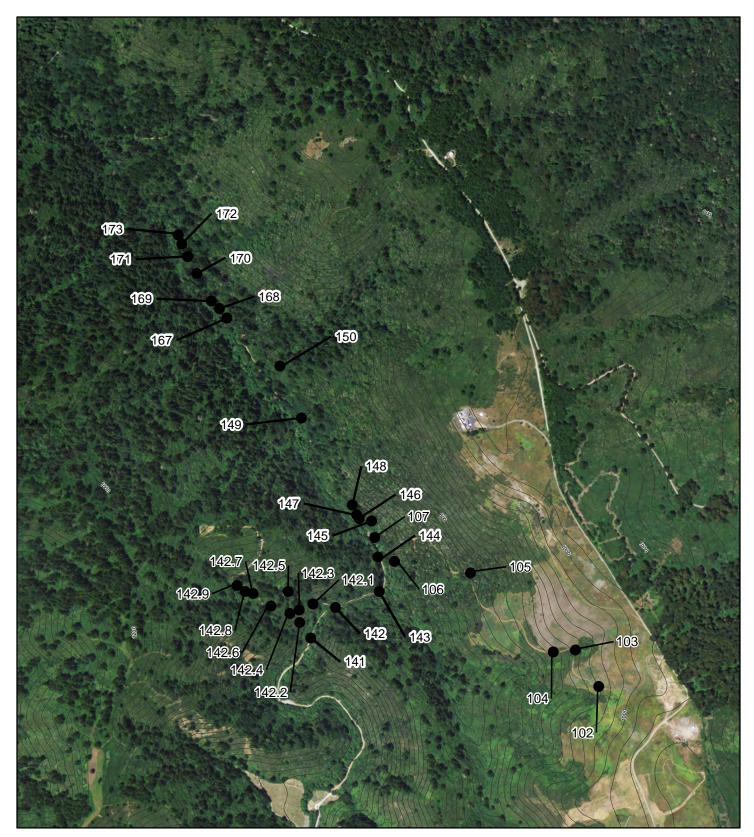
Figure 2. Proposed Treatment Site Locations

Project Site Numbers

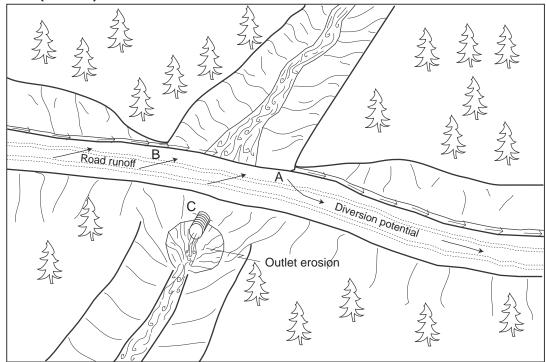
Problem condition (before)

- A Diversion potential
- B Road surface and ditch drain to stream
- C Undersized culvert high in fill with outlet erosion

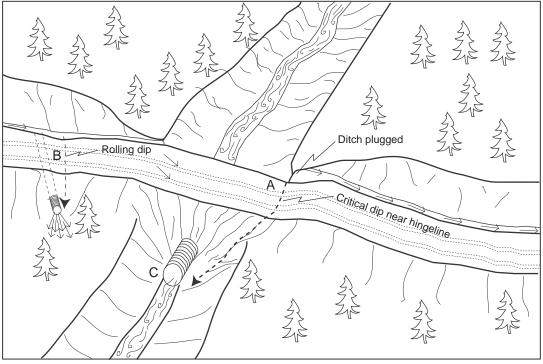
Treatment standards (after)

- A No diversion potential with critical dip installed near hingeline
- B Road surface and ditch disconnected from stream by rolling dip and ditch relief culvert
- C 100-year culvert set at base of fill

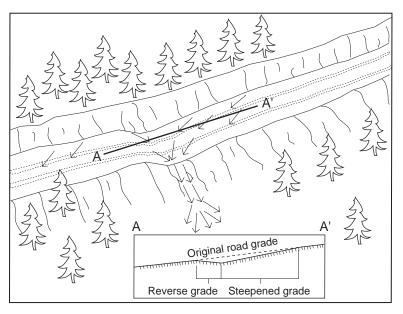
Typical Road Surface Drainage by Rolling Dips

Rolling dip installation:

- 1. Rolling dips will be installed in the roadbed as needed to drain the road surface.
- 2. Rolling dips will be sloped either into the ditch or to the outside of the road edge as required to properly drain the road.

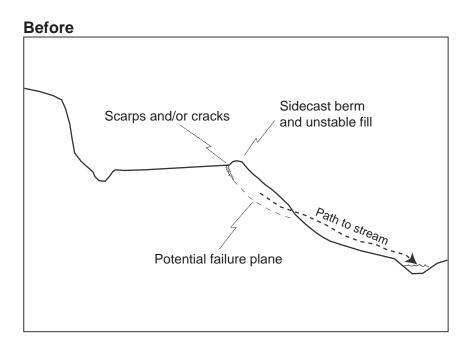
Typical Excavation of Unstable Fillslope on an Upgraded Road

Unstable fill is excavated and taken to a stable spoil disposal site or used to fill the ditch and outslope road

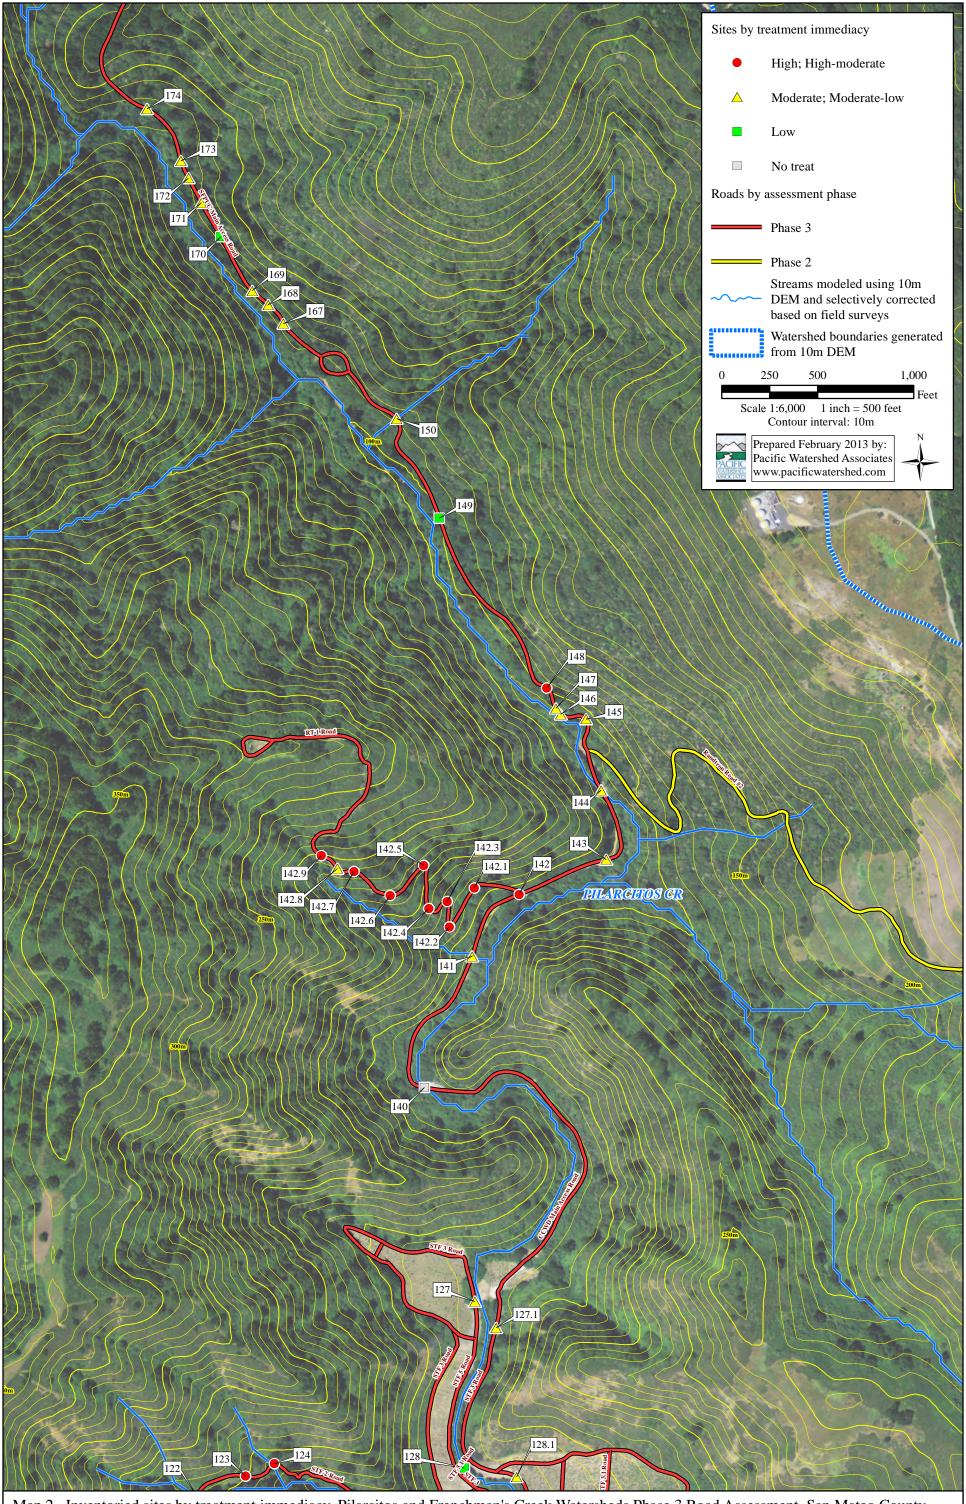
Map 2. Inventoried sites by treatment immediacy, Pilarcitos and Frenchman's Creek Watersheds Phase 3 Road Assessment, San Mateo County, California.
