**Drilling and Testing of  
Montara Water and Sanitary District's  
Well 2004-4, APN 036-180-030,  
San Mateo County, California**

**Well Completion Report**

Balance Hydrologics, Inc.

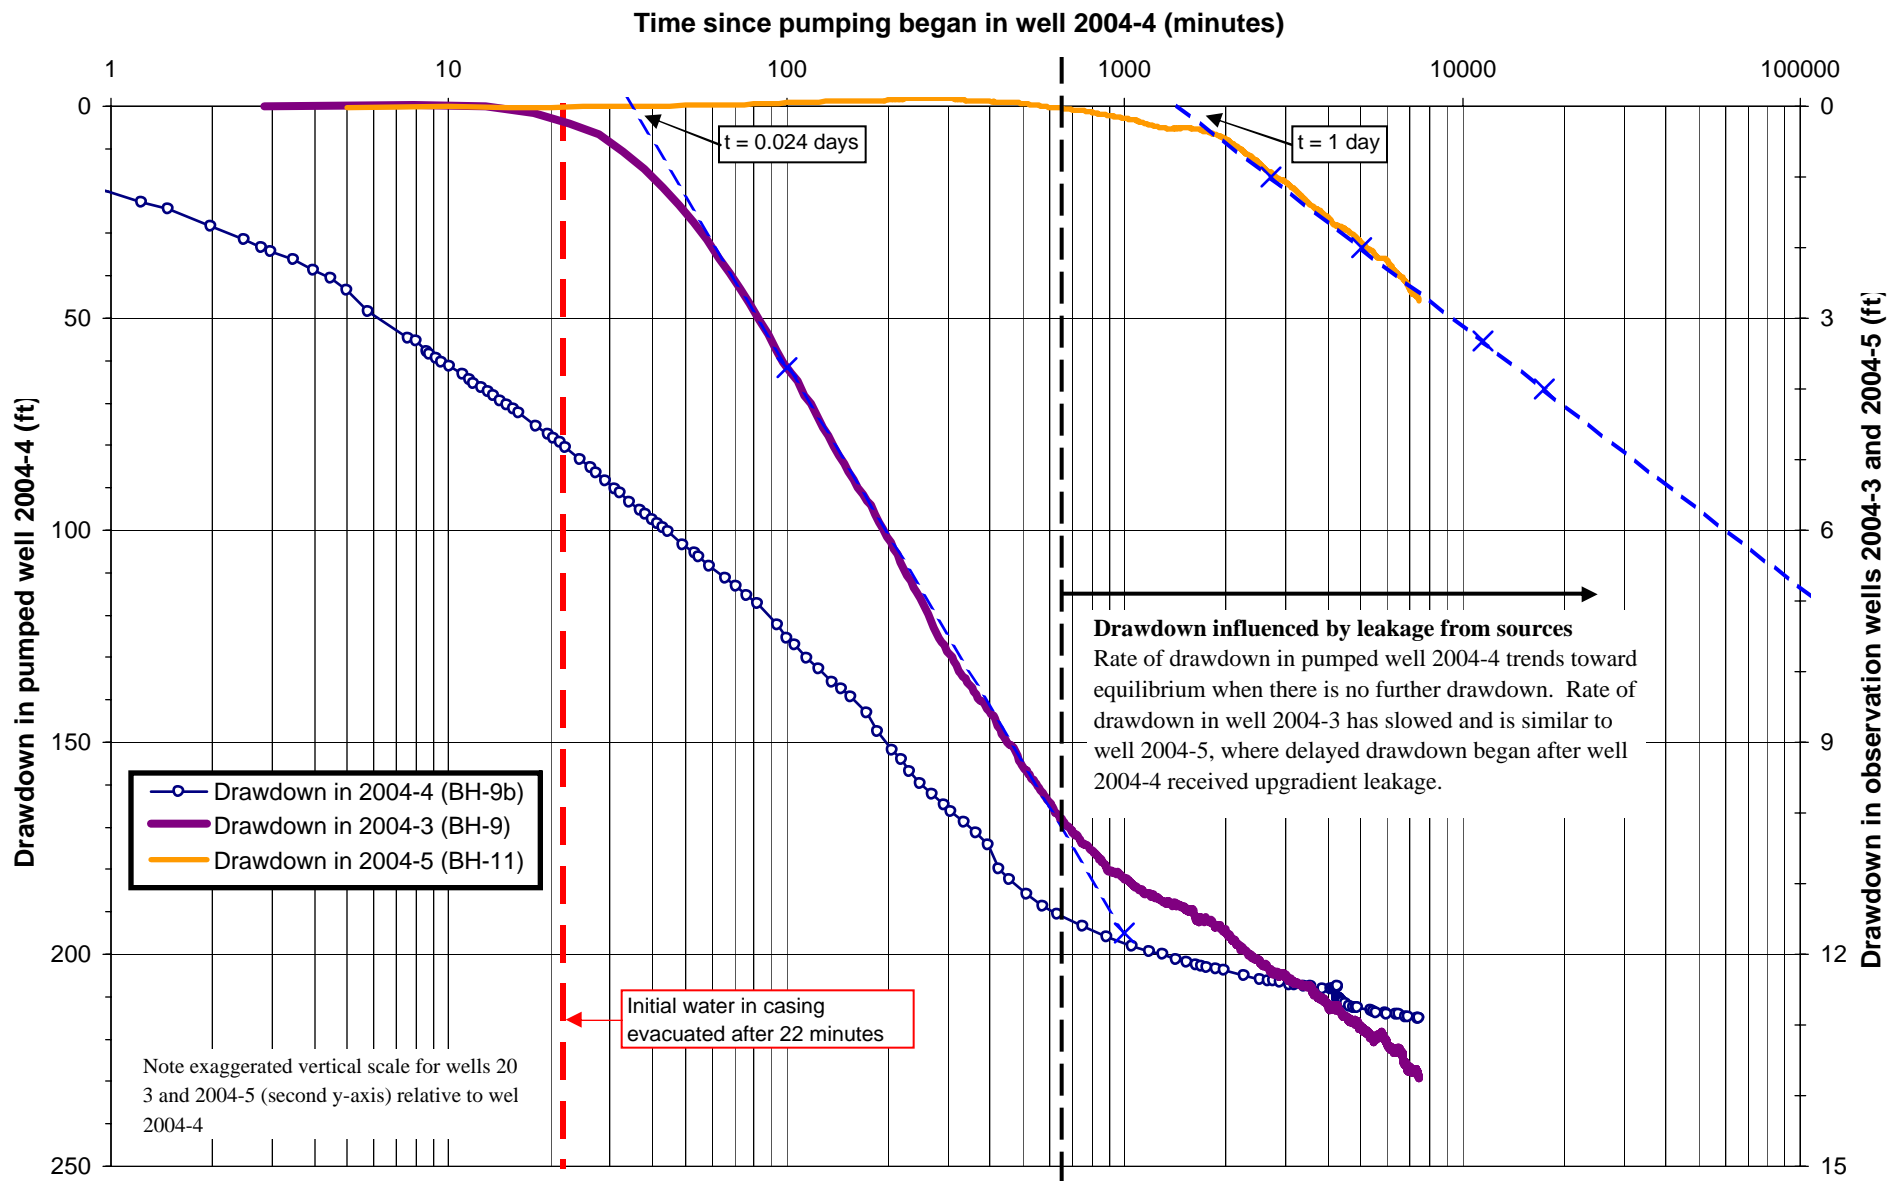
**Figure 8. Water-level drawdown in pumped well 2004-4 (BH-9b) and observation wells 2004-3 (BH-9) and 2004-5 (BH-11) during constant-rate pumping test, November 2 to 12, 2004, APN 036-180-030, San Mateo County, California.**

The conventional technical approach to analyzing drawdown data in pumped wells and observation (non-pumped) wells is to plot drawdown on a semi-log chart as a function of the duration of pumping (Figure 8). In a homogeneous and anisotropic ground-water flow media (or under approximate conditions) this analysis can quantify permeability and storage, and predict ground-water capture areas. The limited effects of the pumping on wells 2004-3 and 2004-5, as well as the observation of no effect on water levels at 770 Alta Vista indicate that the aquifer near well 2004-4 is neither homogeneous nor isotropic, and the weathered granitic rocks are by their very nature highly anisotropic. Hence, the aquifer flow characteristics of the fractured bedrock are too diverse and vary over short distances, and conventional well-test analysis is of limited use. Put in other terms, conventional analysis of time-drawdown or distance-drawdown plots is not a supportable approach, given how sharply local conditions depart from the assumptions on which they rest. We have attempted to avoid analyses requiring a foundation of isotropy, homogeneity, and

Qualitatively, though, changes to the rate of drawdown do tell us about recharge sources and limits to the aquifer, if interpreted together with field evidence. The form of the curves in Figure 8 – the rate of drawdown slowing after about a half a day of pumping well 2004-4 – suggests that the wells were influenced by upgradient recharge to the pumped well during the 5-day yield test. This is commonly called vertical leakage, but in this case may also predominantly include recharge to the well from other high-yielding joints upgradient. Further away, drawdown in well 2004-5 began after well 2004-4 received upgradient leakage, and the rate of drawdown was similar to well 2004-3. Towards the end of the test, well 2004-4 was trending toward ‘equilibrium’ when there would be no further drawdown. No signs of major barrier boundaries to the recharge source were recorded during the well test, implying that the aquifer is horizontally continuous at least to the limits pumped during the five-day test. Among other implications, it appears that the major fractures and/or the zones from which they draw without significant energy losses are laterally continuous within these limits.

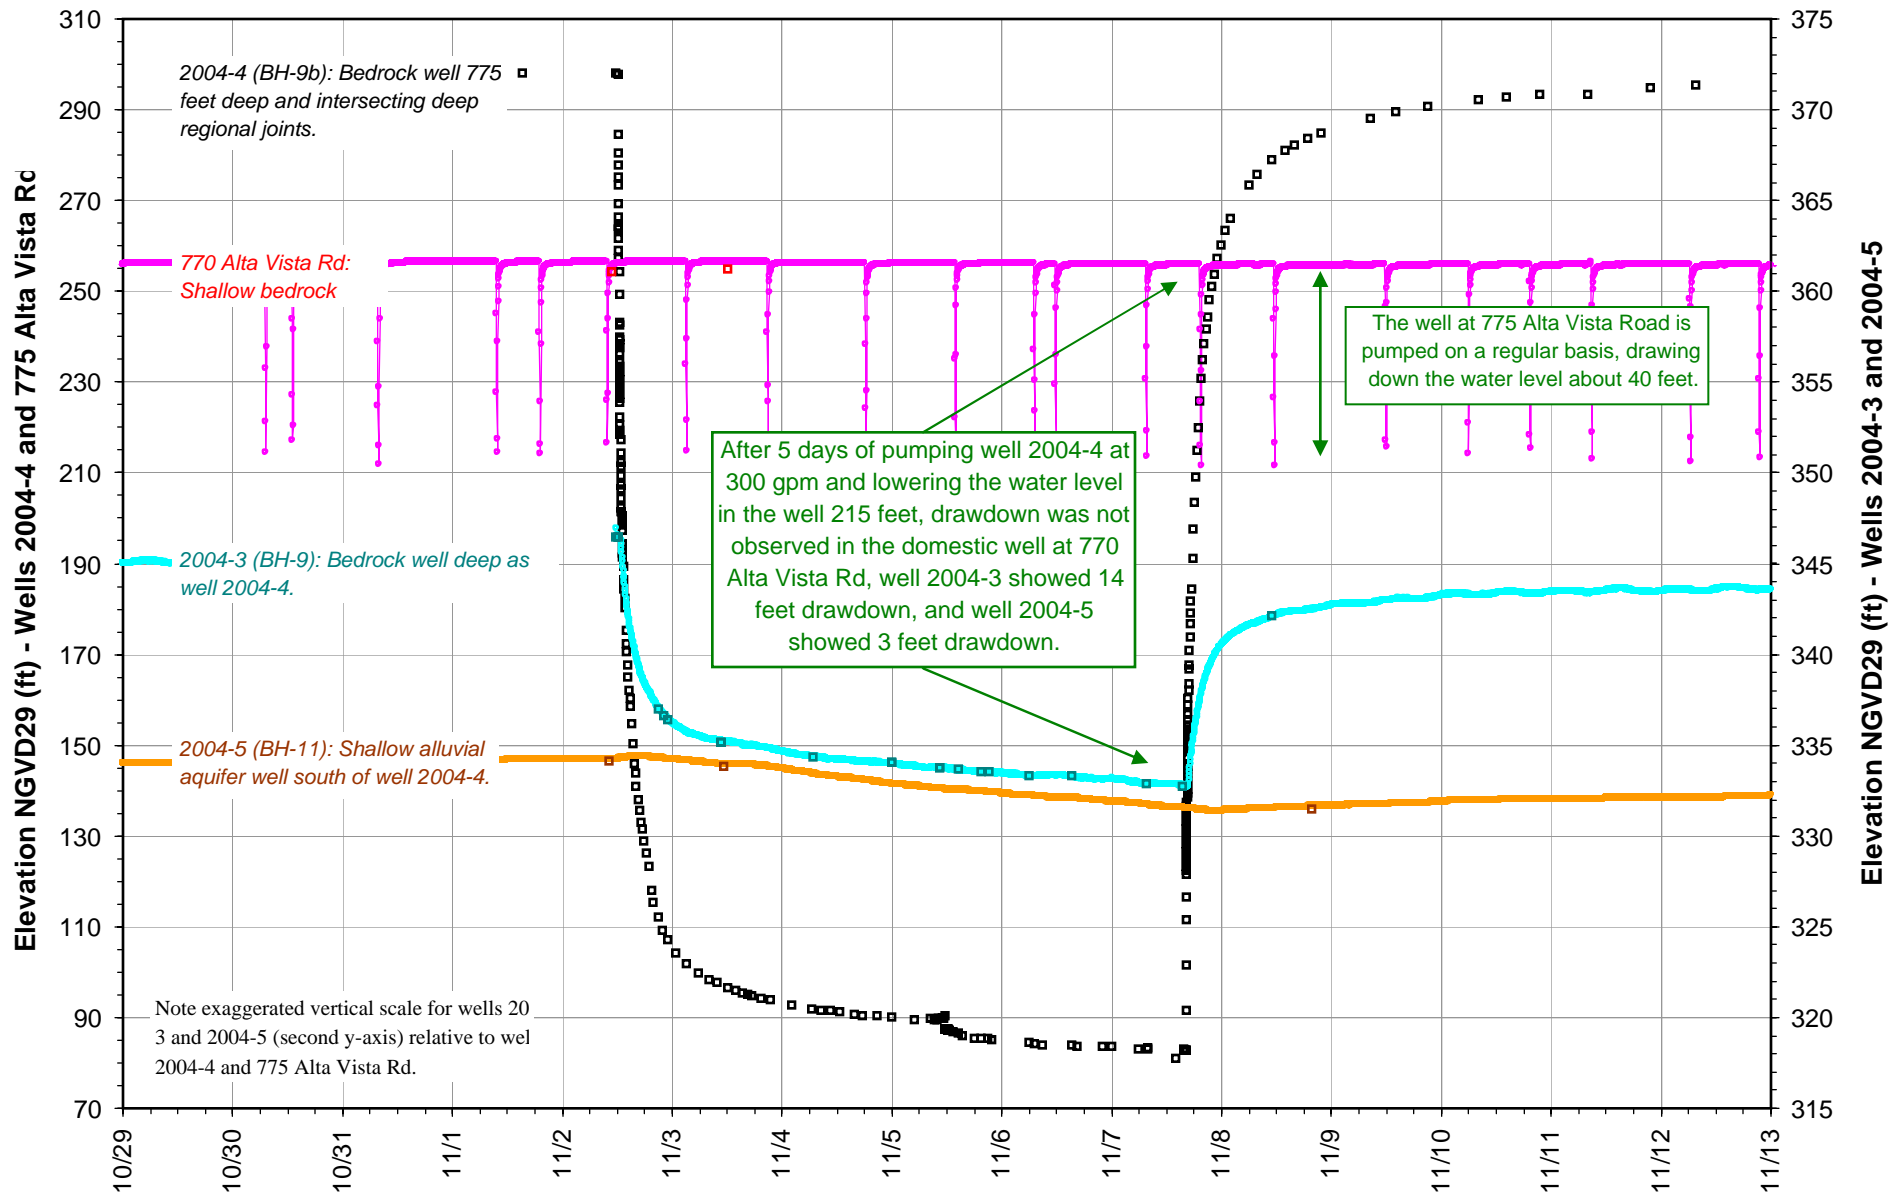
**Figure 10. Water-level elevations in Montara Water and Sanitary District test wells 2004-3, 2004-4, 2004-5, and domestic well at 770 Alta Vista Road, October 29 to November 13, 2004, while conducting a 300-gpm constant-rate pumping test at well 2004-4, San Mateo County, California.**

Note: Manual measurements are indicated as square symbols, other measurements were automated.

Wells 2004-3 and 2004-5 did show drawdown while pumping 2004-4 (Figure 10). Well 2004-3 is a bedrock well nearly as deep as well 2004-4, but with only intersecting fractures in the granitic rock and not deep open joints as in well 2004-4. It is located about 400 feet to the northeast and upgradient of well 2004-4. Well 2004-5 is a shallow well located about 860 feet south of well 2004-4. Well 2004-5 is screened in the weathered, fractured granitics at the base of the alluvium and coluvium at the west edge of the north fork of upper Montara Creek. After 5 days of continually pumping well 2004-4 at 300 gpm and lowering the water level in the well 215 feet, well 2004-3 showed 14 feet of drawdown, and well 2004-5 drew down 3 feet.

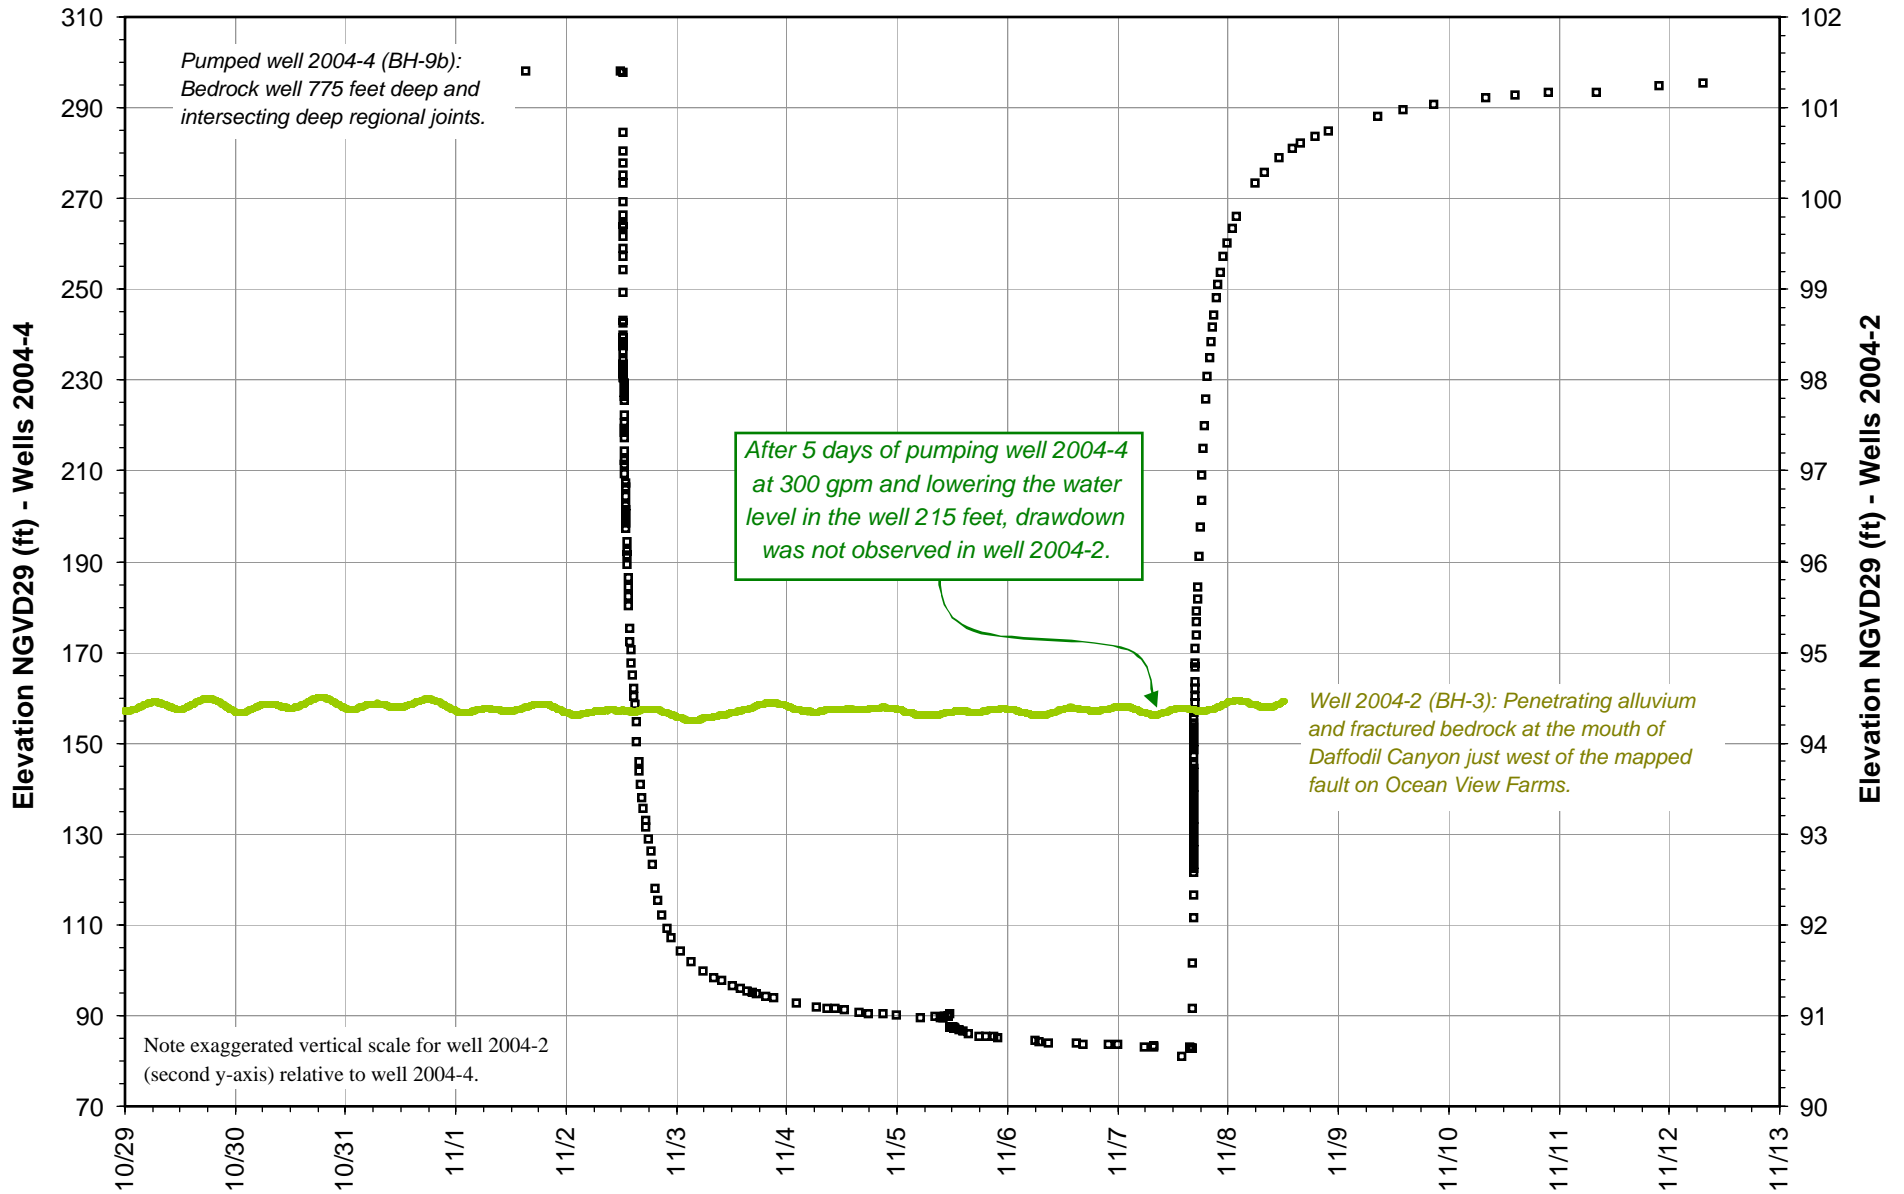
**Figure 11. Water-level elevations in Montara Water and Sanitary District test wells 2004-2 and 2004-4, October 29 to November 13, 2004, while conducting a 300-gpm constant-rate pumping test at well 2004-4, San Mateo County, California.**

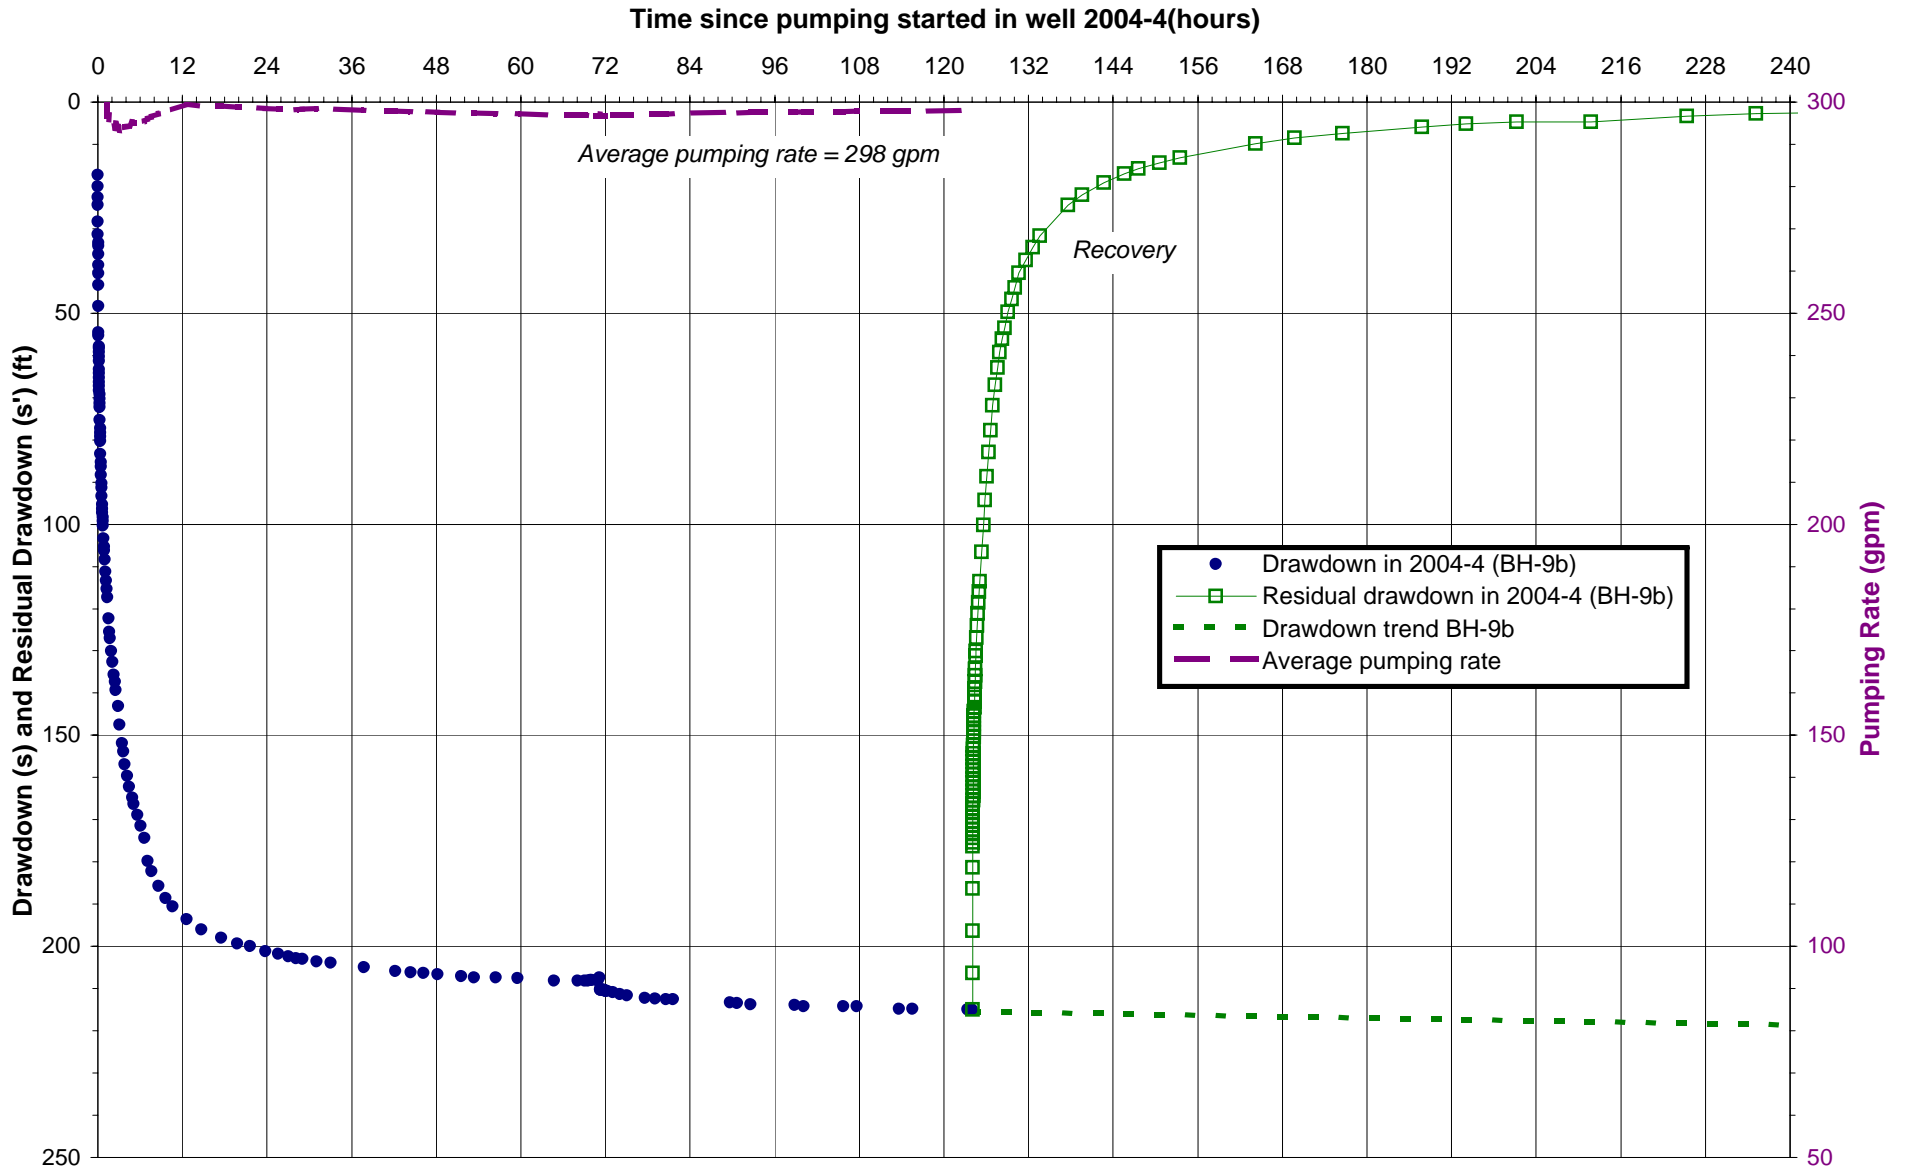
Figure 12. Drawdown and recovery in well 2004-4 (BH-9b), during constant-rate pumping test, November 2 to 12, 2004, APN 036-180-030, San Mateo County, California.

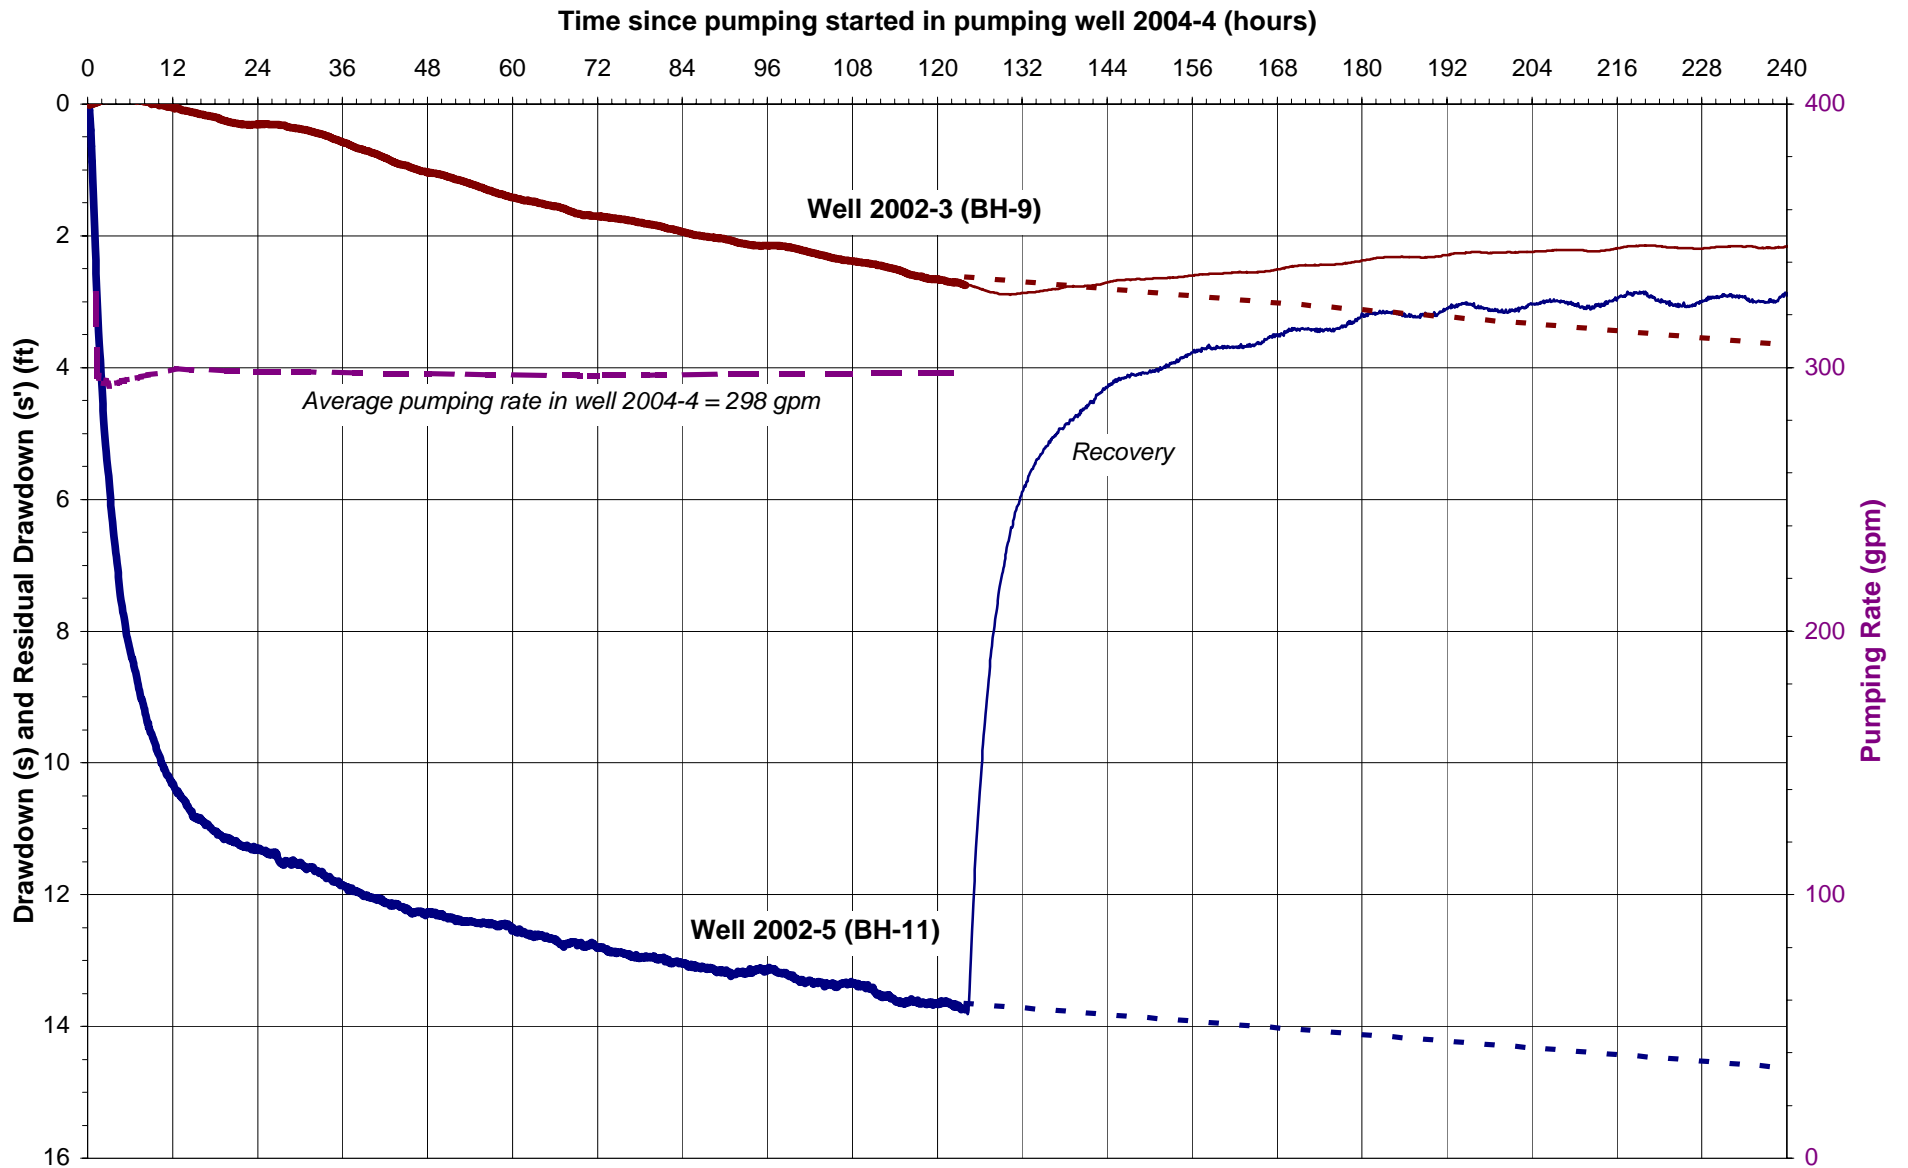
Figure 13. Drawdown and recovery in wells 2004-3 (BH-9) and 2004-5 (BH-11) during constant-rate pumping test, November 2 to 12, 2004 , APN 036-180-030, San Mateo County, CA.

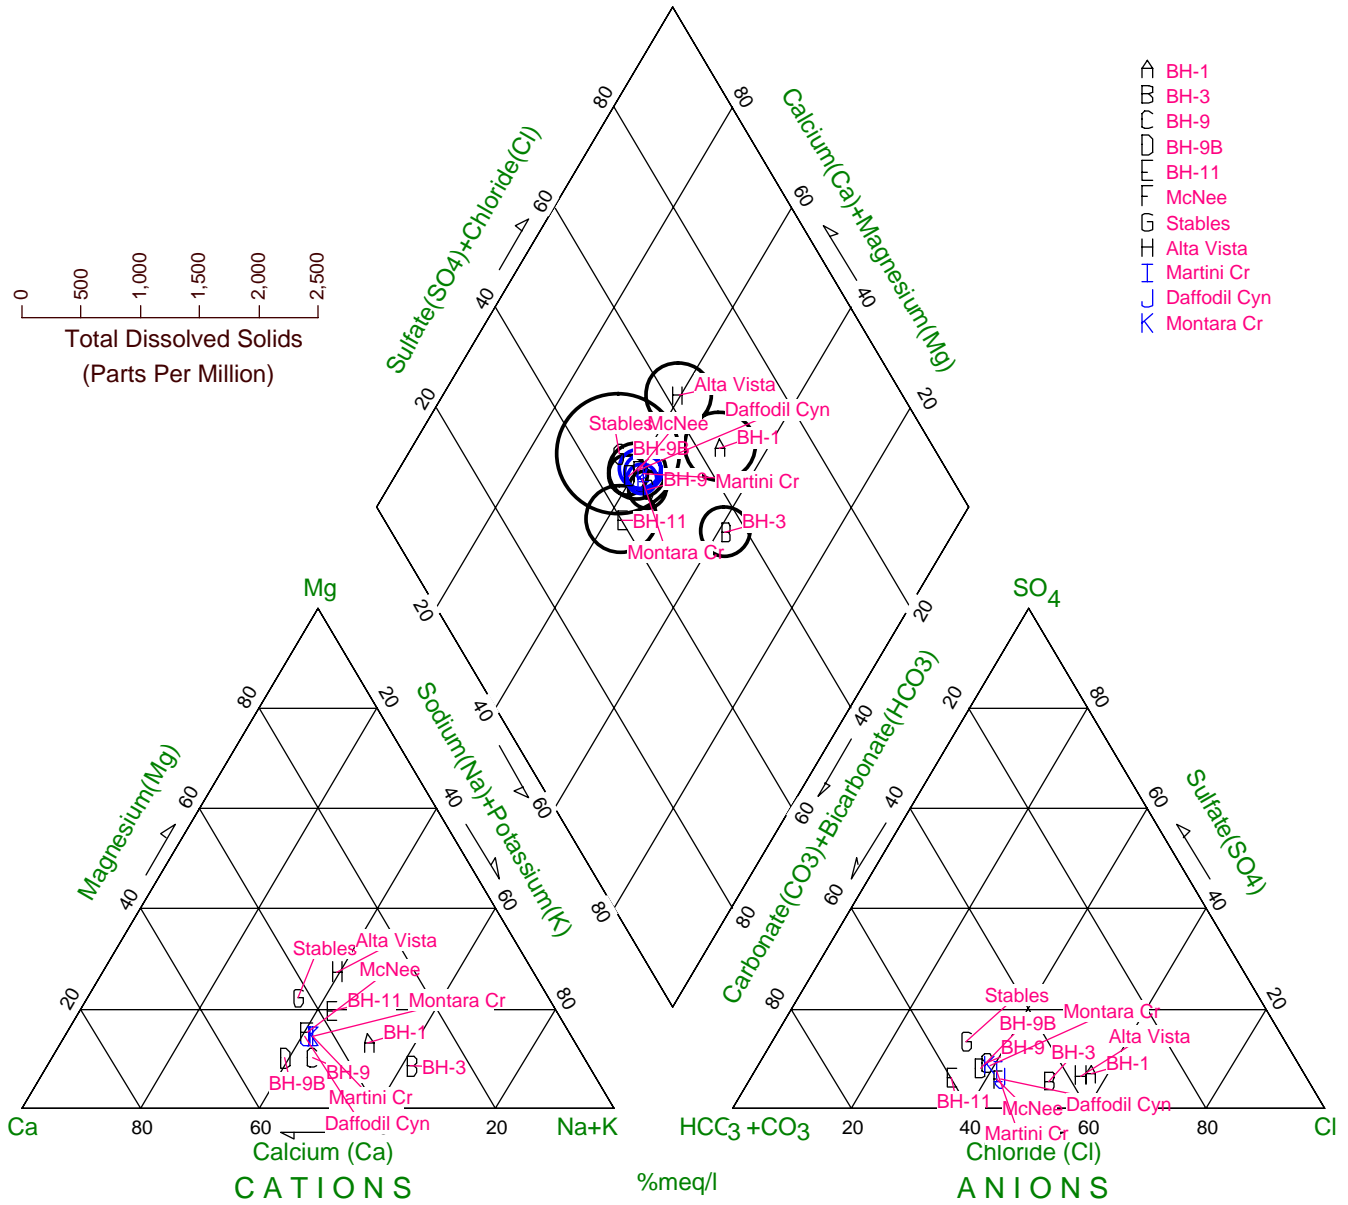
This diagram shows cations in the ternary graph on the left and anions on the right graph. The diamond graph in the center illustrates both cations and anions. Hardness dominated water plots to the left and top of the diamond graph, soft monovalent-salt dominated water to the right, and soft alkaline water towards the bottom. The radius of circle around the plotted points represents the concentration of dissolved solids, calibrated to the scale shown.

**Figure 14.** Piper diagram illustrating different ionic signatures of water samples collected from test wells during yield tests, and from regional wells and surface waters, Montara, San Mateo County, California.

Water samples were collected from well 2004-4 on September 22 after 8 hours of pumping at 300 gpm, and then again on November 7 after 5 days of pumping at 300 gpm. The samples were analyzed for general mineral composition and Title 22 inorganic constituents by Soil Control Laboratories in Watsonville (Appendix D), a facility certified by the State to conduct such analyses. Results are shown in Table 2, and compared in the table and in Figure 14 with analyses of other sources in the immediate area, including samples collected at:

General-mineral analyses (Figure 14) show that ground water from well 2004-4, drawing water from the granitic bedrock, is similar to other regional surface waters, and differs to varying degrees from water drawn from (1) weathered granitics, (2) valley alluvium, and (3) marine terraces. The waters from this well and local streams is sufficiently similar to suggest that they have a common aquifer of origin. The small amount of nitrate found well 2004-4 also indicates some connection with the near-surface waters (deep percolation from nearby sources such as septic systems, irrigated agriculture, or perhaps even decomposition of natural vegetation). Conversely, the trace amount of arsenic may also suggest that a portion of the ground water emanates from considerable depth.

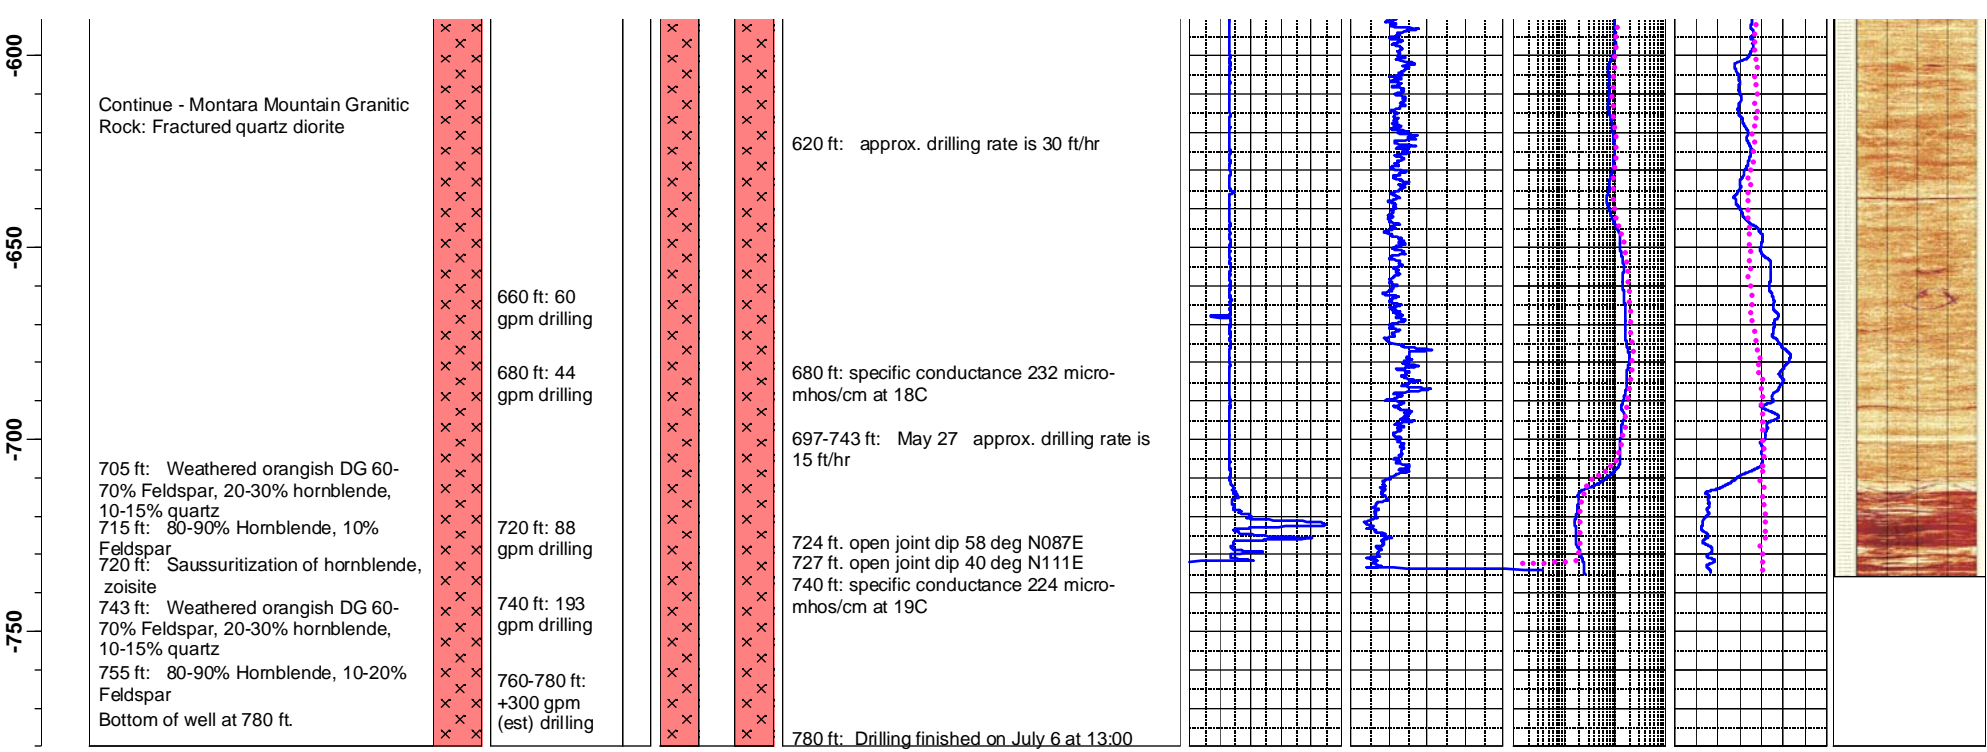
**Appendix A: Well log and construction diagram, hydrogeologists' observations and geophysical logs at BH-9b (well 2004-4).**

APN: 036-180-030	Driller: Steven Estebon, Maggiora Bros. Drilling
Location: Alta Vista Rd., Montara, CA	Drilling rig: Ingersoll Rand 1150/350
Latitude, Longitude: N37.5502, W122.4957 NAD27	Drilling bits: 8 3/4 in. air rotary, 8 3/4 in. air hammer, 16 in. rotary ream
Ground surface elevation: 530 feet	Cutting samples taken every 5 feet
Start drilling date: May 19, 2004	Depth of borehole: 780 feet
Well completion date: July 7, 2004	Depth of casing: 370 feet
Borehole geologists: Jason Parke, Gustavo Porras, Vic Abadie	Diameter of casing: 12 inches, I.D.
Geophysical log: Bill Henrich, Norcal Geophysics, June 1, 2004	9 inch non-cased borehole below 370 feet

Depth feet	Lithology	Hydrology	Well Construction	Remarks	Caliper Inches	Natural Gamma API Cs.	16N Ohm-m 10 10000	SPR Ohm 0 700	Acoustic Tele Viewer (360° view) N E S W N
------------	-----------	-----------	-------------------	---------	-------------------	--------------------------	--------------------------	---------------------	--

Drilling began on May 19, 2004 and the well was completed on July 7, 2004. The drilling rig used was an Ingersoll Rand 1150/350. Balance geologists Jason Parke and Gustavo Porras with assistance from local geologist Vic Abadie were on site to observe and sample drilling chips and cuttings, and log lithologic interpretations and hydrogeologic conditions. From May 19 to 27, a 9-inch borehole (approx.) was drilled to 743 feet below ground surface (bgs) using air. An 8 ¾ rotary bit was used from the surface to a depth of 272 feet bgs, where an 8 ¾ hammer was used to 743 feet bgs. Heavily-weathered granitics were found from 0 to 15 feet bgs, characterized as orangish brown cohesive sandy clay, which we interpret as developed-in-place soil. Weathered granitic rock was found from 15 to 235 feet. Fractured, typically unweathered Montara Mountain granitic rock was encountered from 235 feet to the final depth of 743 feet. The geologists' log of the well is presented in Appendix A.

The logs showed heavily fractured granitics above 350 feet bgs with principal fractures at 245 to 255 feet bgs, 310 to 315 feet bgs, and 330 to 340 feet bgs. Below 350 feet, there is about 360 feet of uniform, almost unfractured granitic rock to 714 feet bgs where dense fractures continued to the bottom of the surveys at 736 feet. Two large open joints were found at 724 and 727 feet bgs, which were interpreted as a primary source of the high water yields observed while drilling. The largest joint (at 724 feet bgs) strikes 3 degrees west of north, and dips east 58 degrees east (or dipping  $58^{\circ}$  N $87^{\circ}$ E). The other joint strikes north 21 degrees east and dips 40 degrees east ( $40^{\circ}$  N $111^{\circ}$ E).

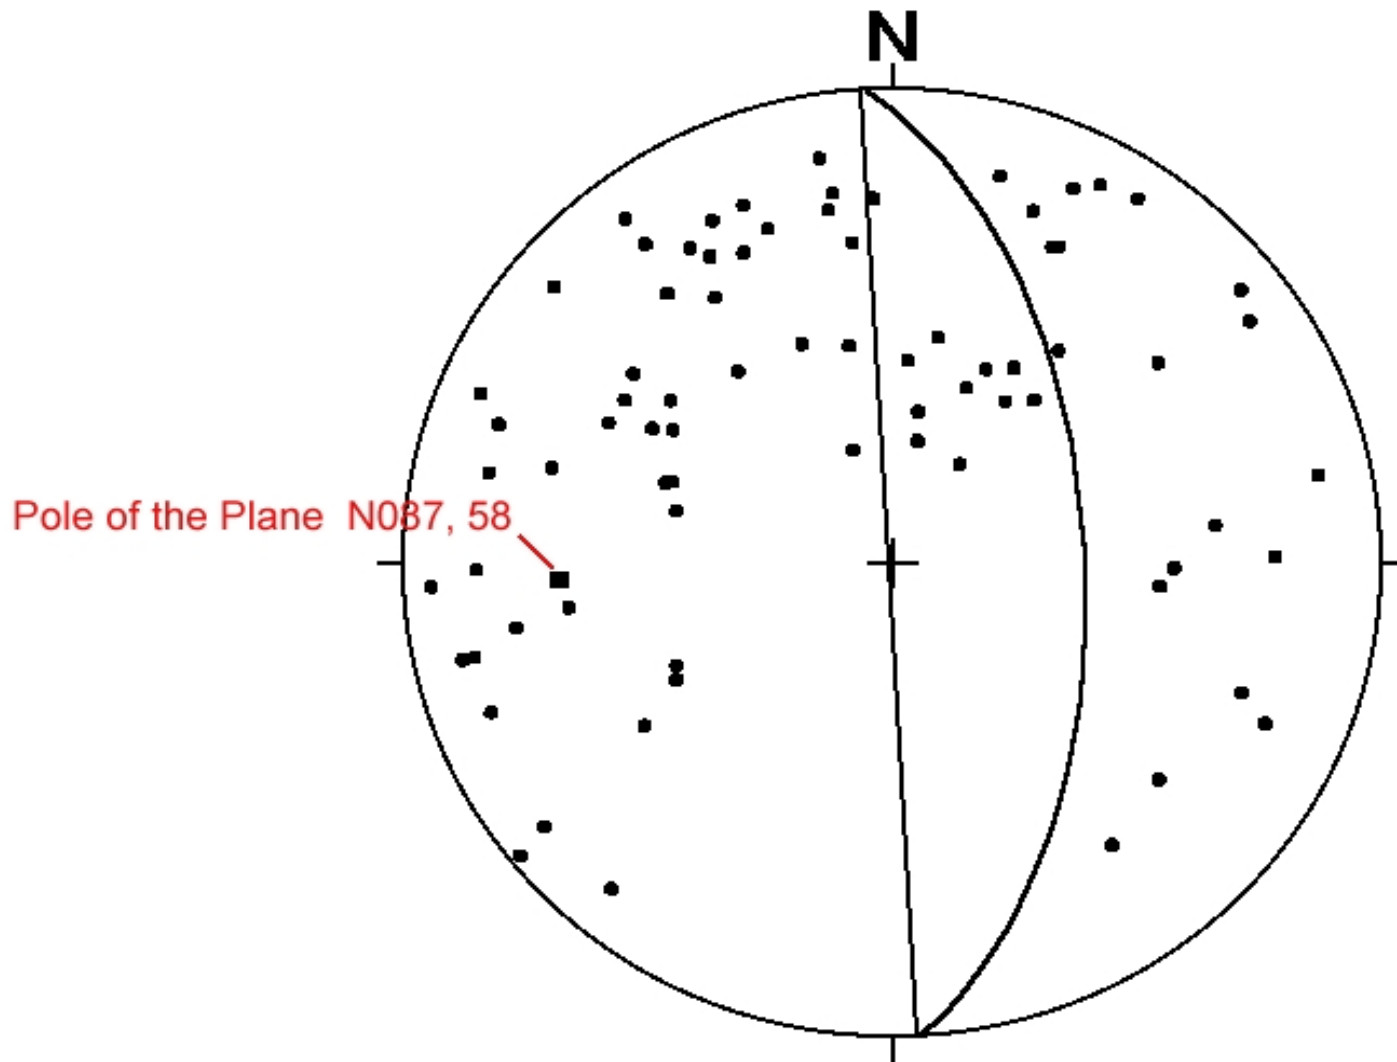
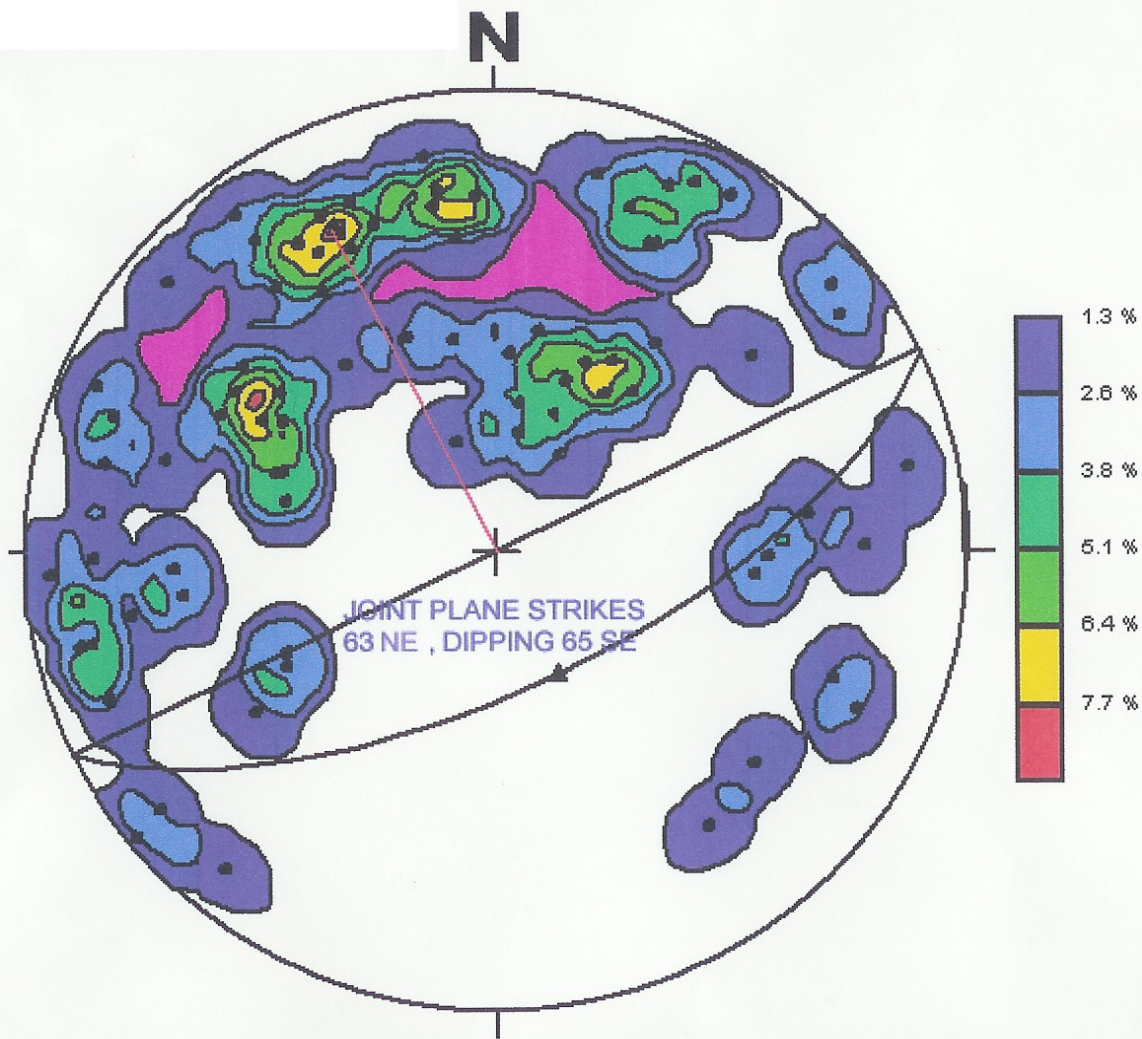
**Appendix B. Schmidt-net plot of discontinuities in BH-9b, APN 036-180-030, San Mateo County, California.**

The high water-yielding open joint at 724 feet has a dip azimuth of N87°E and a magnitude of 58°. It strikes N3°W. The joint plane and pole to the plane (projected perpendicular to the lower hemisphere) is identified in the plot. Acoustic televiewer survey and data interpretation performed by Norcal Geophysics.

Lower hemisphere - Bh-9B AZIMUTH-DIP			
N=78	Search area=1.0%	Peak=6.00

fractured and is dissected by regional faults and open joints.<sup>8</sup> Figure 4 shows the orientations of fractures, joints and faults in the vicinity of well 2004-4 (see Appendix B for details of the fracture orientations). The high water-yielding joints found at depth in well 2004-4 (the largest shown in Figure 4 and 5) appear to intersect this fracture flow and is broadly connected to even more permeable 'pocket' aquifers on the mountain through the fracture network of the batholith. Several springs are found at considerable elevations, including the springs feeding the MWSO raw-water diversion (Figure 15), suggesting similar joint and fracture ground-water sources elsewhere on the mountain.
