SAN PEDRO CREEK AND PACIFICA STATE BEACH FECAL INDICATOR BACTERIA TMDL STATUS AND MONITORING REPORT WATER YEAR 2018

IN COMPLIANCE WITH PROVISION C.14 OF THE MUNICIPAL REGIONAL STORMWATER PERMIT

March 15, 2019

Prepared by the County of San Mateo and City of Pacifica

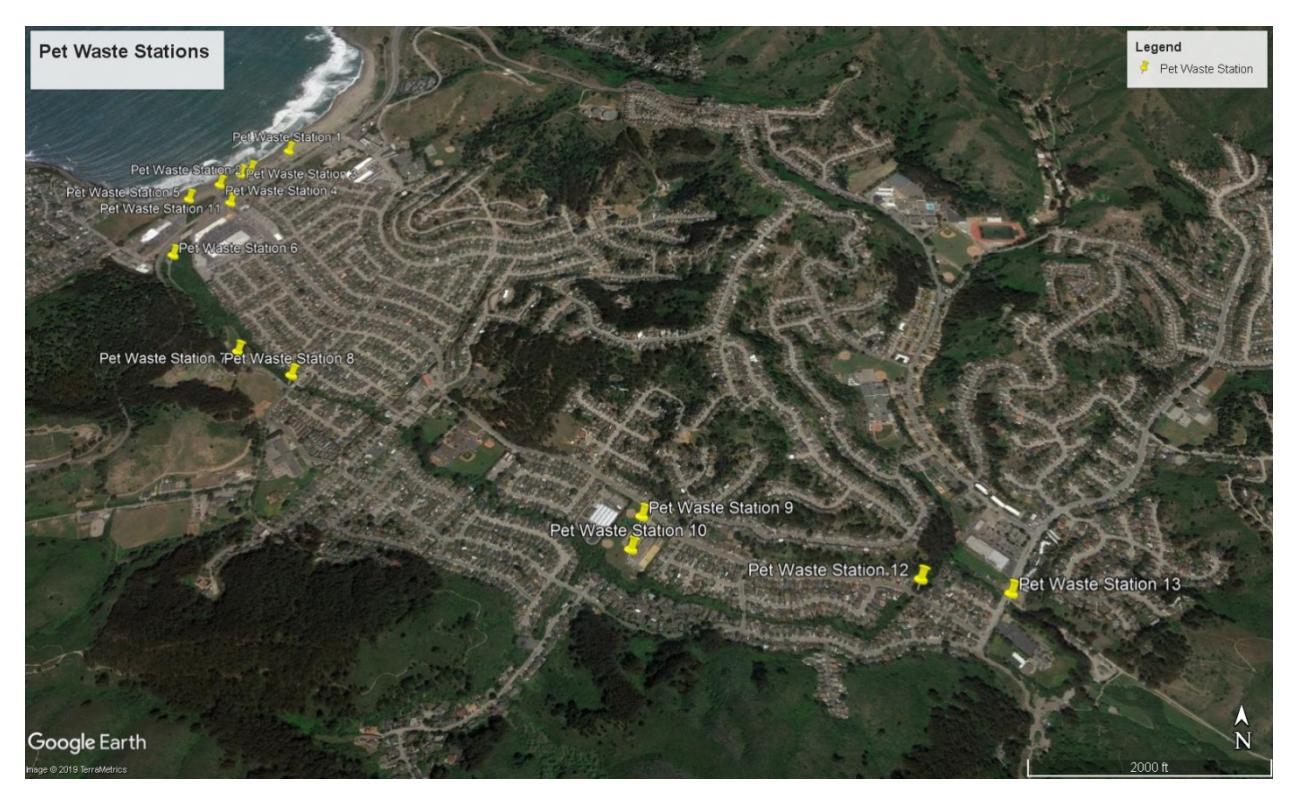
Figure 1. San Pedro Creek and Pacifica State Beach Pet Waste Stations

The City of Pacifica installed 10 new dog waste clean-up signs, waste bag dispensers and trash cans at high priority locations within the TMDL Project Area. The high priority sites were determined via visual inspections of popular dog walking areas and their potential to discharge improperly deposited pet waste to San Pedro Creek and Pacifica State Beach. The City is in the process of installing additional pet waste station along the Highway 1 trail at Linda Mar Boulevard and at locations where San Pedro Creek crosses Linda Mar Boulevard and Oddstad Boulevard. The locations are listed on Table 1 and shown on Figure 1.

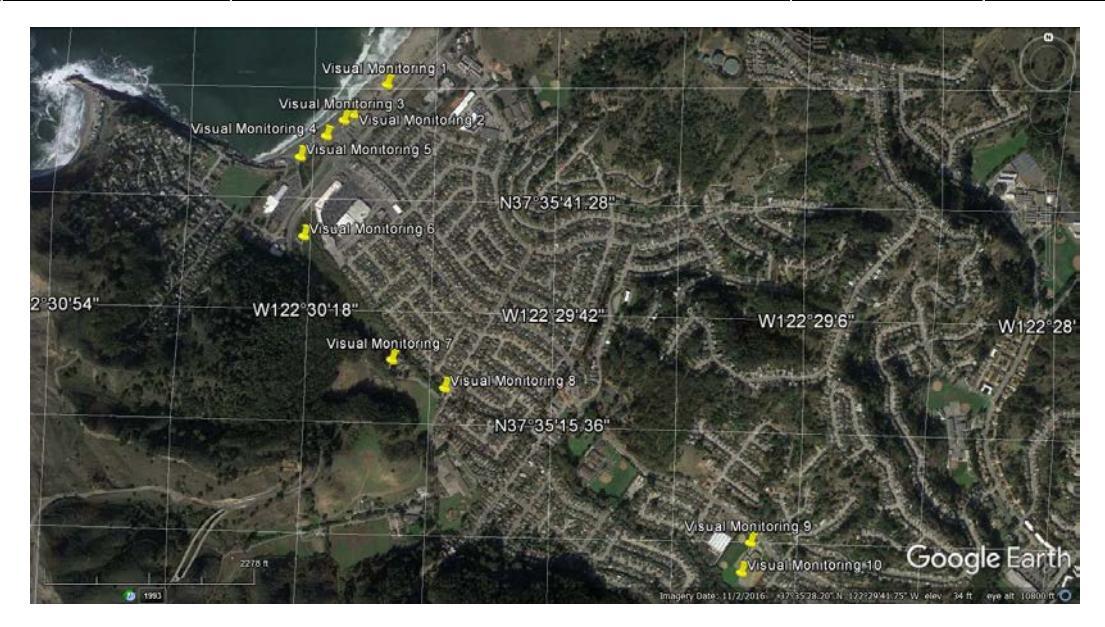
Figure 2. San Pedro Creek and Pacifica State Beach Visual Monitoring

In February 2017, the City of Pacifica developed and implemented a visual inspection and cleanup plan for high dog waste accumulation areas along San Pedro Creek and its tributaries. The locations of visual inspection and cleanup areas are listed on Table 2 and shown on Figure 2. Visual inspections completed in October 2018 and January 2019 found pet waste left on two (2) of the ten (10) walking pathways.

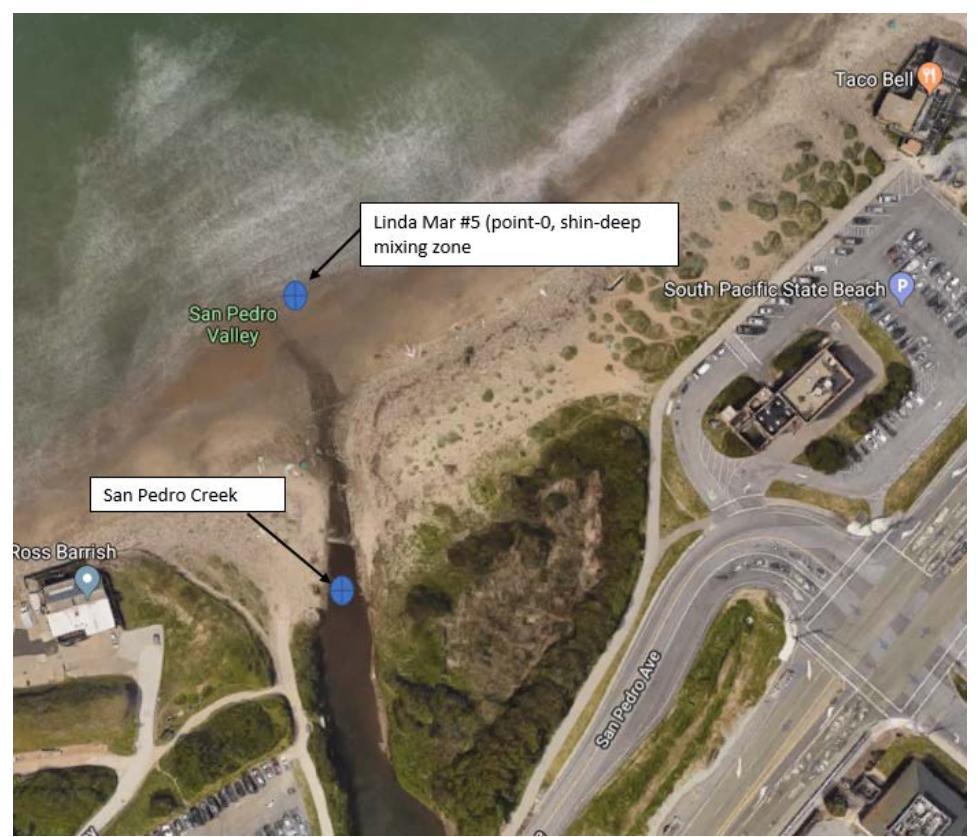
Figure 6: Compliance monitoring sampling sites

This report includes an analysis of compliance monitoring conducted in WY 2018. County Environmental Health performed weekly compliance monitoring on behalf of the City and the County at Pacifica State Beach (Linda Mar Station #5) and the mouth of San Pedro Creek (Creek Mouth). See Figure 6 for a map of sampling locations. Ocean water samples from Linda Mar beach were analyzed for total coliform, enterococci, and *E. coli* (in place of fecal coliform). Creek mouth samples were analyzed for *E. coli* and total coliform. Monitoring data from Linda Mar and the Creek Mouth is entered by County Environmental Health into the State Water Board's Beach Watch database on a weekly basis.

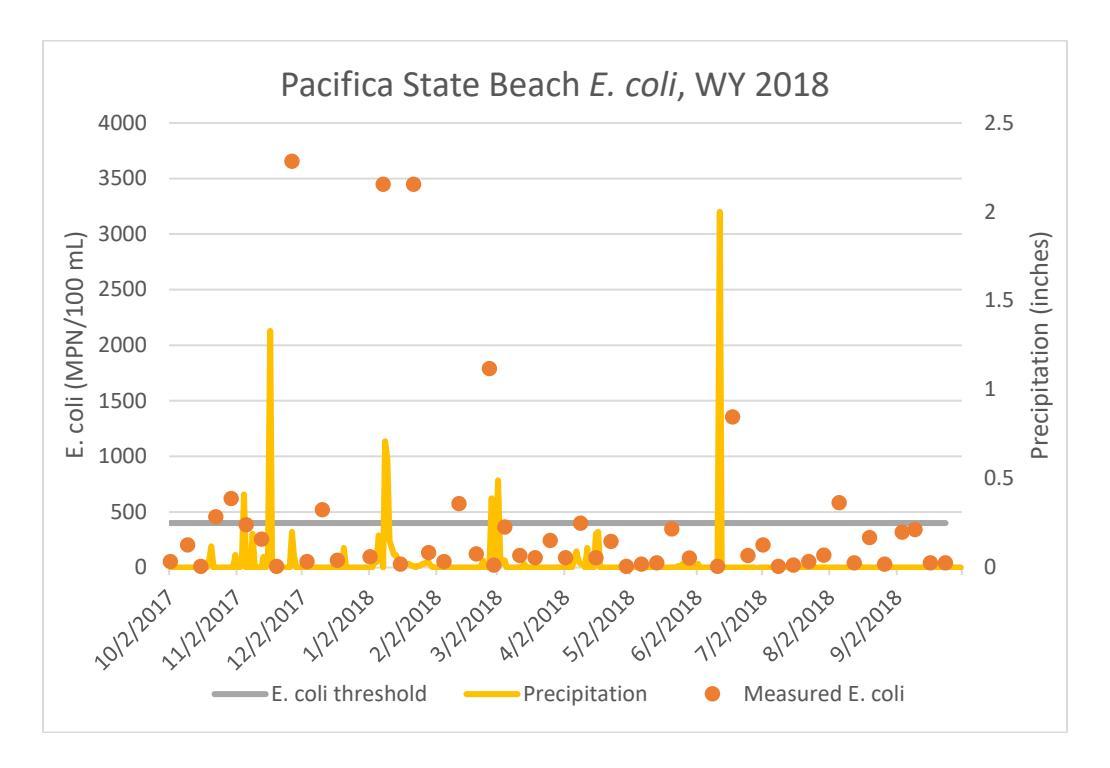
Figure 7: Pacifica State Beach E. coli, WY 2016

Three of the five highest *E. coli* concentrations occurred during winter wet weather. The lowest *E. coli* concentrations all occurred during dry weather.

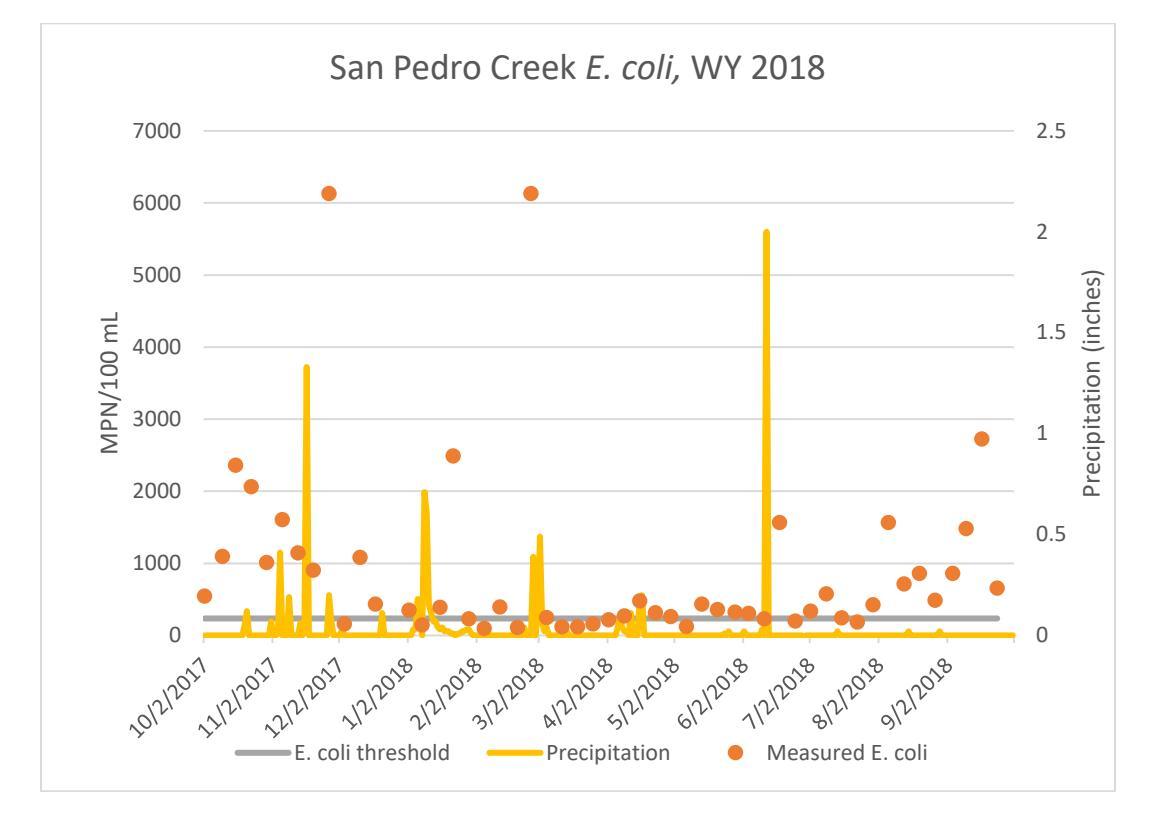
Figure 8: San Pedro Creek E. coli, WY 2018

E. coli concentrations exceeded water quality objectives throughout the year. The lowest *E. coli* concentrations occurred during dry weather. Half of the top six highest concentrations of *E. coli* occurred during wet weather, the other half occurred during dry weather.

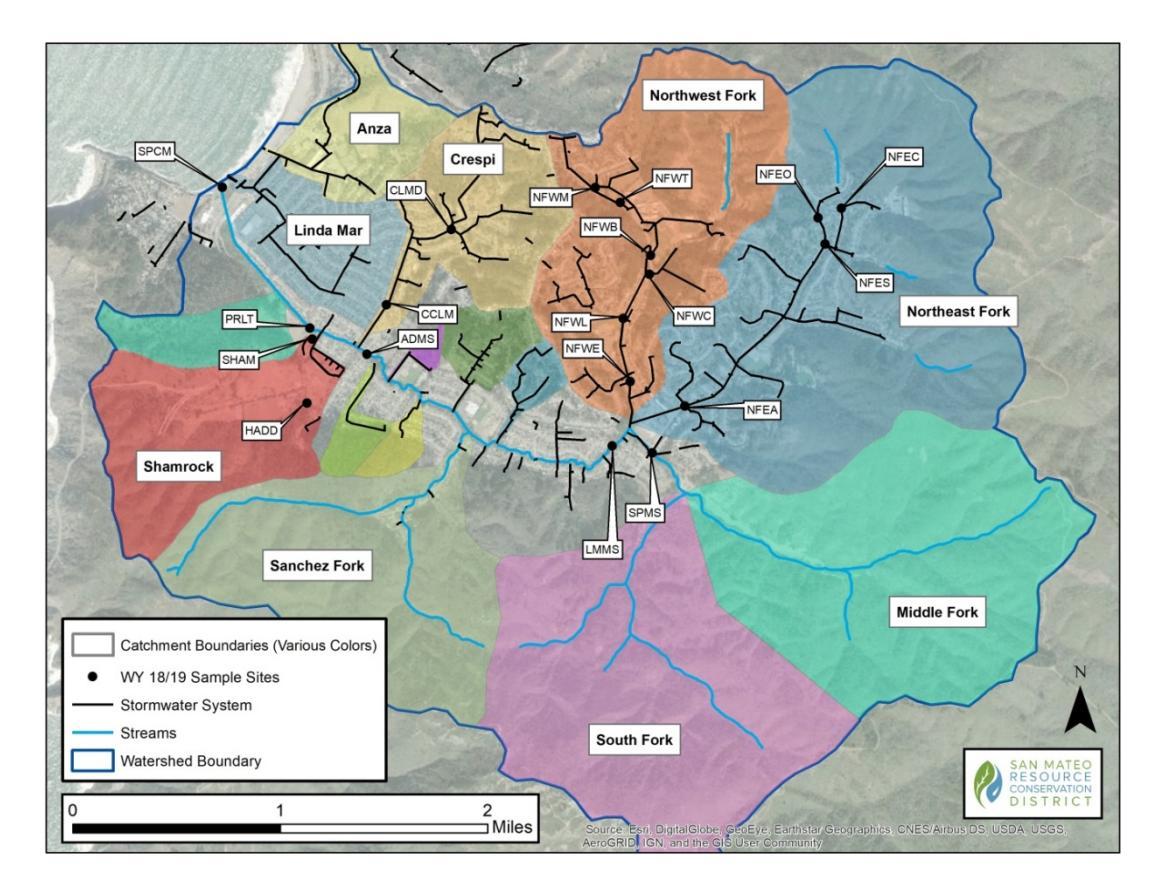
Figure 1. San Pedro Creek watershed catchments, stormwater system, and WY18/19 sample sites.

The San Pedro Creek watershed is comprised of the mainstem of the creek, numerous catchments with perennial and intermittent tributaries, and spring water within the stormwater network (Fig 1). The Middle Fork, the South Fork, and the Sanchez Fork are open channel, perennial streams with vegetated banks. The Northeast and Northwest Forks consist of several perennial and intermittent tributaries that are conveyed into the stormwater system before discharging to the mainstem. The Shamrock catchment is comprised of intermittent open channel tributaries routed through ponds before being routed into the stormwater system and discharging to the mainstem. The Crespi catchment consists of perennial spring water within the stormwater system that is routed to an open concrete-lined channel that discharges to the mainstem. Anza and Linda Mar catchments do not drain to San Pedro Creek but rather to pump stations where stormwater is conveyed to a water recycling plant or to Pacifica State Beach. The small remaining catchments in the watershed convey wet weather flows through the stormwater network to the mainstem of the creek.

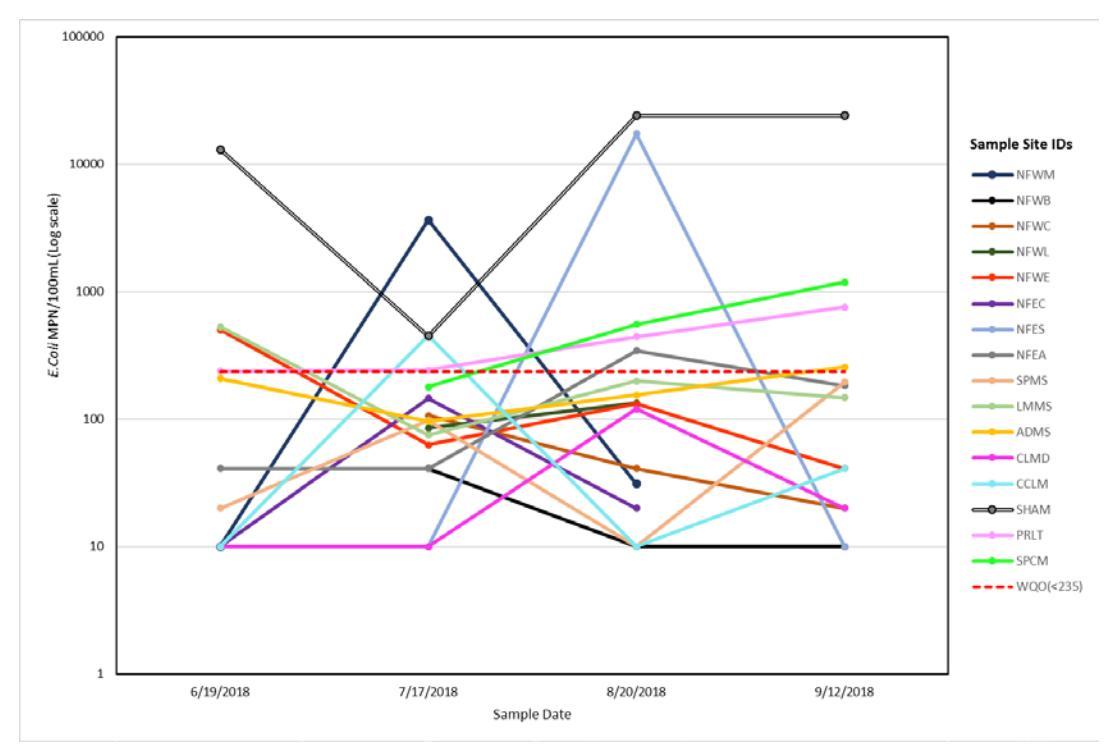
Figure 2. *E.coli* by sample date in the dry season of WY18. Note the figure does not include data from 8/6/18 sampling event in the Northwest Fork in order to better visualize trends.

The *E.coli* WQO of 235 MPN/100 mL was exceeded in 36% of the samples in the WY18 dry season. Most exceedances of the WQO occurred at the three sample sites furthest downstream (SHAM, PRLT, SPCM). Some of the highest concentrations of *E.coli* were seen at the SHAM sample site which had a median *E.coli* level of 6,724 MPN/100 mL. There were five sample sites (NFWB, NFWC, NFEC, SPMS, CLMD) where the WQO was never exceeded (Fig 2). There was an upstream/downstream trend of higher *E.coli* along the mainstem of the creek between each sample site except between LMMS and ADMS (Fig 3). Note, if the recently adopted *E.coli* WQO of 320 MPN/100 mL is used to assess the WY18 dry season data, there would be three less exceedances of the WQO (at PRLT and ADMS).

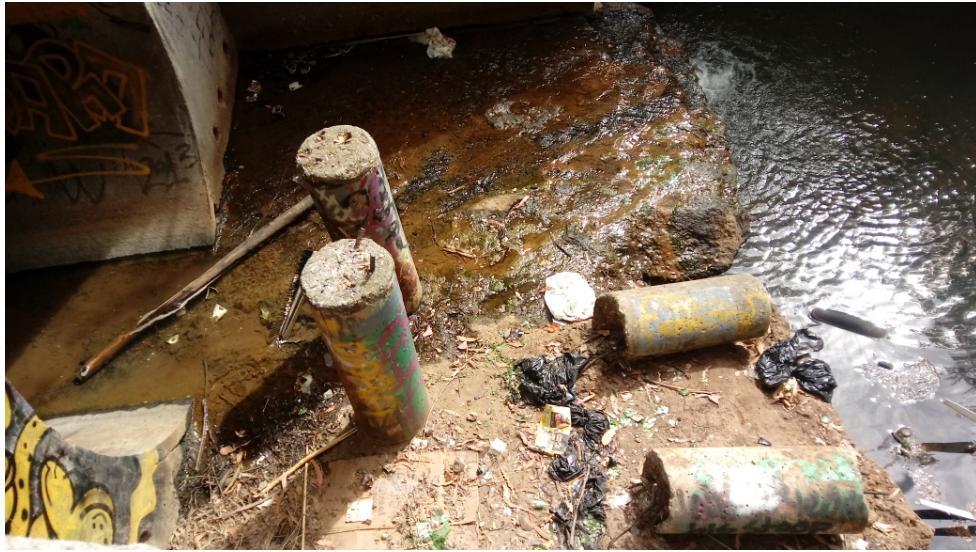
Figure 4. Outfall transporting water from the North Forks to the mainstem of the creek.

The next sample site downstream is LMMS, which is just downstream of where the Northeast and Northwest Forks join the mainstem. Therefore, LMMS is comprised of Middle and South Forks, as well as the North Forks which include large residential areas, horse facilities, schools, and commercial areas. In the dry season of WY18, the WQO was exceeded during one sampling event at LMMS. So the North Forks may impact *E.coli* levels on the mainstem of the creek in the dry season. Note that the North Forks join together and discharge at a large outfall to the creek where litter, trash bags, raccoon prints and erosion have been observed (Fig 4).

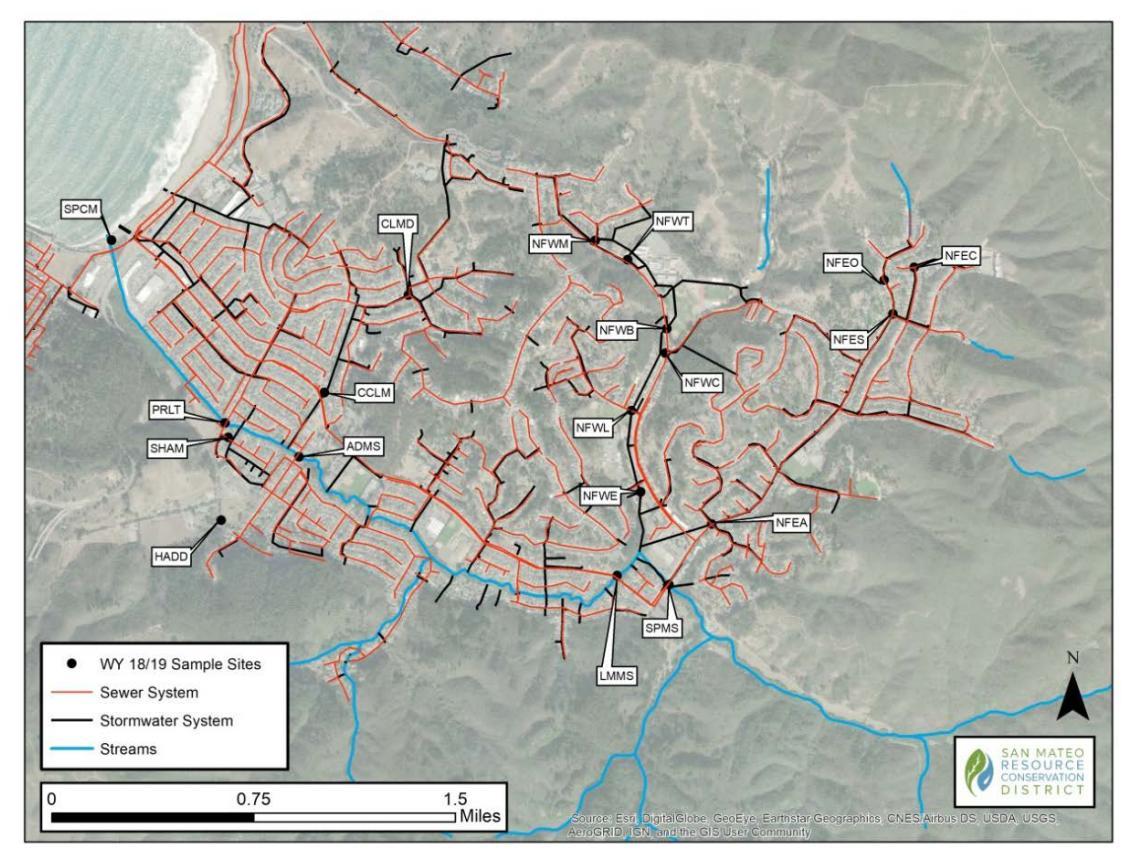
Figure 5. Stormwater lines and City sewer lines in the San Pedro Creek watershed

No homeless encampments or dumping has been observed in this area and the City noted that RV activity in the watershed is minimal. Stormwater lines and the City's sewer lines are close to each other at these sample sites but not between these sample sites (Fig 5). The City's sewer system in the Northwest Fork is ~60-70 years old and is therefore reaching the end of its lifespan (Fig 6). Most sewer pipes and laterals in this area are made of clay and are therefore outdated and likely deteriorated (RMC 2011). Exfiltration of sewer water into surrounding soil, groundwater and potentially the stormwater system is possible. The stormwater system was built around the same time as the sewer system, and the condition (cracks, fractures, holes etc) is unclear as it has not been assessed.

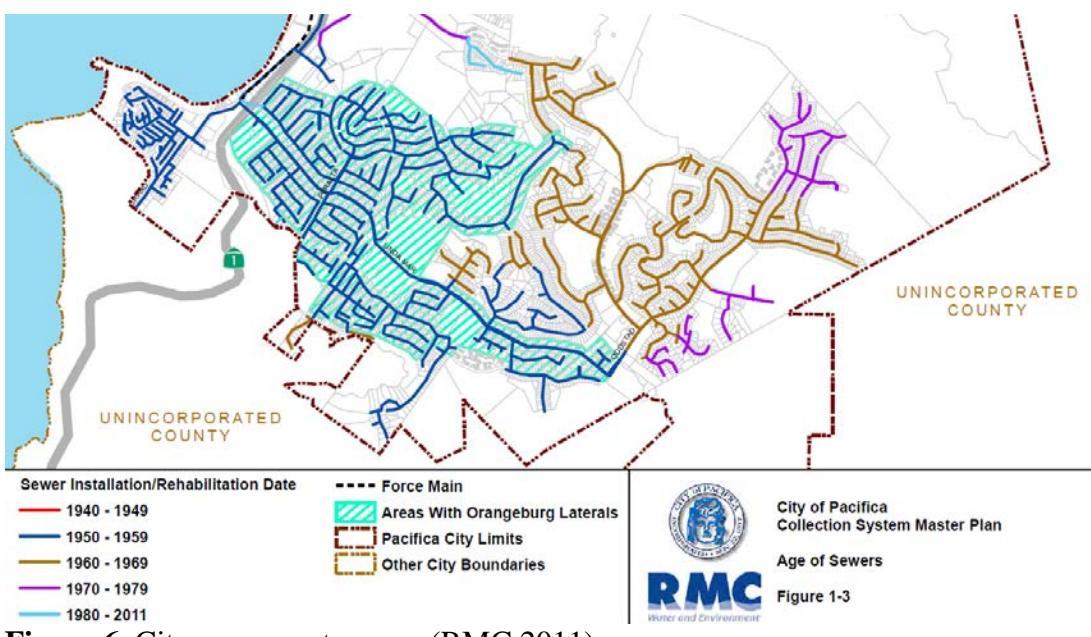
Figure 6. City sewer system age (RMC 2011)

The Sewer System Collection Master Plan (RMC 2011) indicates that there is a major structural defect along Terra Nova Blvd near the intersection with Everglades Drive (near NFWC) that is considered a high priority for repairs. It also indicates that increased pipe sizes are needed along Terra Nova Blvd from Lerida Way to Oddstad Blvd (near NFWL and NFWE). The City began upsizing these pipes on Terra Nova Blvd in January 2019 and indicated that this should address issues identified upstream such as the defect at Everglades Drive.

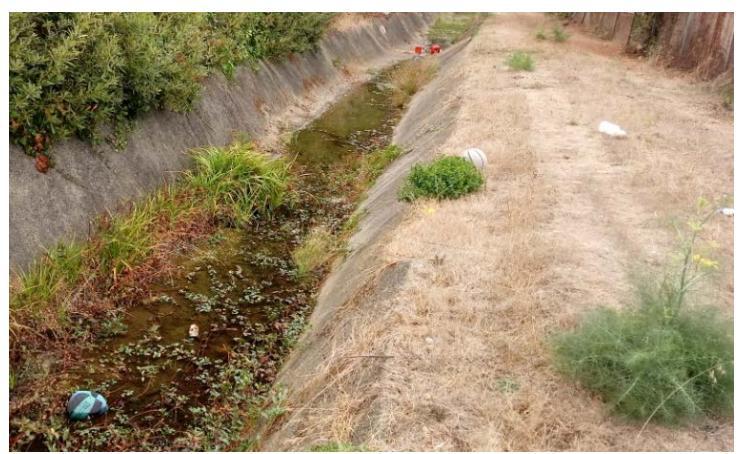
Figure 7. Crespi canal in the dry season.

During sampling events and reconnaissance surveys, horse waste was never observed at or near CCLM and there does not appear to be any horses in the entire catchment. The MDL for horse is 60 gc/mL and the highest concentration at CCLM was 181 gc/mL. According to the laboratory, it is possible that these were false positives or that the horse marker was picking up other species such as ruminants. Although the Crespi canal is largely fenced off, there is a small section of the canal that is not fenced off (~25 ft). It is clear that wildlife access the canal as evident by large amounts of scat from deer, rabbits, and raccoon. Even though the dog marker was not detected during the WY18 dry sampling events, dog waste is observed frequently along the banks of the canal. This waste appears to be coming from dogs at residences lining the canal where there are holes in some of the private fences. Dog waste bags have also been observed inside the storm drain on Crespi Drive right above the canal. Further over the course of the dry season, trash accumulates inside and along the canal (Fig 7). Cleaning up trash and animal waste along the canal would likely be beneficial in improving the overall health of the creek.
